Subject: Transmittal of the Cow Pen Creek Bank Stabilization and Floodplain  
Reconstruction Monitoring: 2018 Report  
Lockheed Martin Corporation – Middle River Complex  
2323 Eastern Boulevard, Middle River, Baltimore County, Maryland

**COW PEN CREEK  
BANK STABILIZATION AND FLOODPLAIN  
RECONSTRUCTION MONITORING: 2018 REPORT  
LOCKHEED MARTIN MIDDLE RIVER COMPLEX  
2323 EASTERN BOULEVARD  
MIDDLE RIVER, MARYLAND**

December 2018

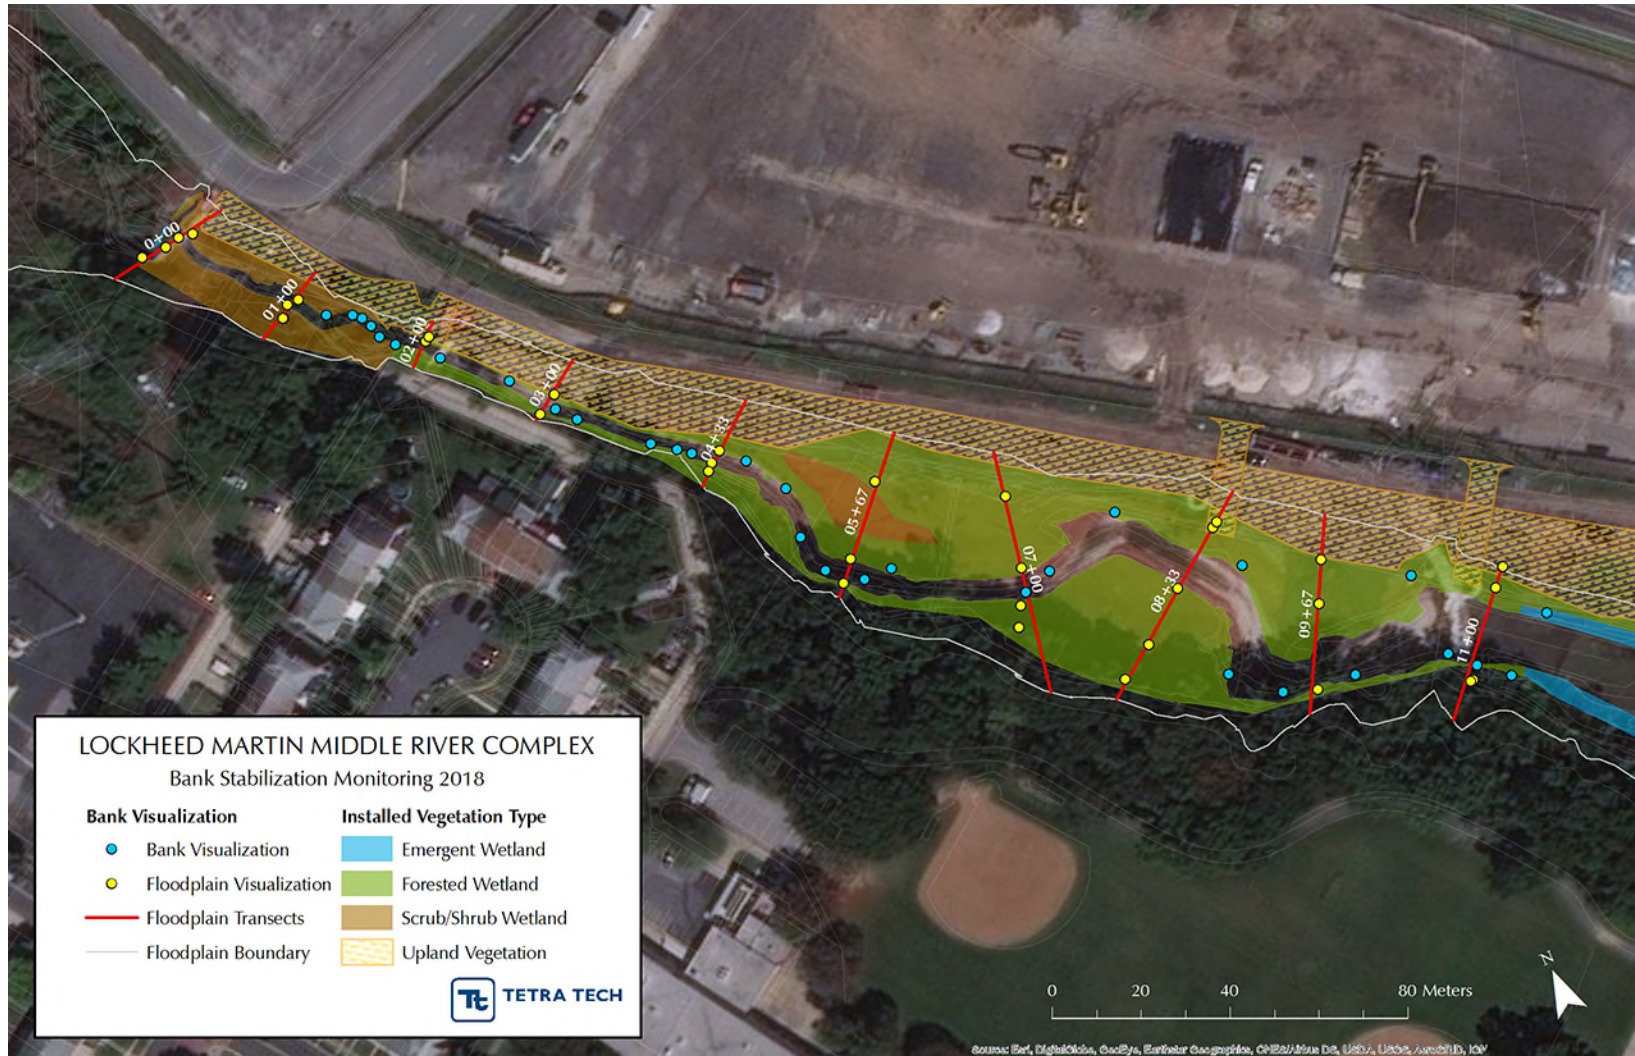
Within the Cow Pen Creek (CPC) study area, data were collected along streambanks and in transects across the floodplain (Figure 4-1). Findings of the field assessments are described below. Locations of representative photographs along the channel and other views are shown on Figure 4-2. Appendix A is a photo log containing representative photographs of the channel (upstream and downstream views at transect locations) and photographs taken from streambank assessments, floodplain transects, and other views. Appendix B lists global positioning system (GPS) coordinates at field assessment points for both the streambank and floodplain assessments.

**Figure 4-1 Map of Cow Pen Creek study area showing bank stabilization segment endpoints along both streambanks (blue) and floodplain survey points (yellow) along 10 floodplain transects. Upland and wetland vegetation types are from revegetation plan, Nov. 20, 2017.**

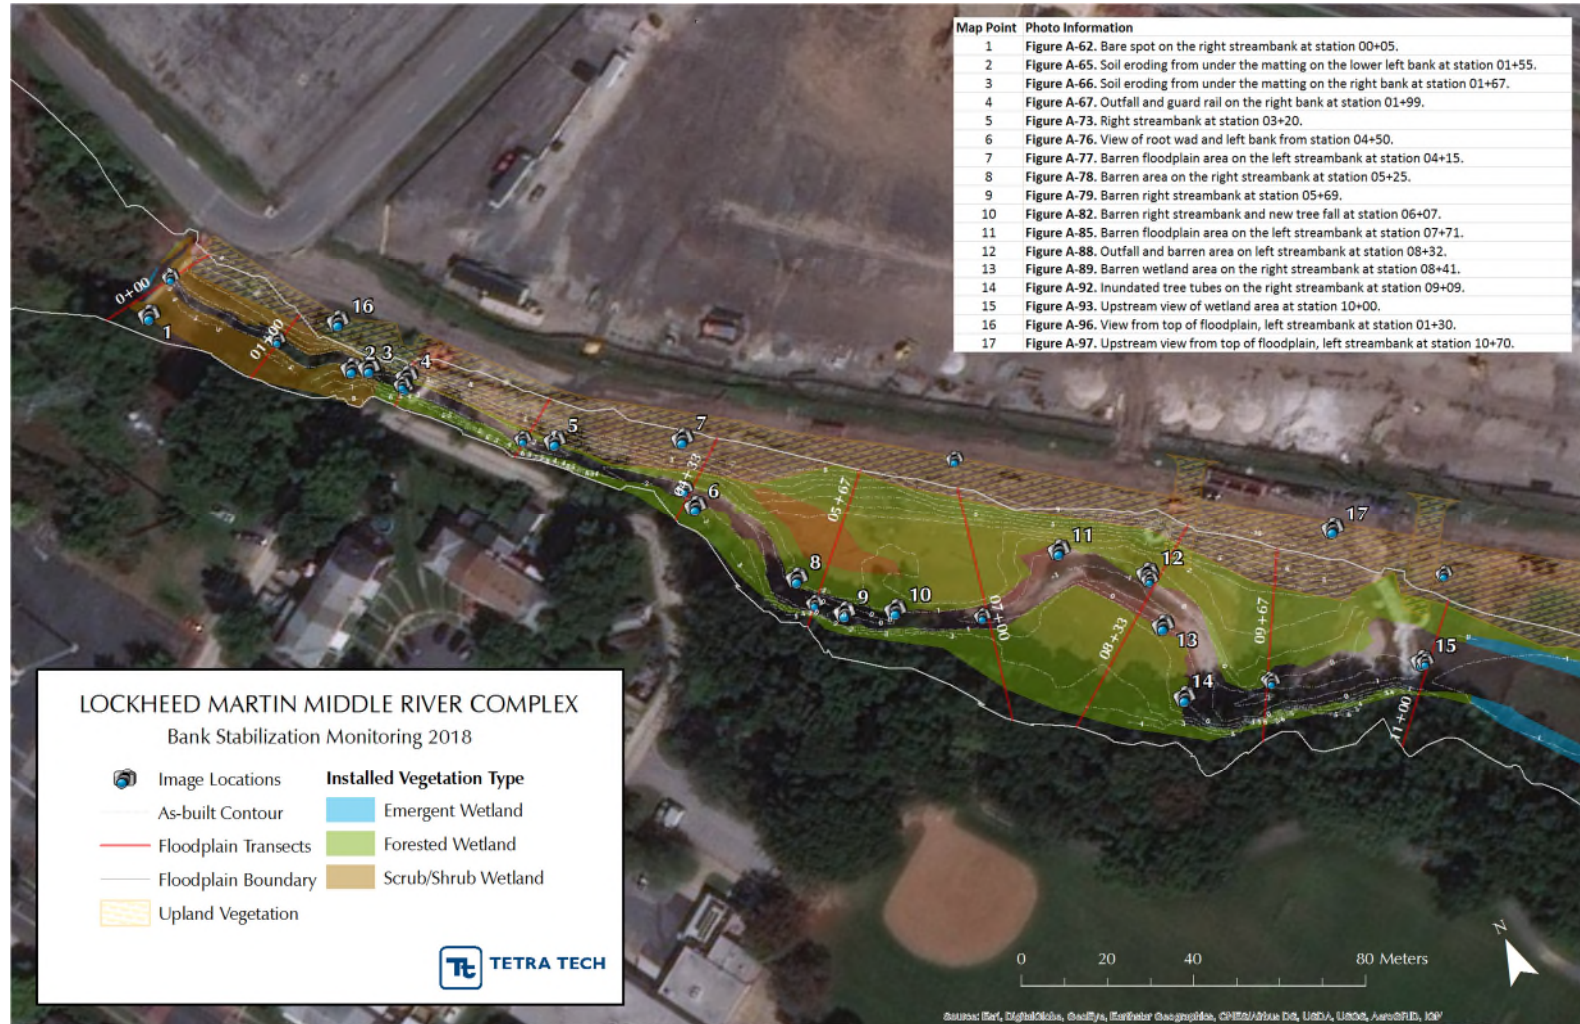
**Figure 4-2 Map of Cow Pen Creek study area showing locations of representative photographs along the stream channel (upstream and downstream views at each transect) and photographs of other features of note (map points 1-17, with photograph descriptions). For photographs, see Appendix A, Figures A-60 to A-97. Upland and wetland vegetation types are from revegetation plan, Nov. 20, 2017.**

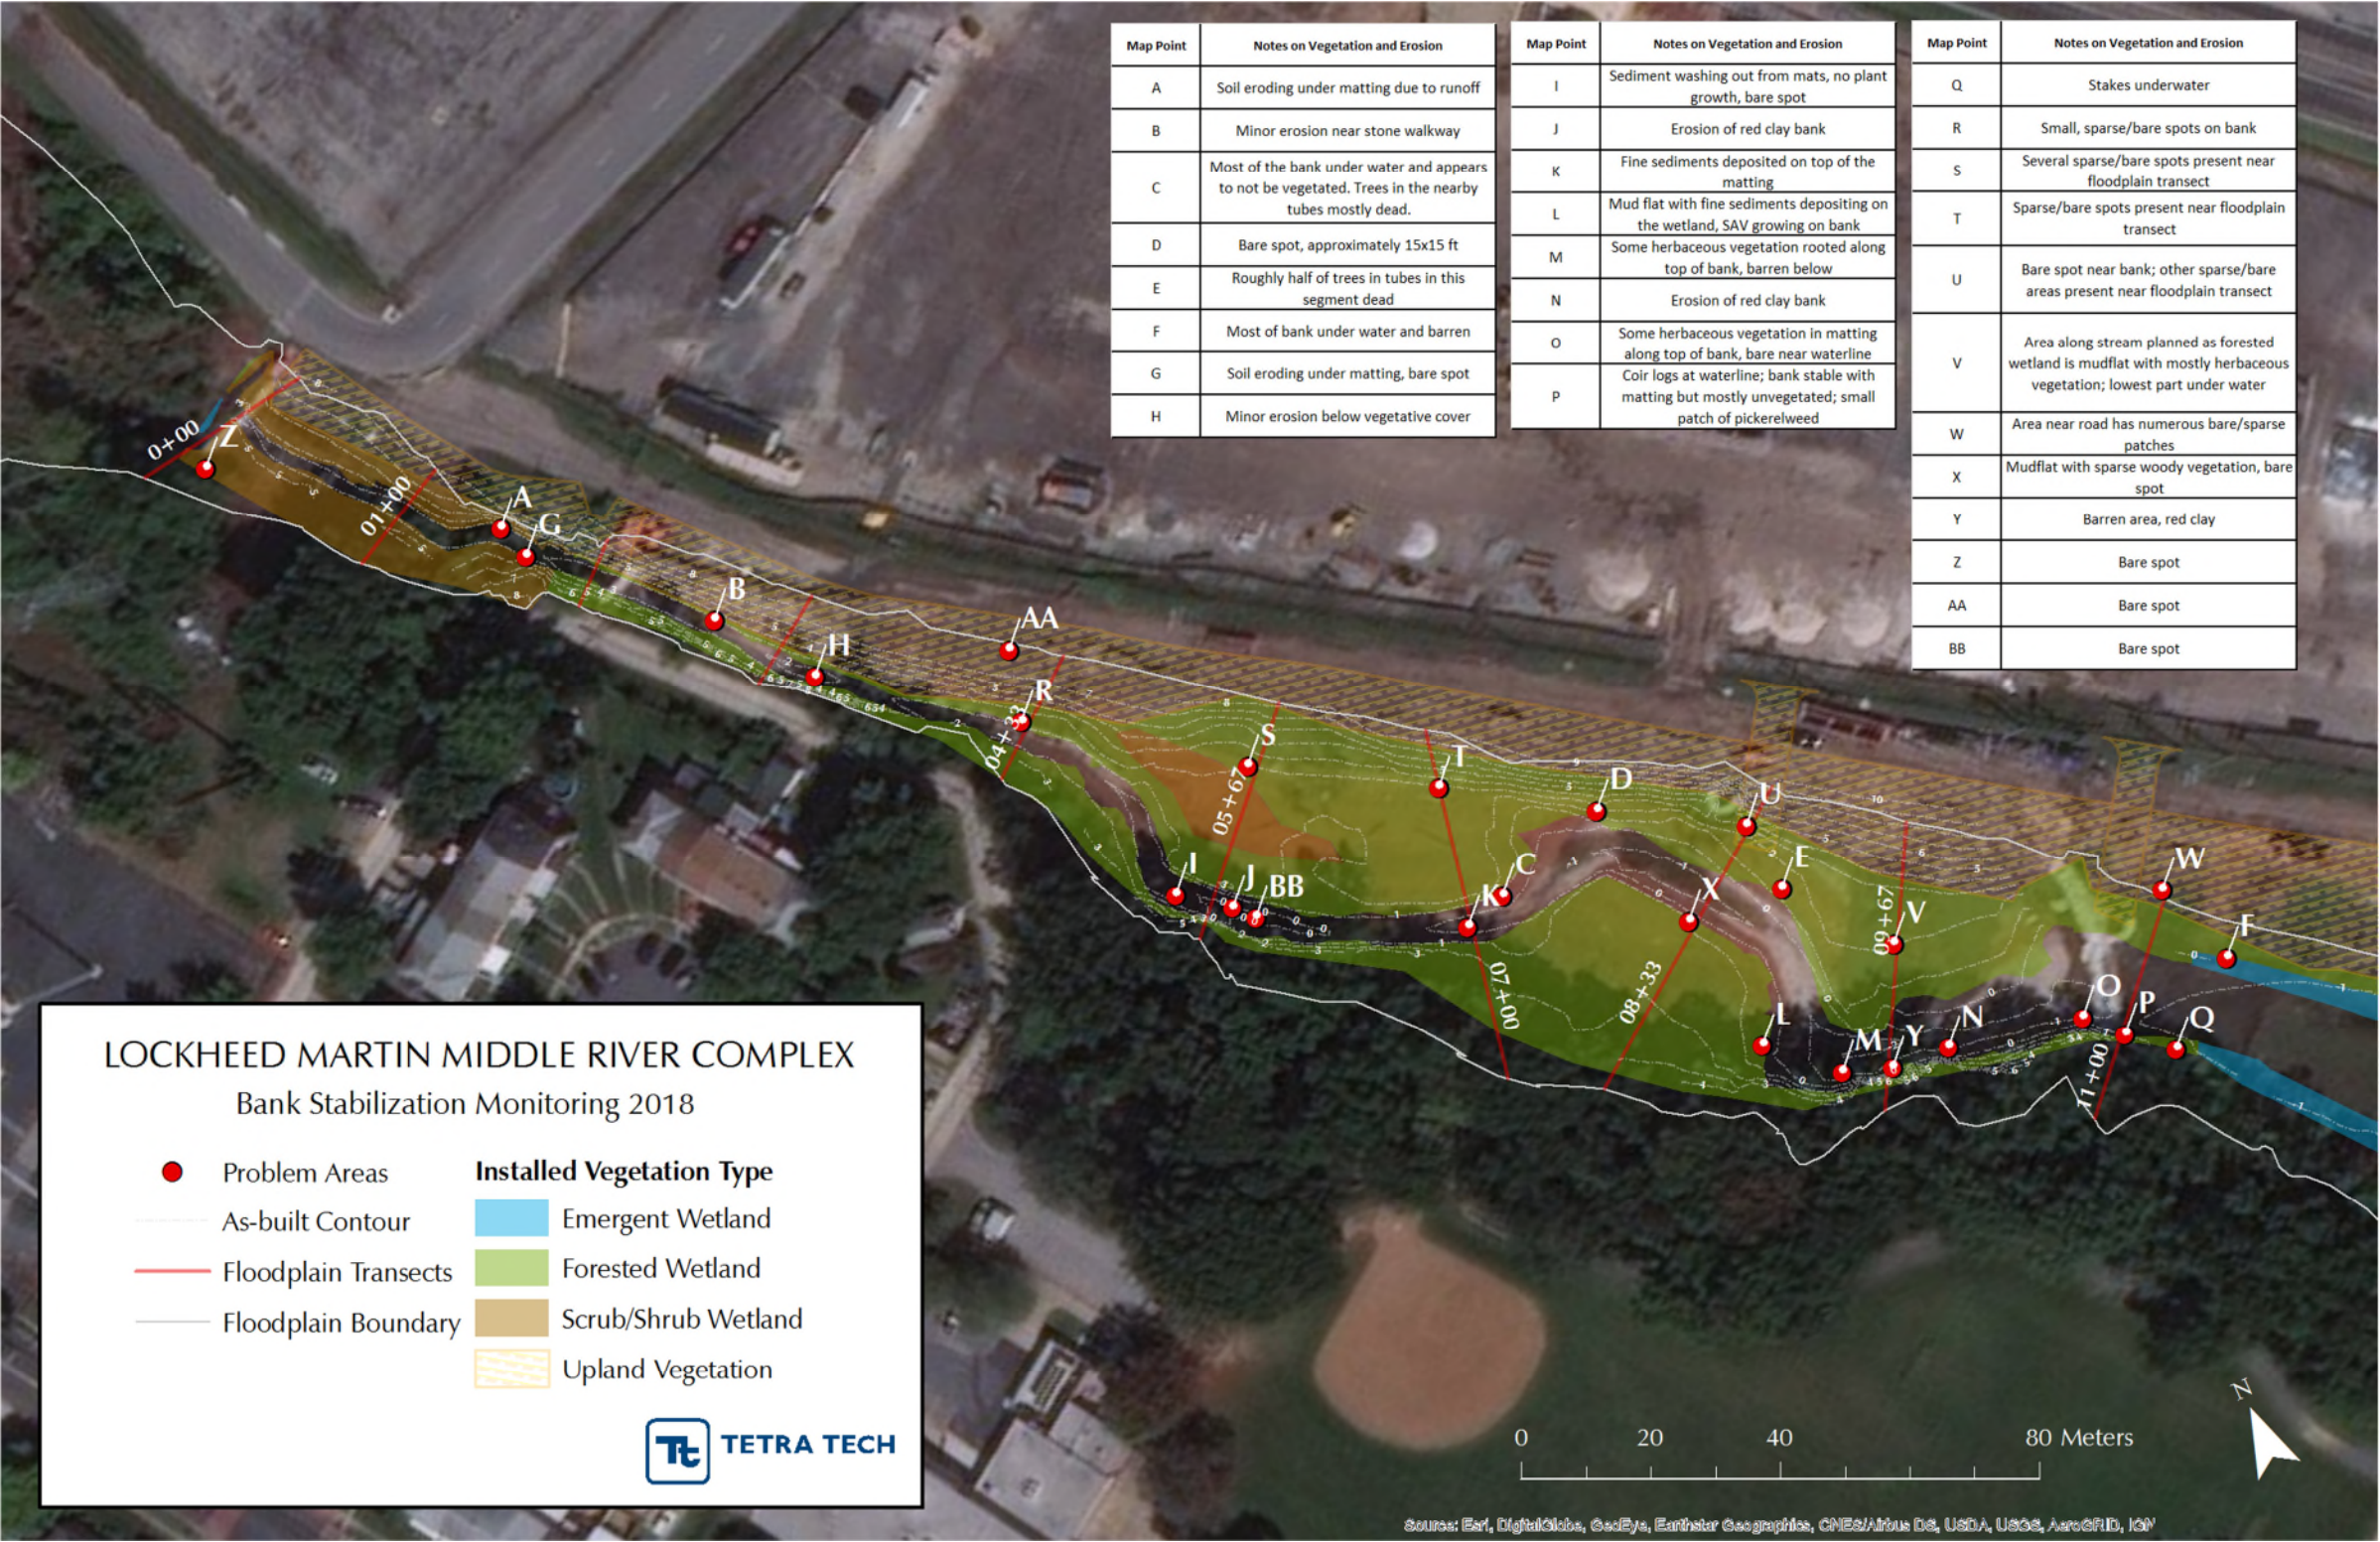
Locations of particular areas with notes about erosion or vegetation cover concerns are shown on the map in Figure 4-5.

Figure 4-5 Map of Cow Pen Creek study area showing locations of areas noted based on concerns for erosion or vegetative cover condition. Upland and wetland vegetation types are from revegetation plan, Nov. 20, 2017.

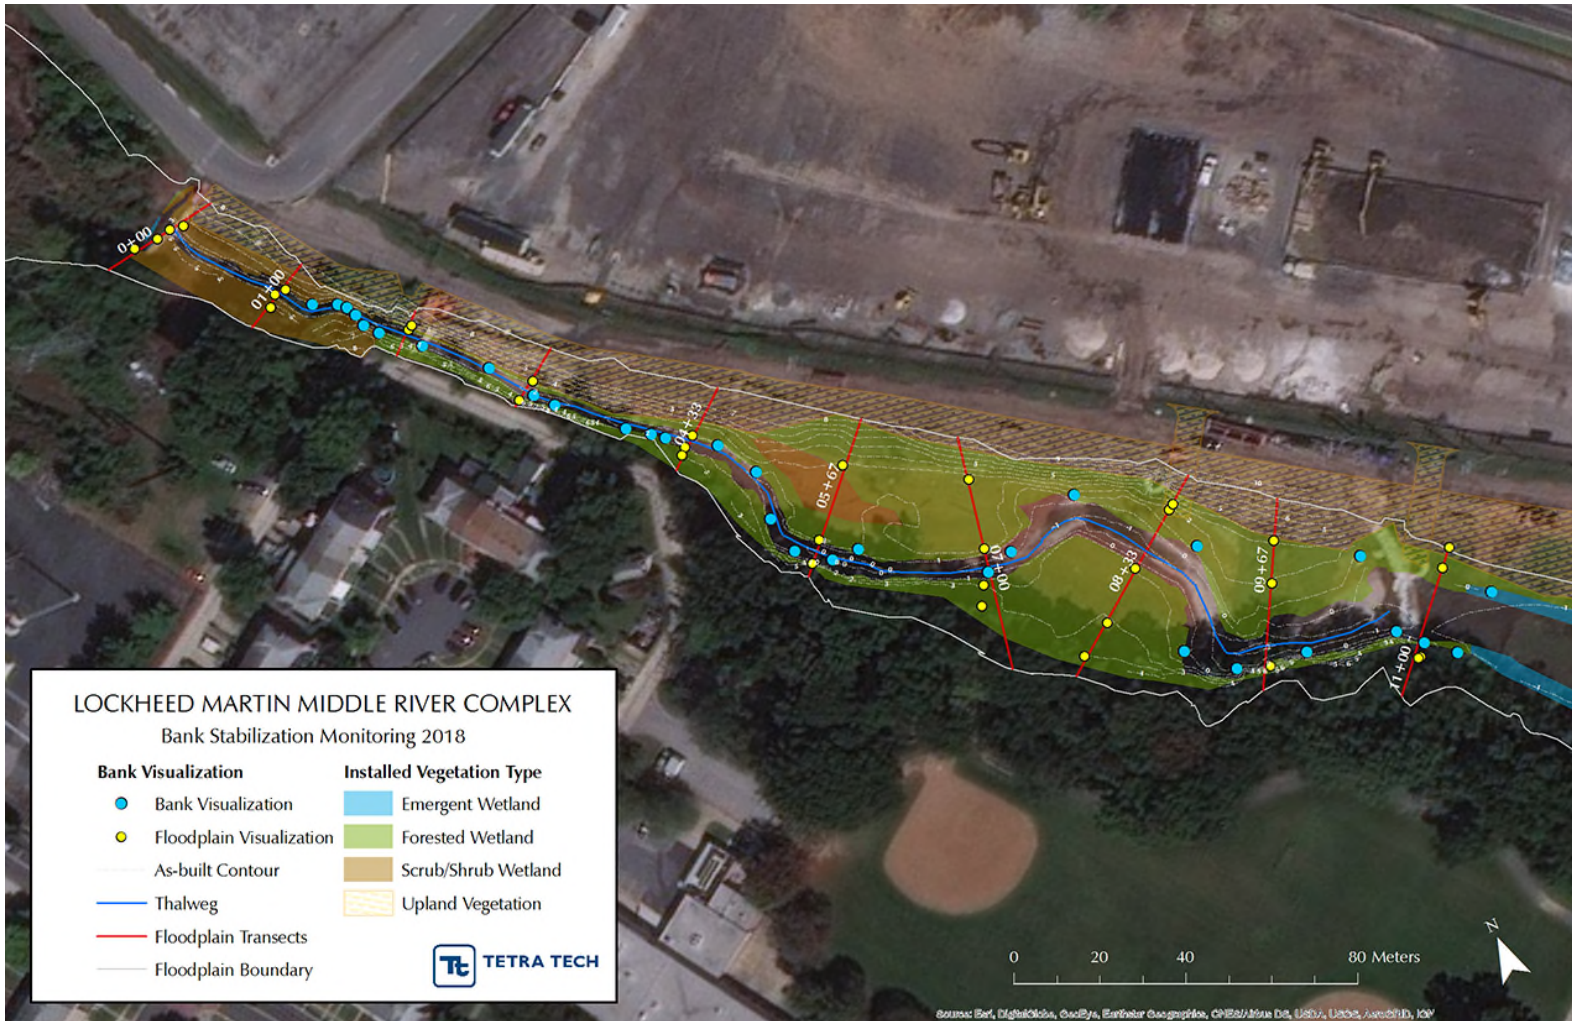
Start points of floodplain monitoring transects, which had been field-placed at the top of bank on both sides of the stream, corresponded well with as-built survey contours, as illustrated in Figure 4-6. These benchmarks can be used in future years to check for lateral erosion of the banks.

**Figure 4-6 Map of Cow Pen Creek study area showing streambank and floodplain field survey points, along with as-built survey topography. Floodplain transect start points (yellow points closest to stream along transect) were field-placed at top of bank on both sides of stream. As-built survey is from Dec. 27, 2017. Upland and wetland vegetation types are from revegetation plan, Nov. 20, 2017.**

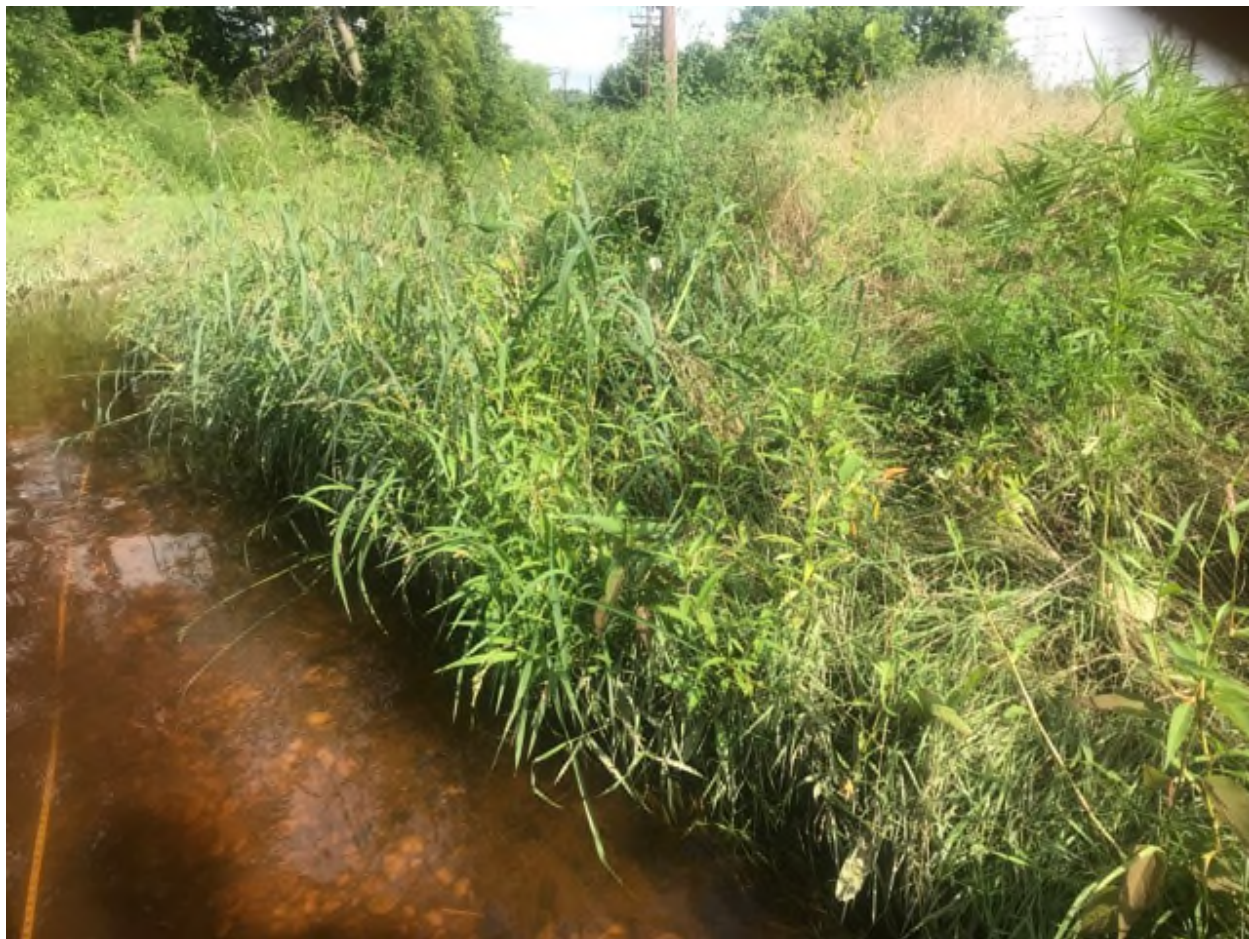
**Figure A-1. Left streambank, upstream view at station 01+38.**

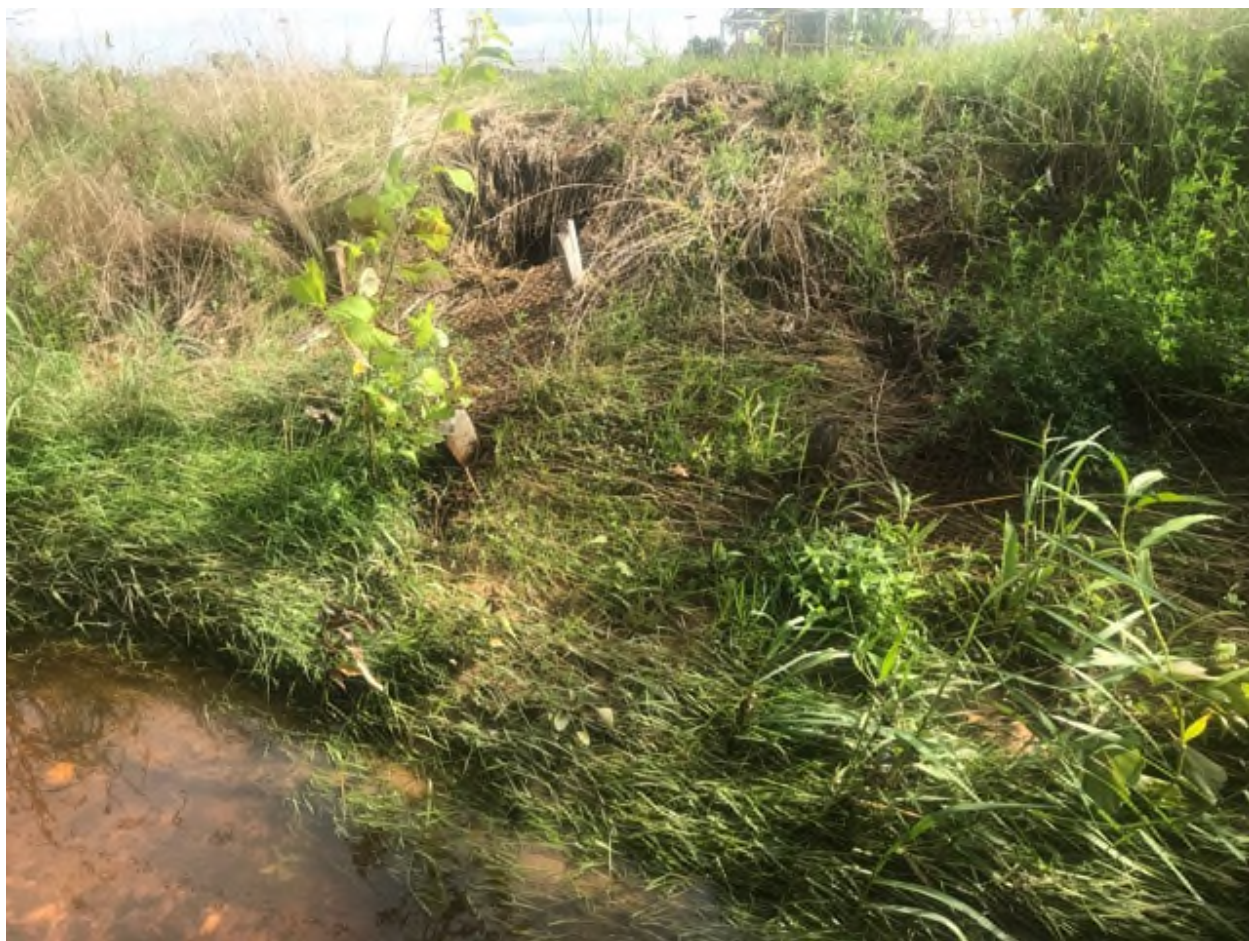
**Figure A-2. Left streambank at station 01+48.**

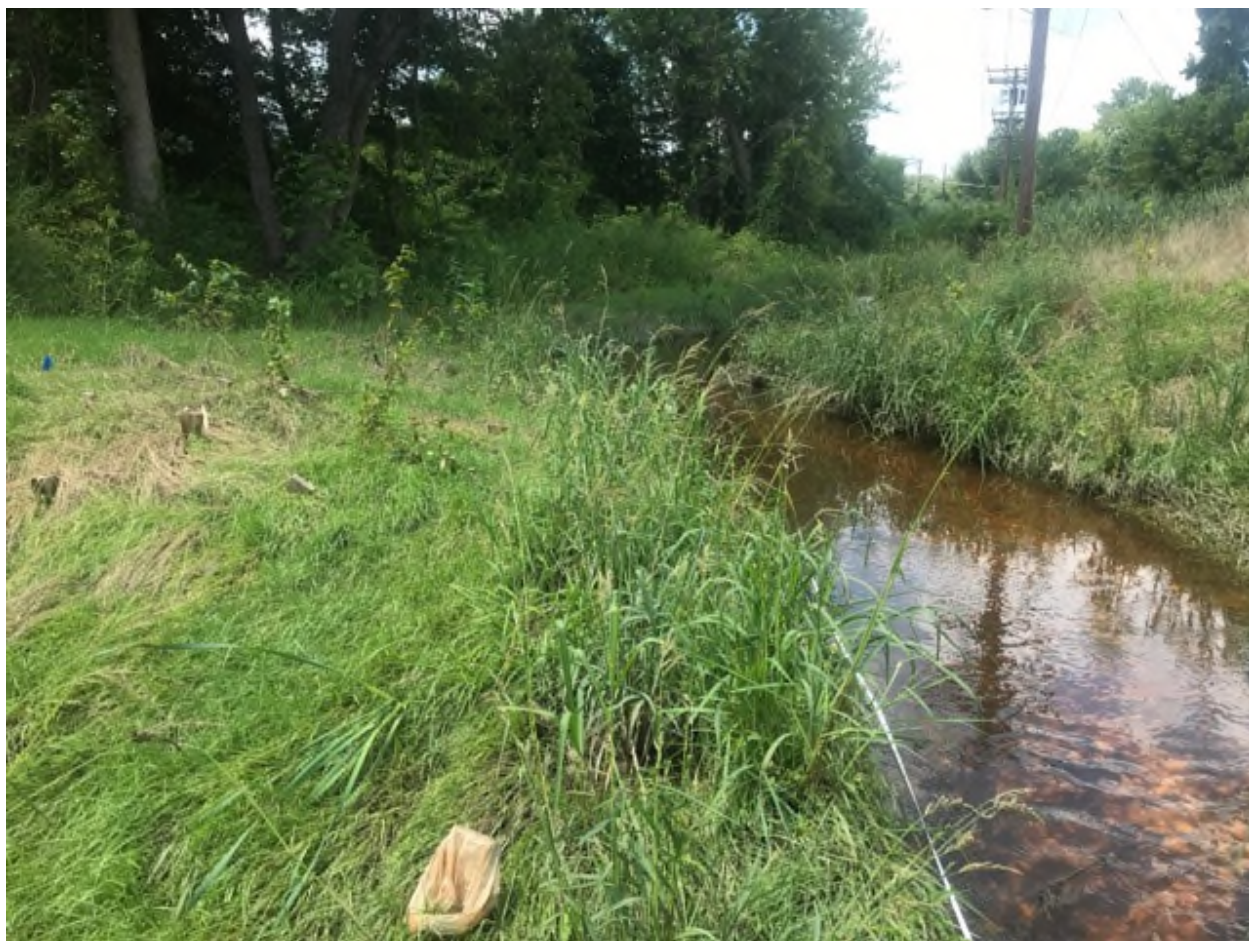
**Figure A-3. Right streambank, upstream view at station 01+56.**

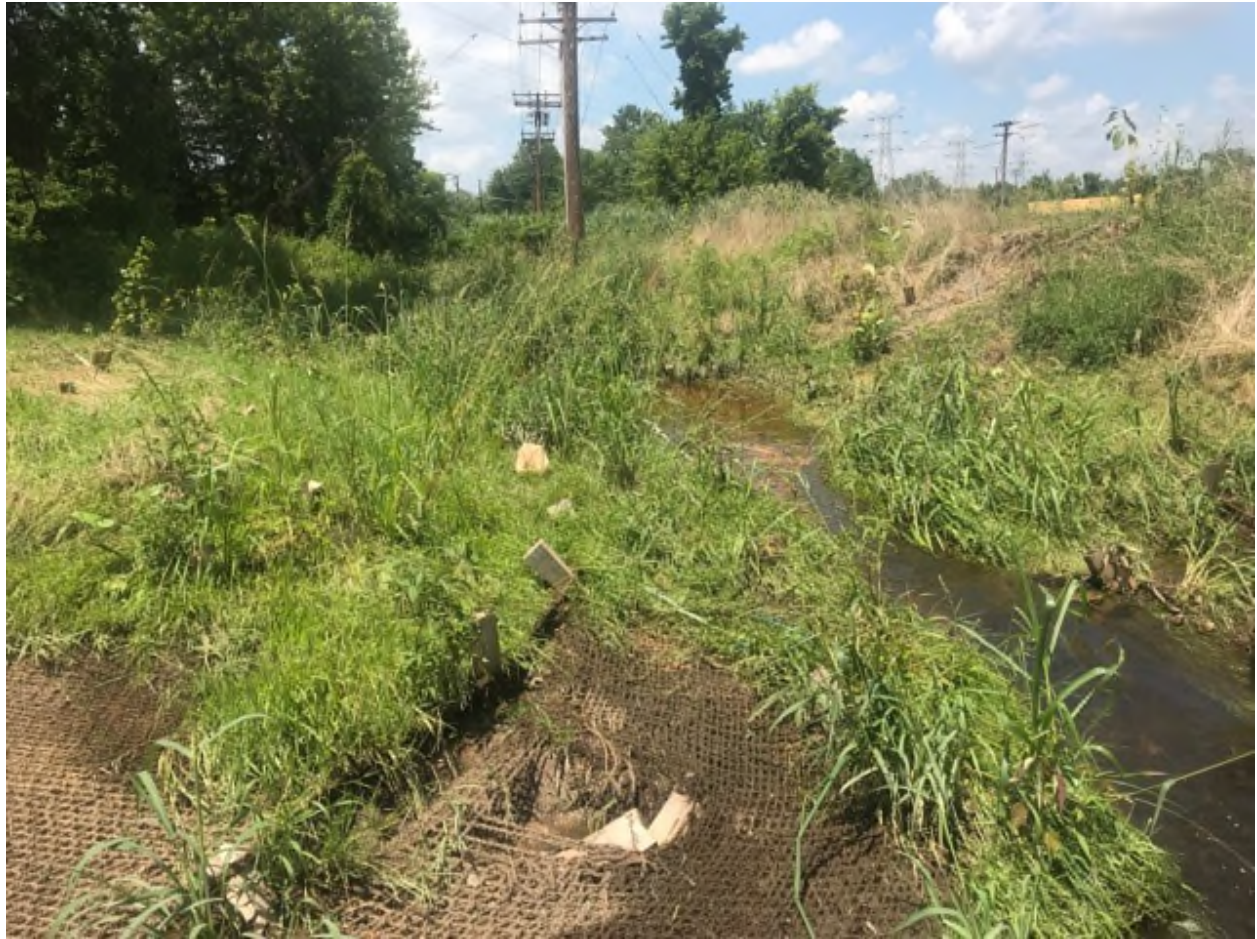
**Figure A-4. Right streambank, upstream view at station 01+67.**

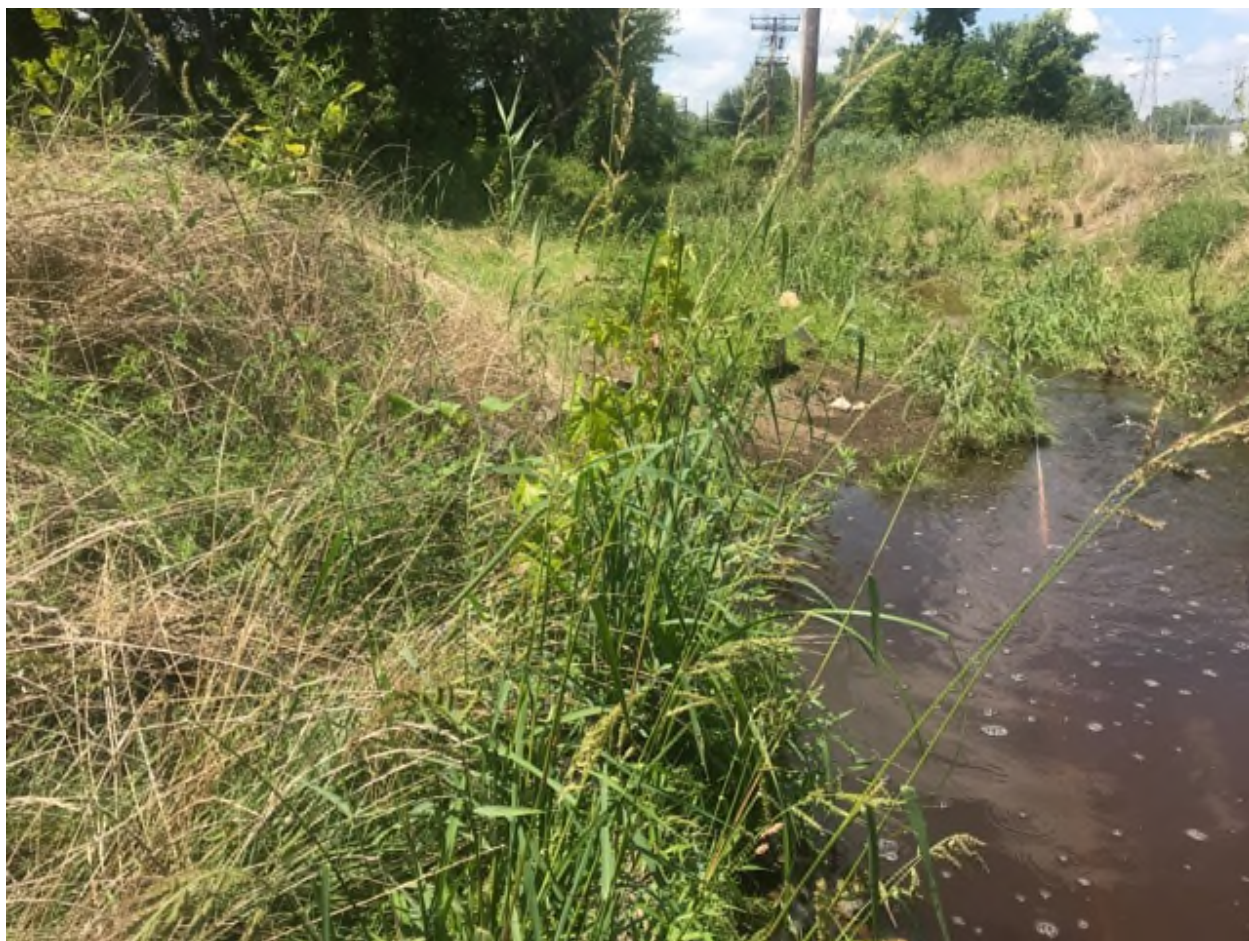
**Figure A-5. Right streambank, upstream view at station 01+78.**

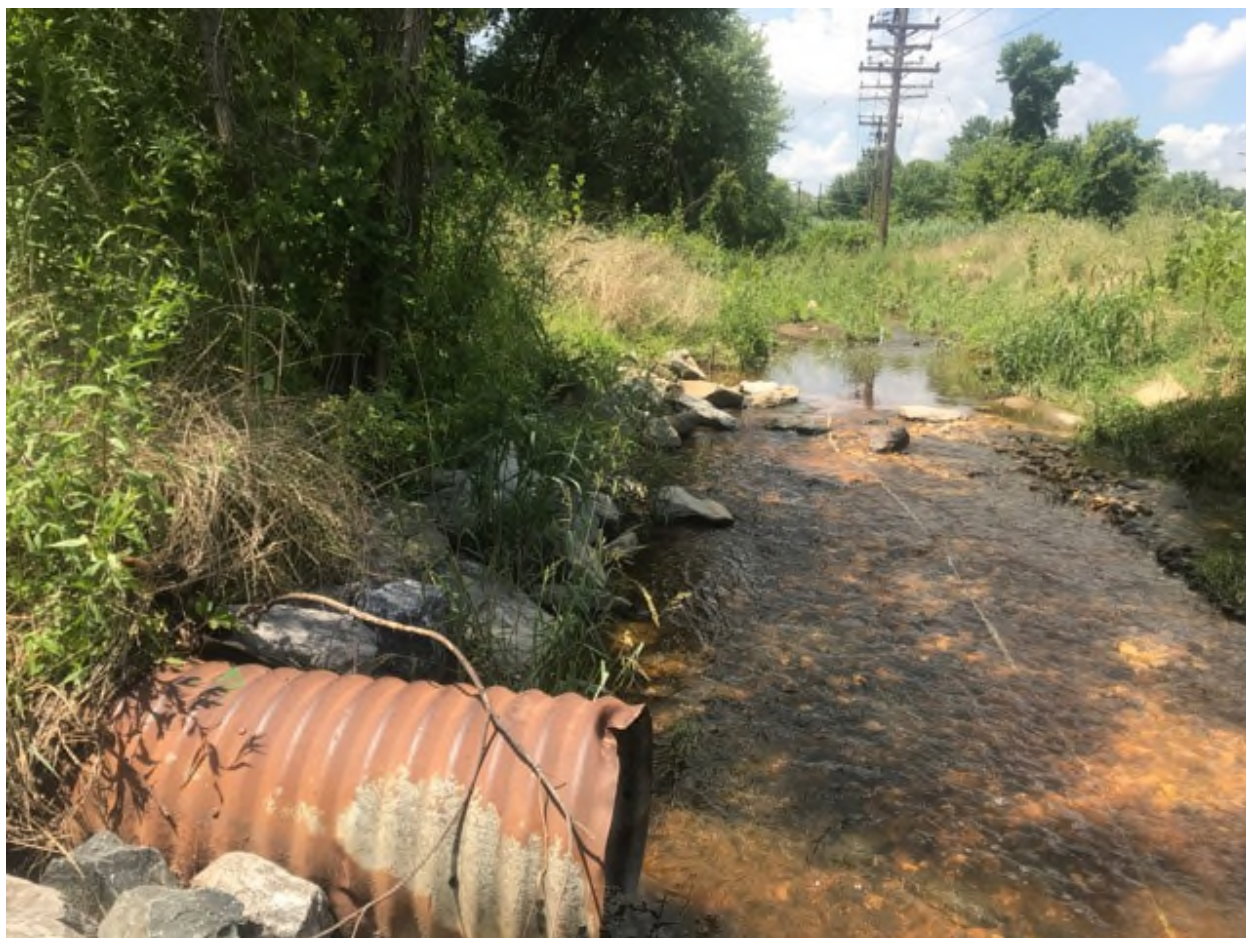
**Figure A-6. Right streambank, upstream view at station 02+12.**

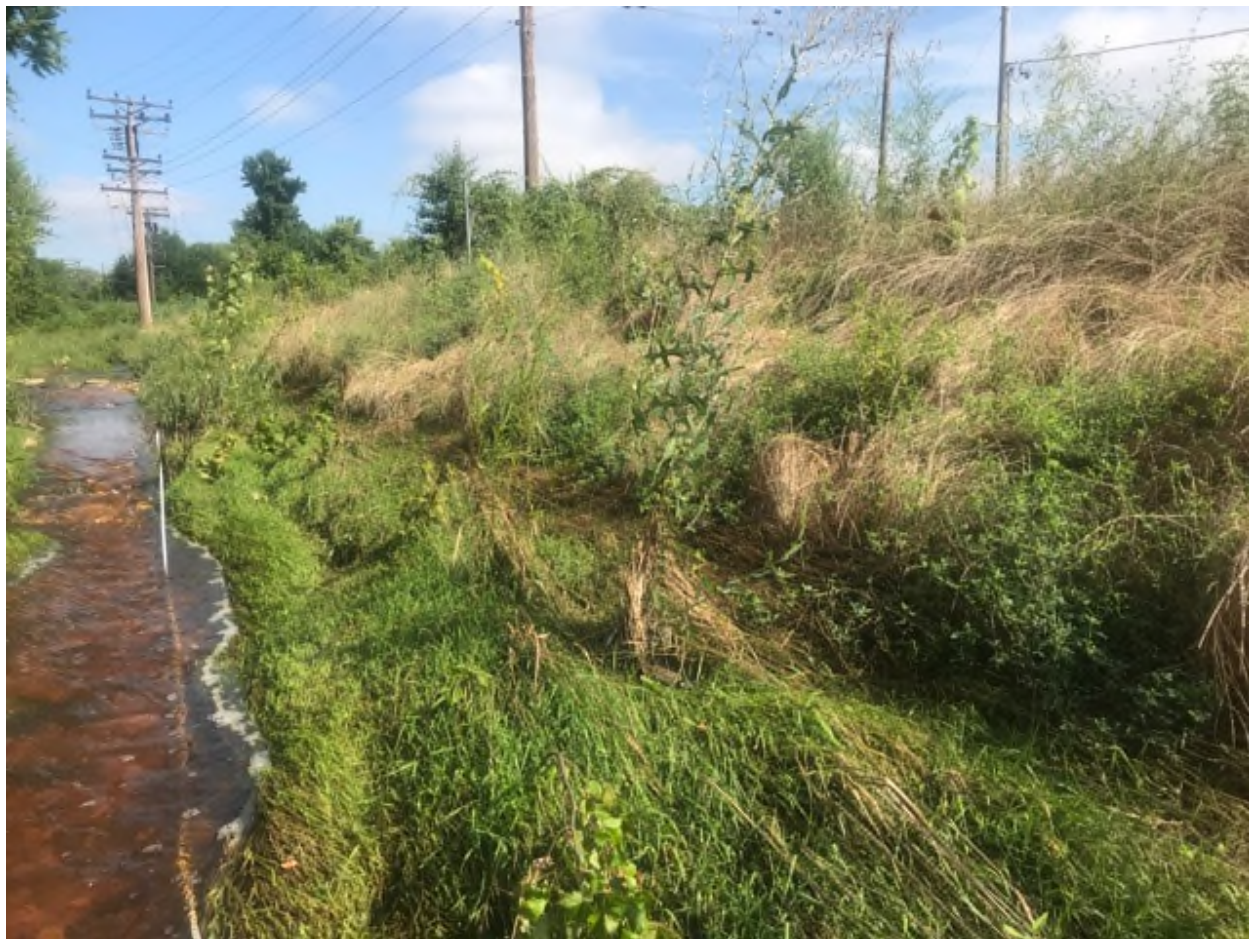
**Figure A-7. Left streambank, upstream view at station 02+64.**

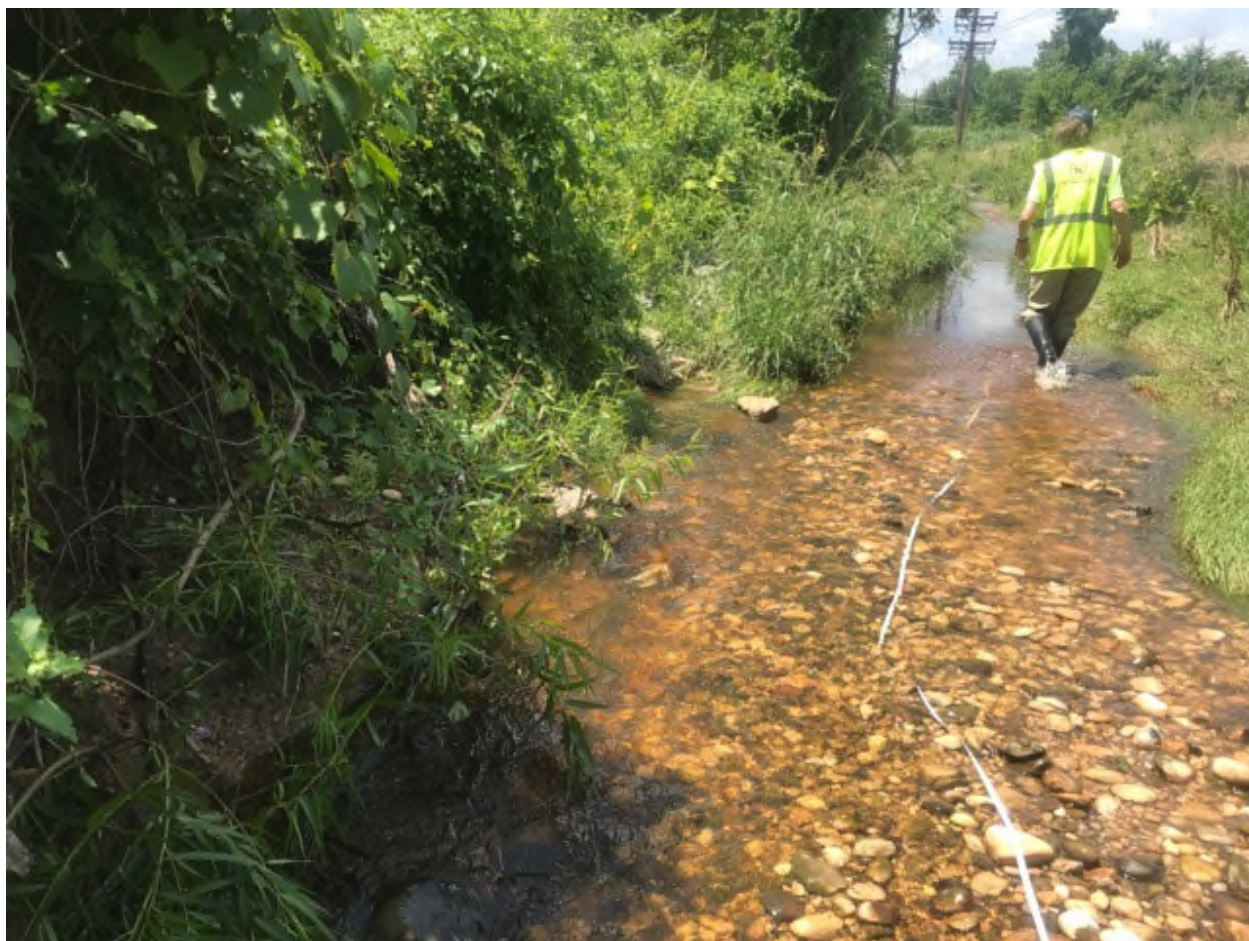
**Figure A-9. Right streambank, upstream view at station 03+22.**

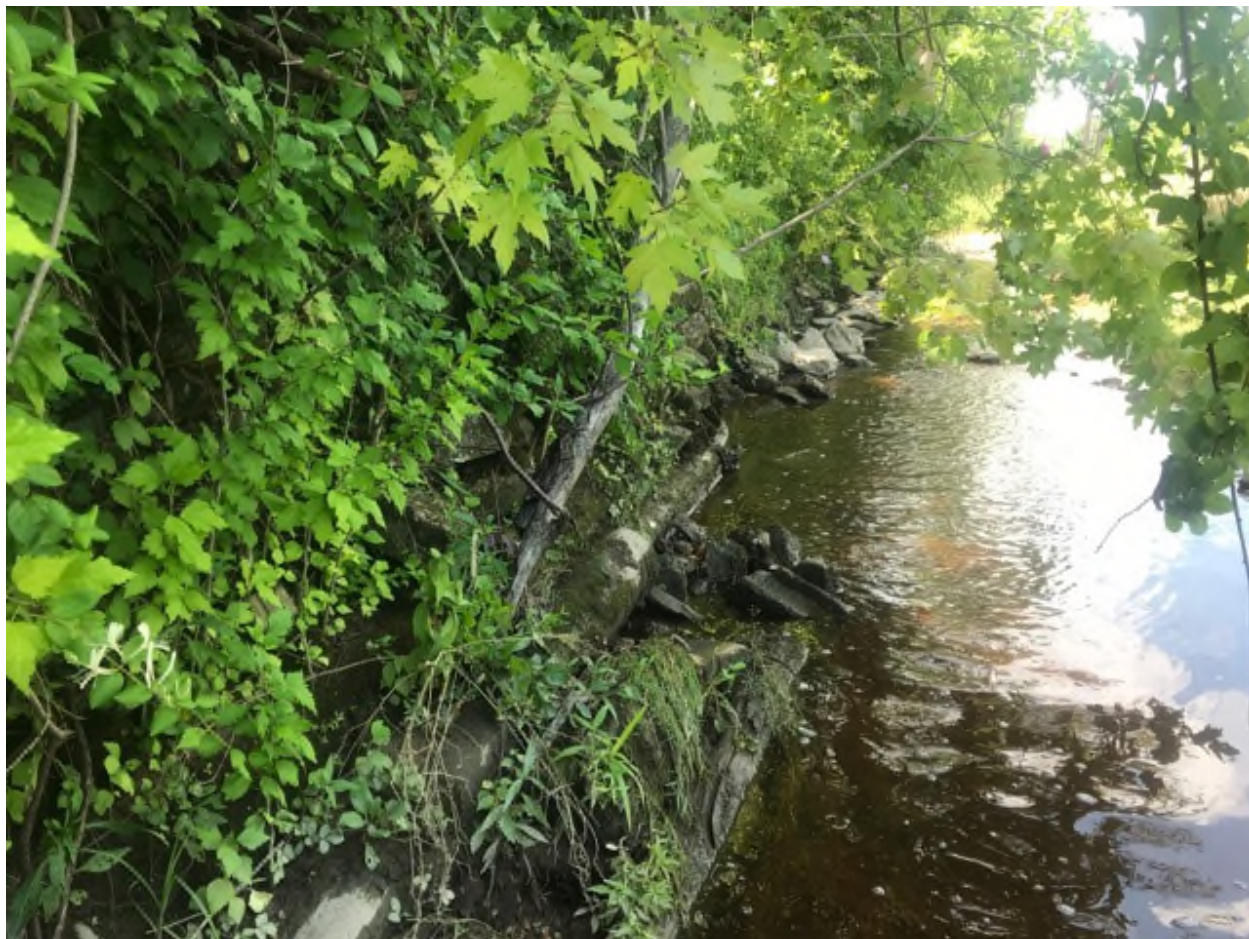
**Figure A-11. Right streambank, upstream view at station 03+79.**

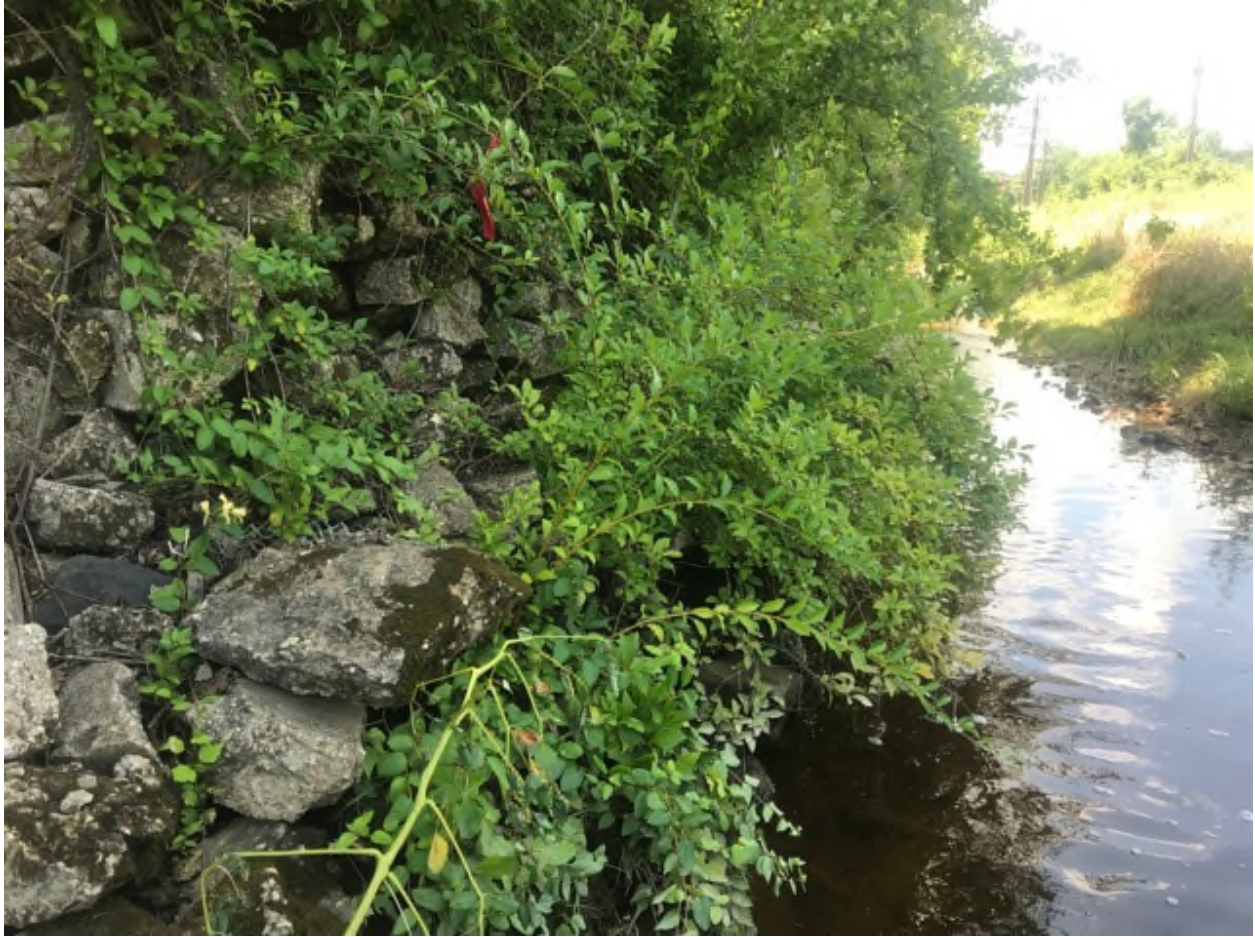
**Figure A-12. Right streambank, upstream view at station 03+90.**

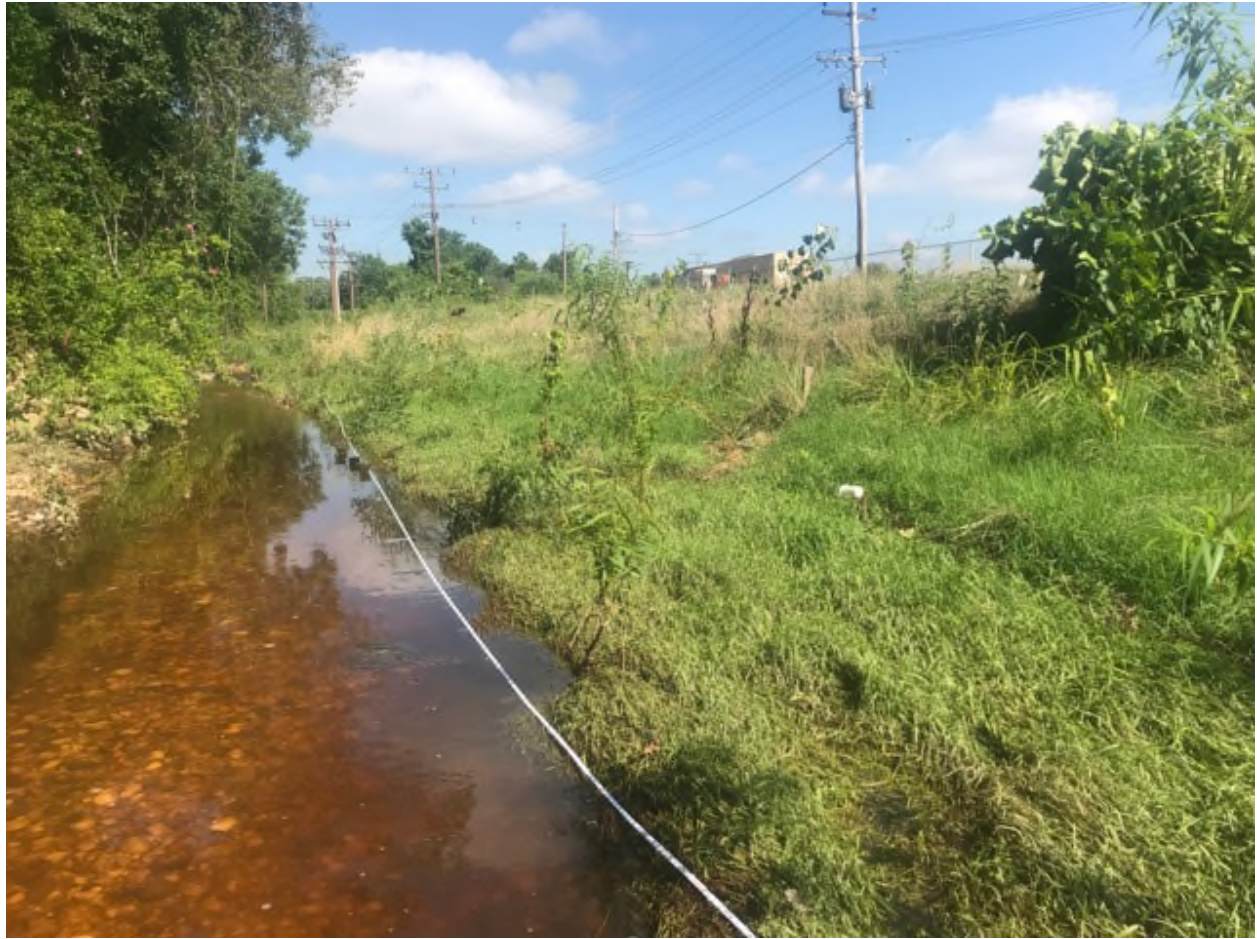
**Figure A-13. Left streambank, upstream view at station 04+55.**
