Subject: Transmittal of the Cow Pen Creek Bank Stabilization and Floodplain  
Reconstruction Monitoring: 2018 Report  
Lockheed Martin Corporation – Middle River Complex  
2323 Eastern Boulevard, Middle River, Baltimore County, Maryland

**COW PEN CREEK  
BANK STABILIZATION AND FLOODPLAIN  
RECONSTRUCTION MONITORING: 2018 REPORT  
LOCKHEED MARTIN MIDDLE RIVER COMPLEX  
2323 EASTERN BOULEVARD  
MIDDLE RIVER, MARYLAND**

December 2018

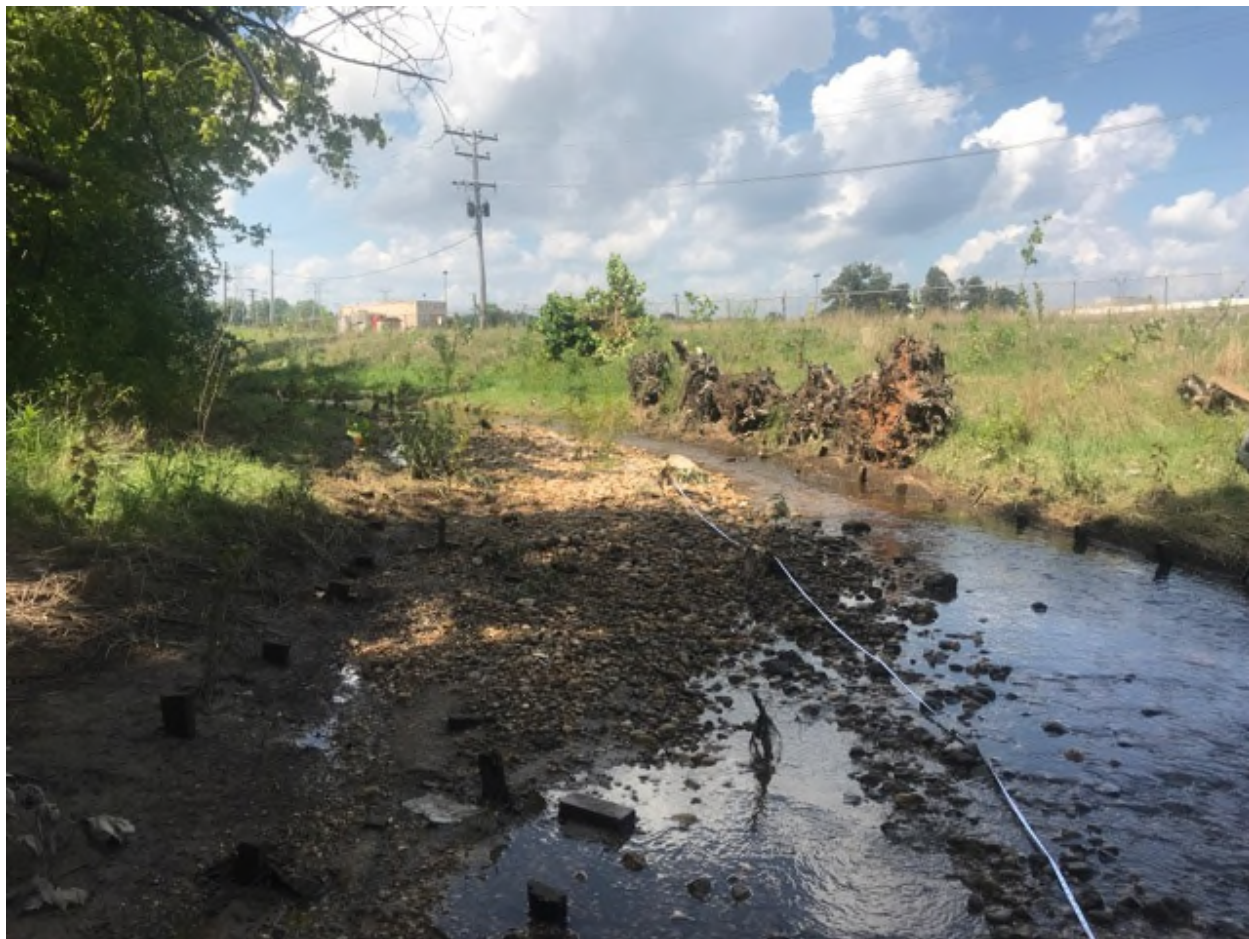
**Figure A-15. Right streambank, upstream view at station 04+98.**

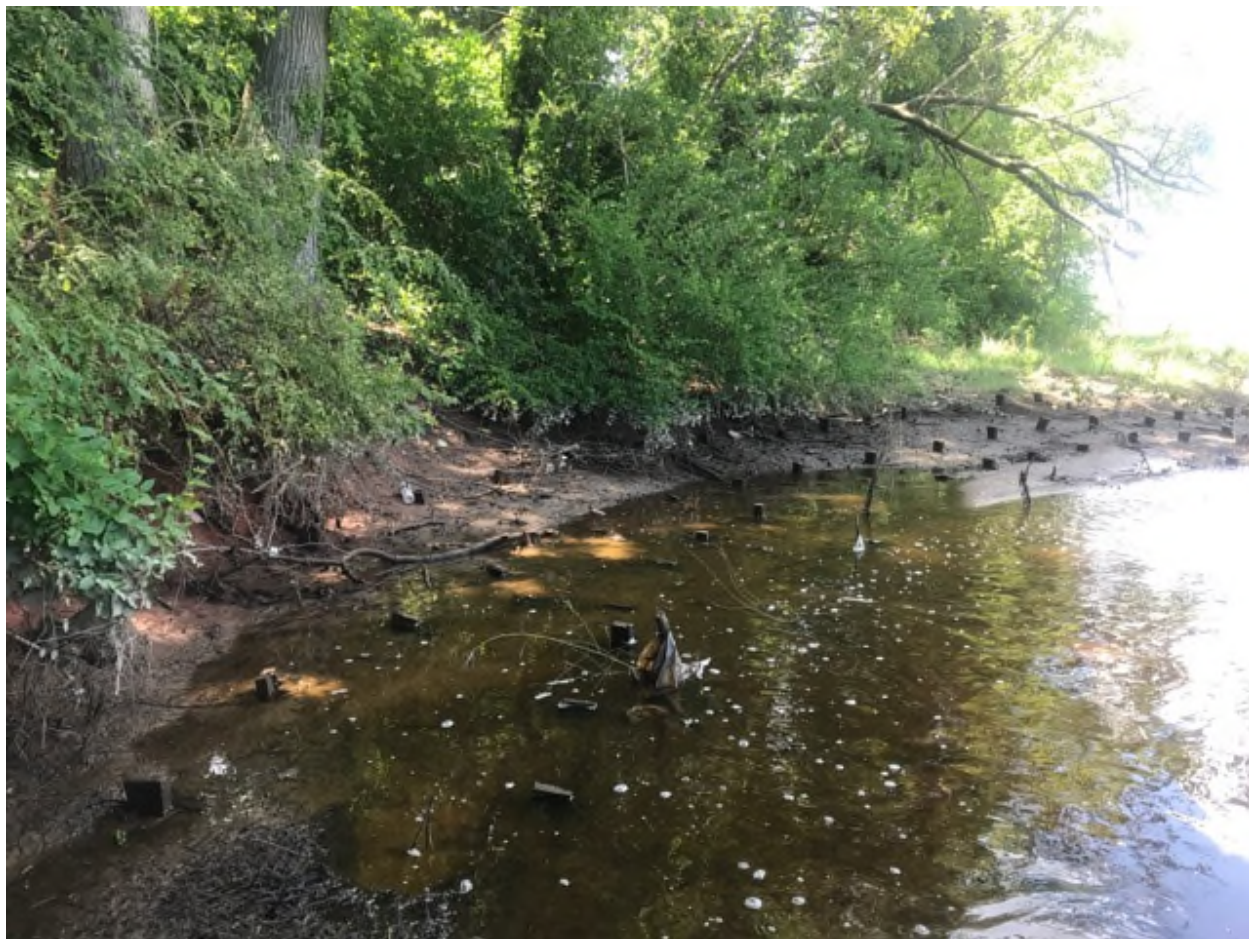
**Figure A-16. Right streambank, upstream view at station 05+30.**

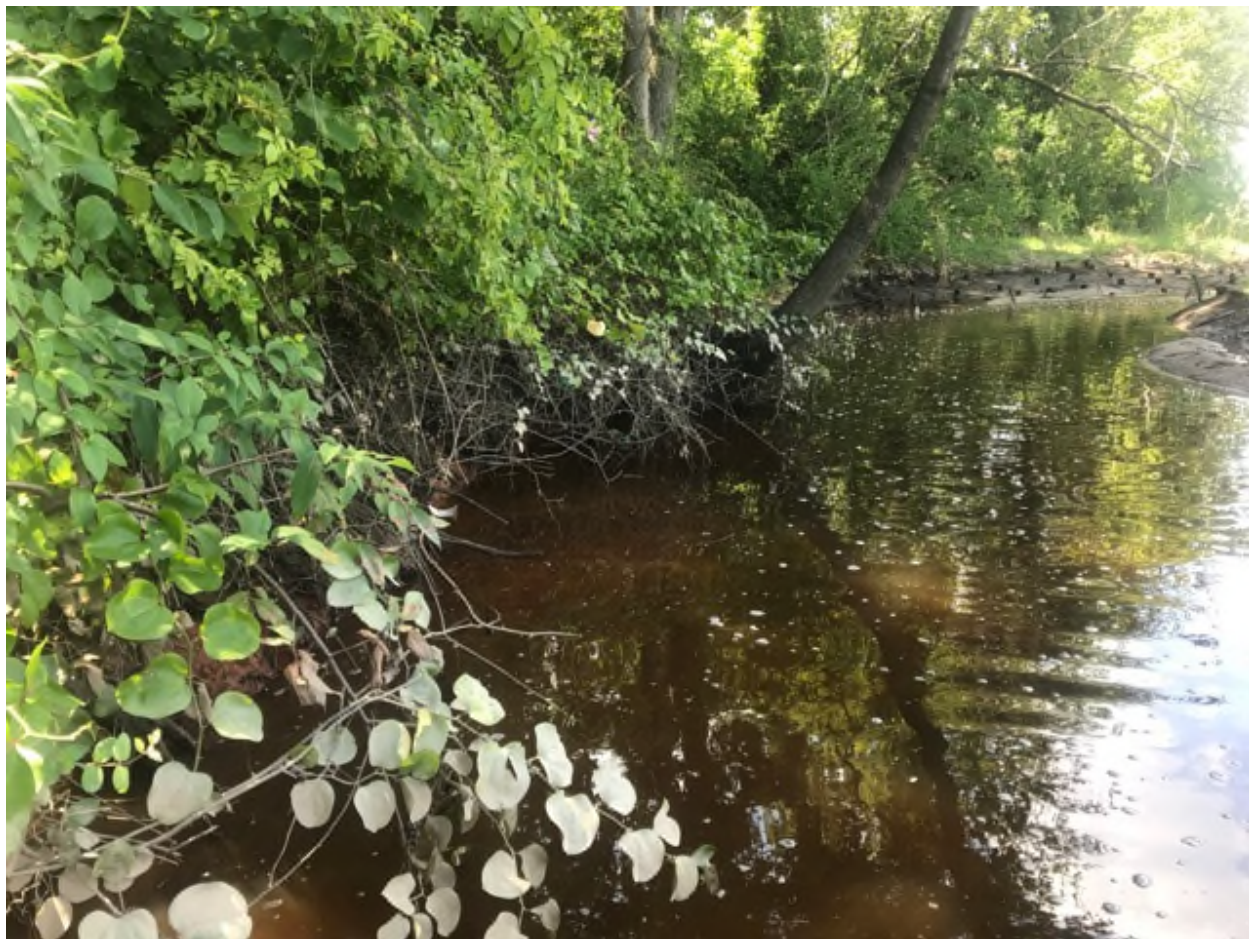
**Figure A-17. Right streambank, upstream view at station 05+58.**

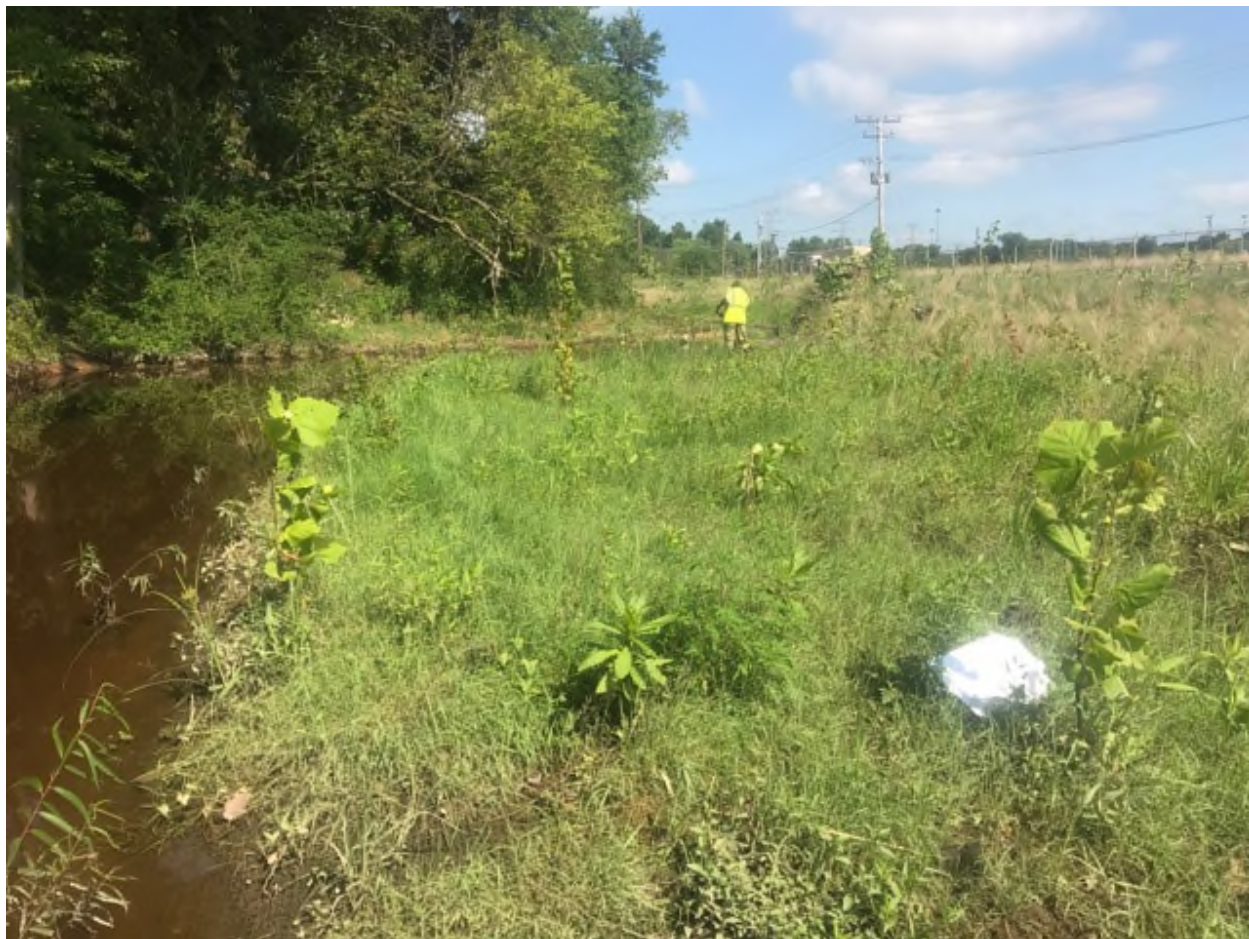
**Figure A-18. Left streambank, upstream view at station 05+93.**

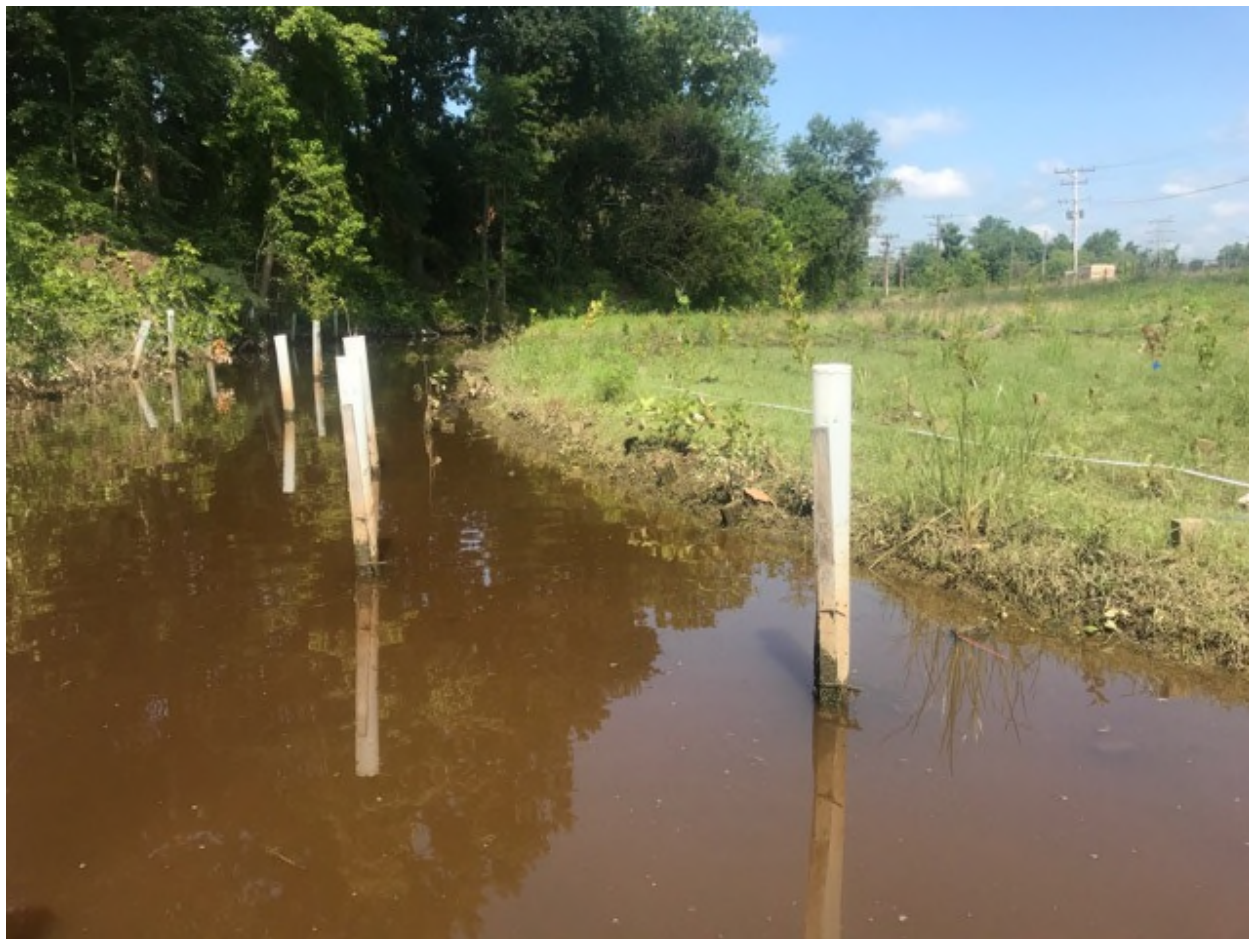
**Figure A-20. Left streambank, upstream view at station 07+10.**

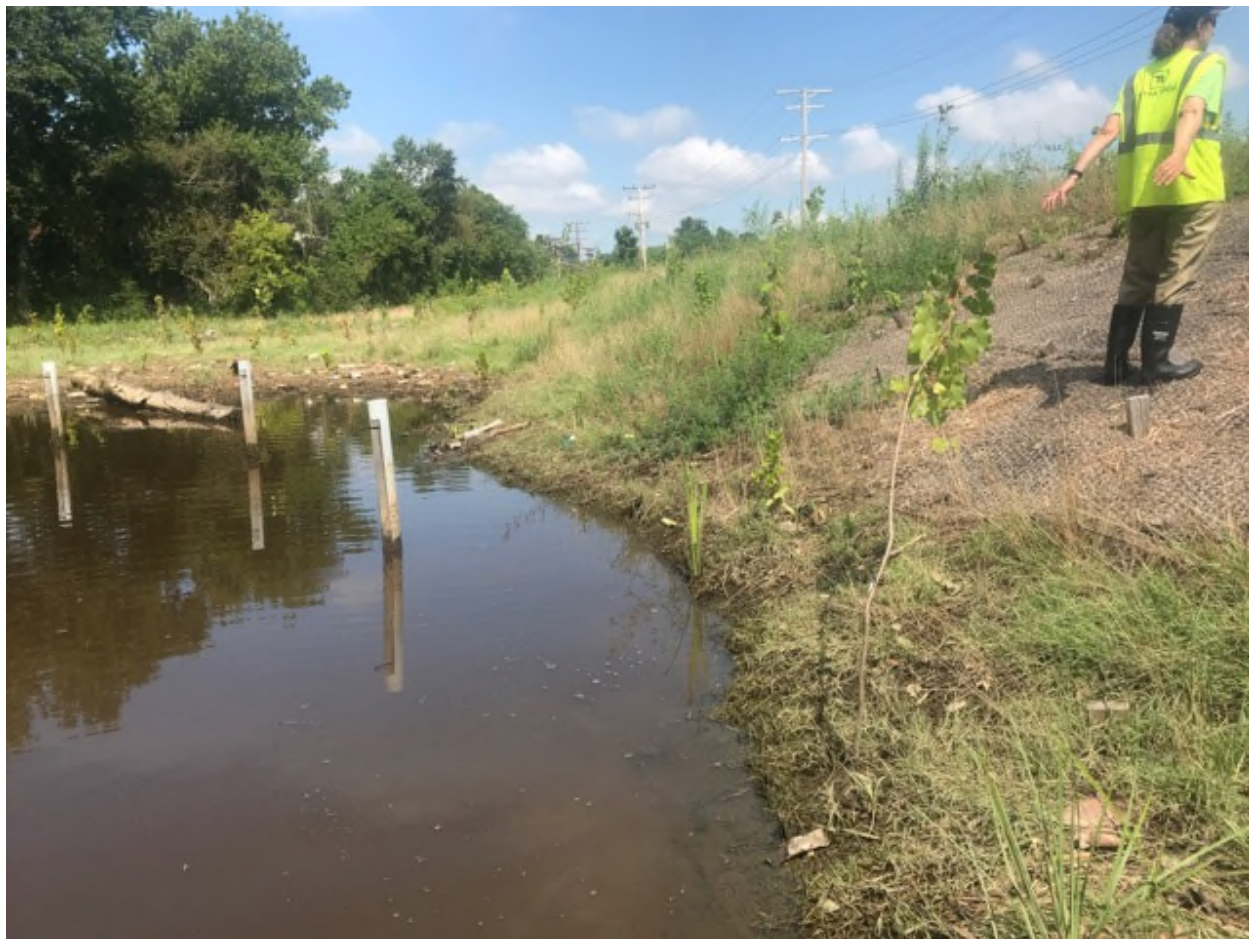
**Figure A-21. Left streambank, upstream view at station 07+71.**

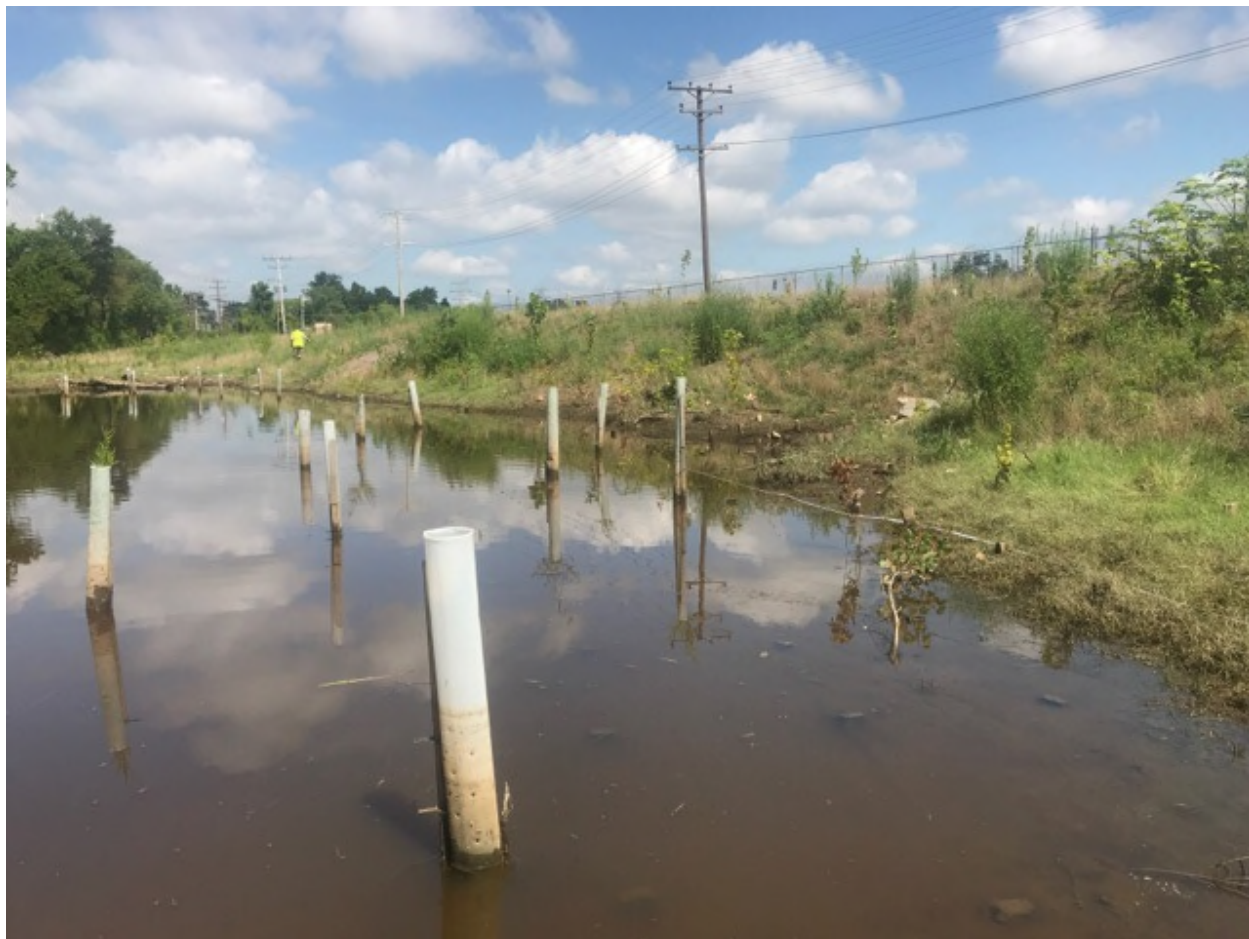
**Figure A-22. Left streambank, upstream view at station 08+75.**

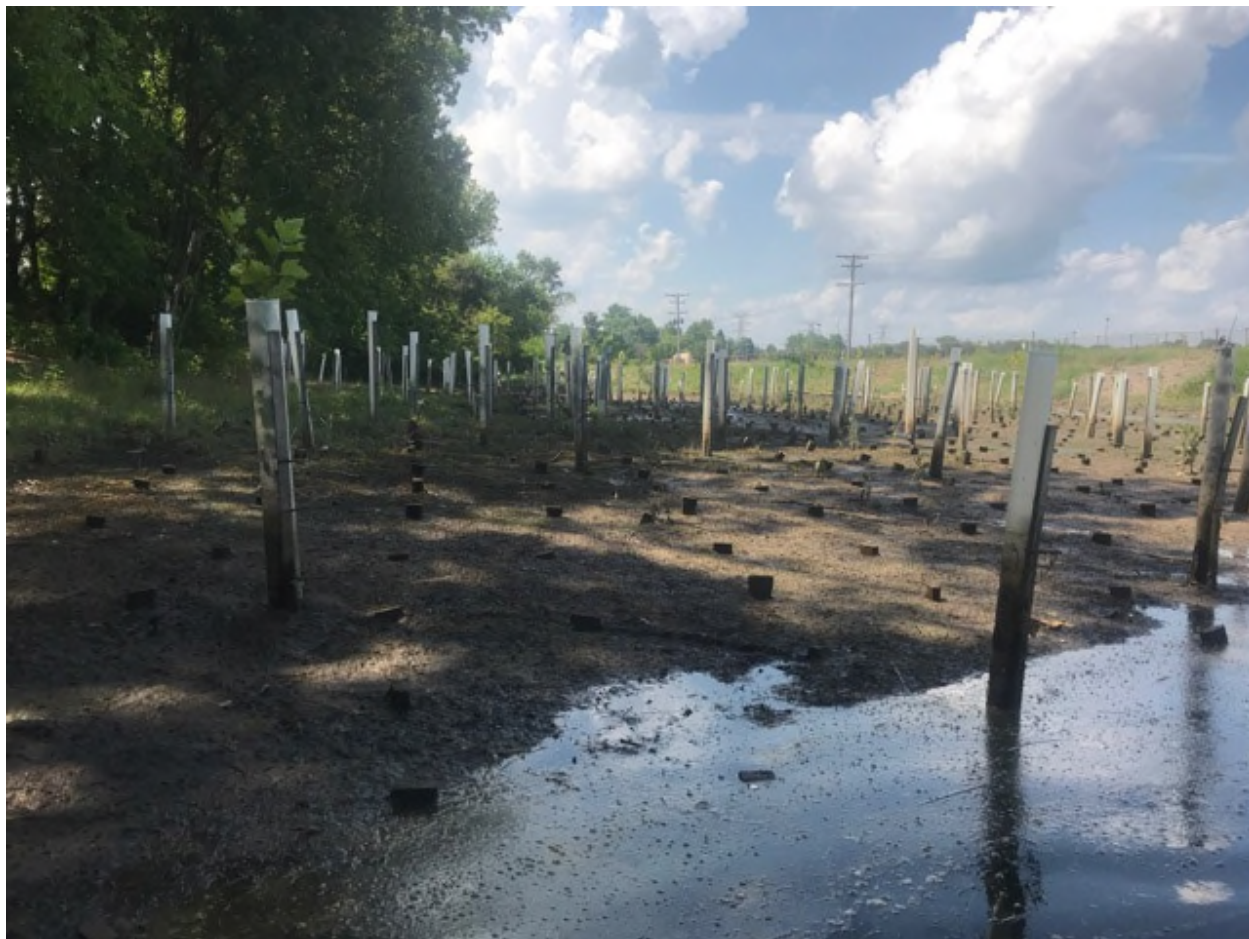
**Figure A-23. Right streambank, upstream view at station 09+09.**

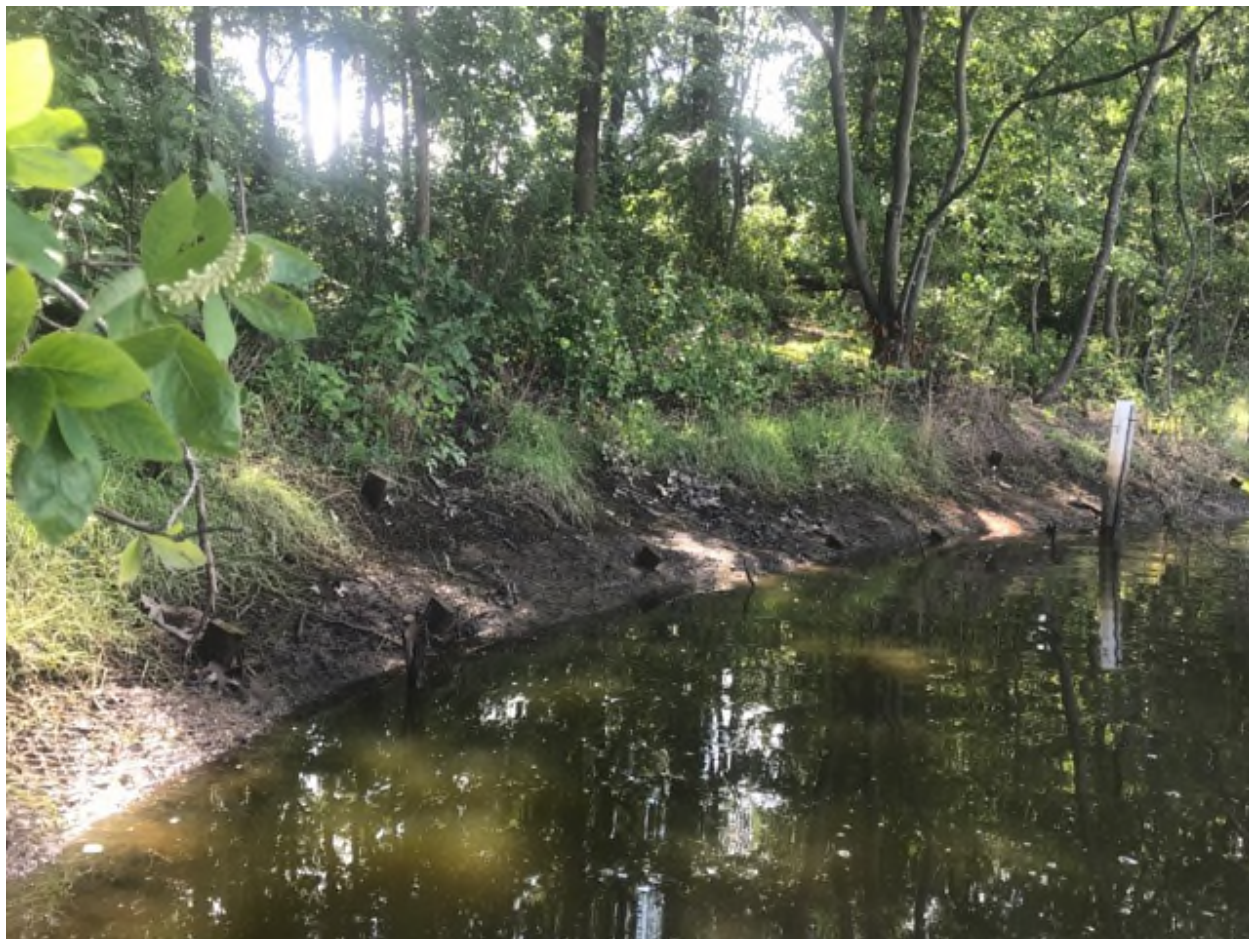
**Figure A-24. Right streambank, upstream view at station 09+42.**

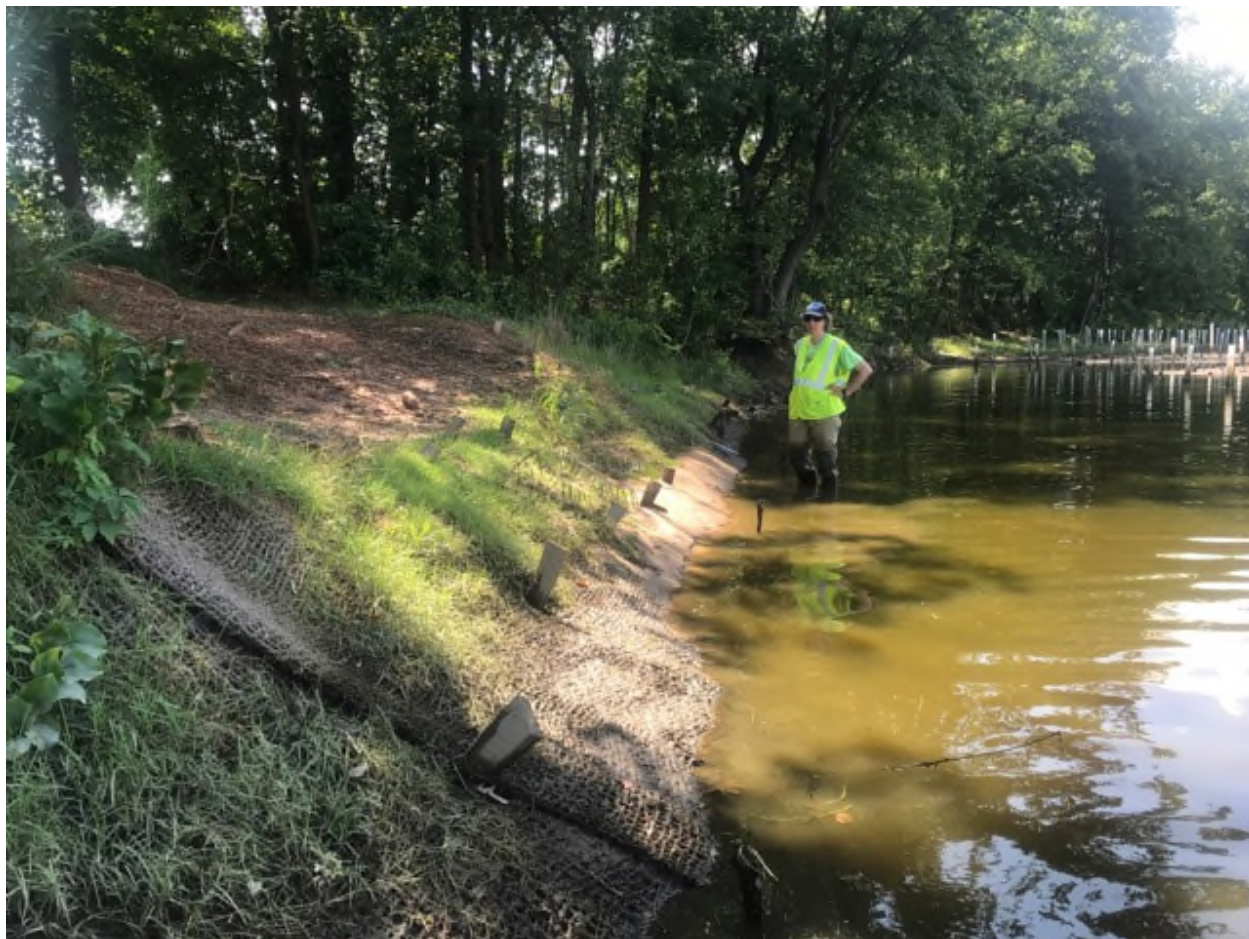
**Figure A-26. Right streambank, upstream view at station 10+70.**

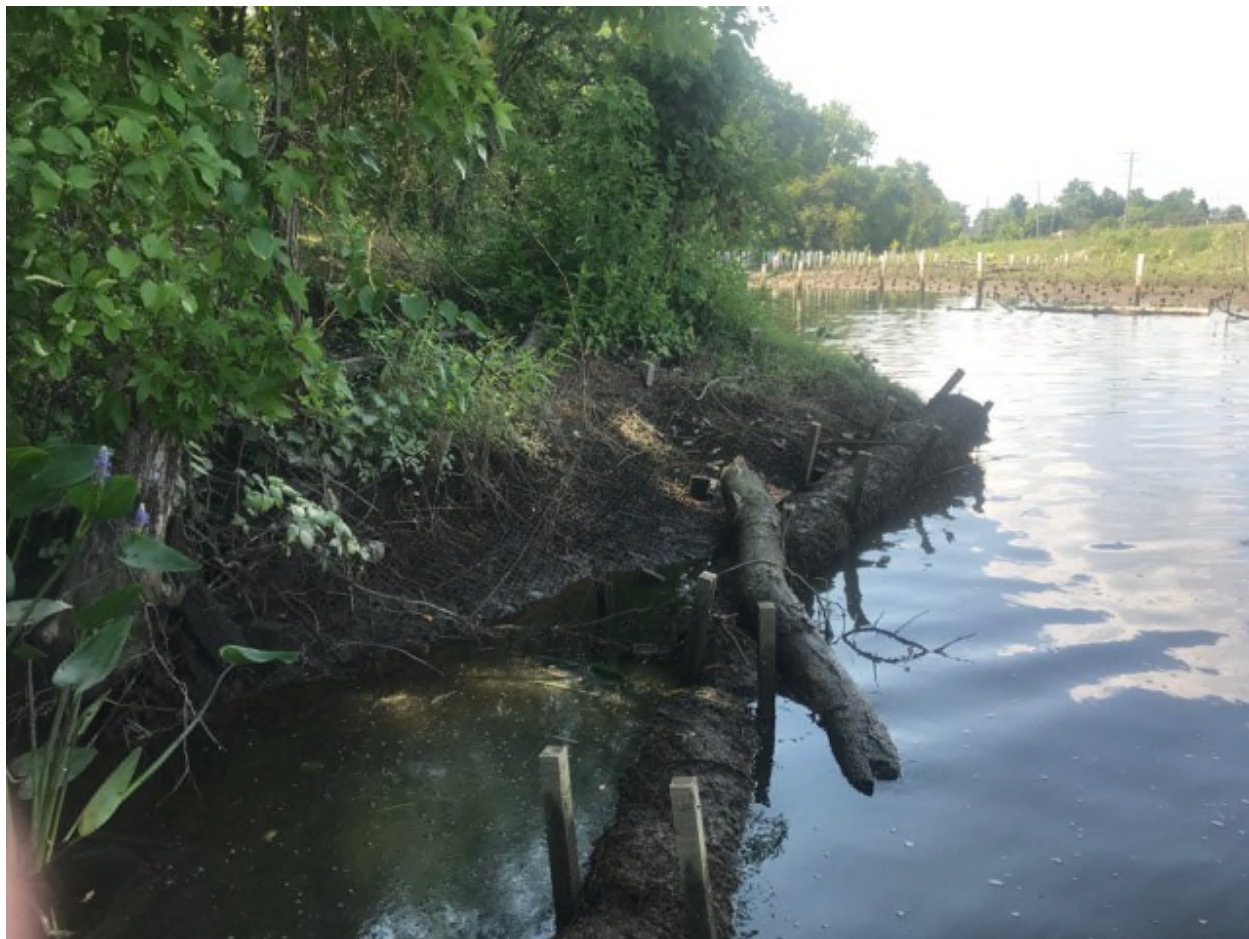
**Figure A-27. Right streambank, upstream view at station 11+10.**

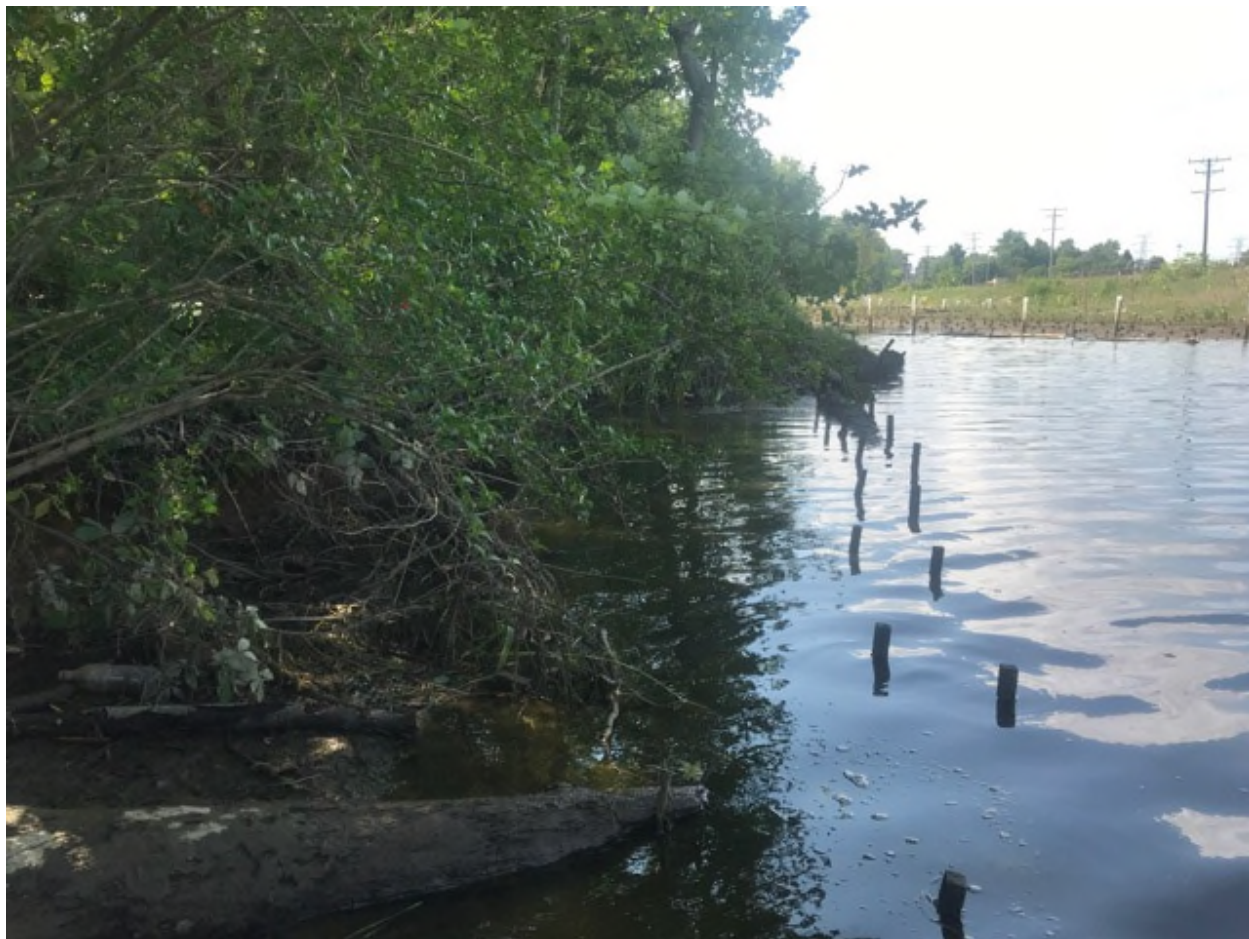
**Figure A-28. Right streambank, upstream view at station 11+35.**

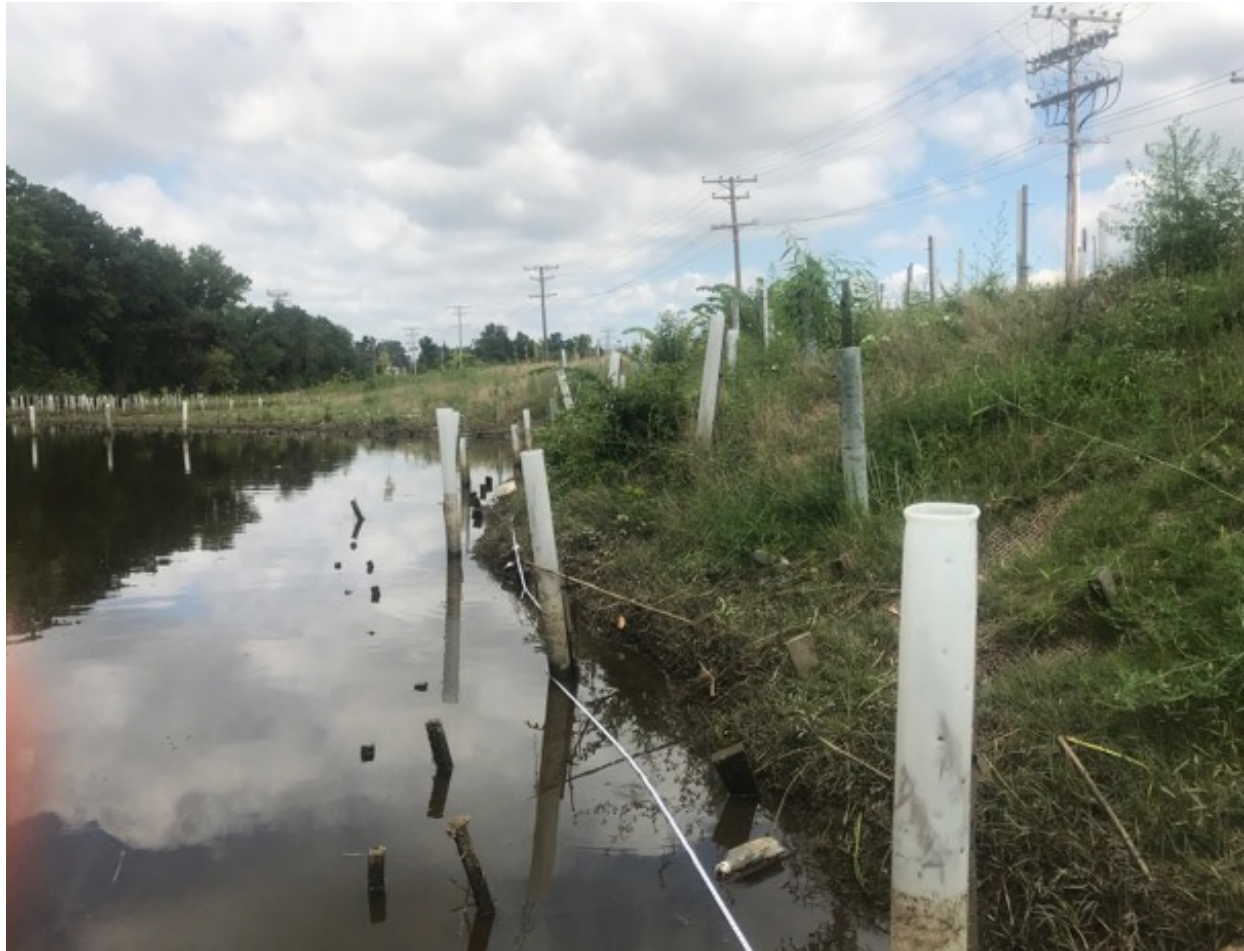
**Figure A-29. Left streambank, upstream view at station 11+80.**

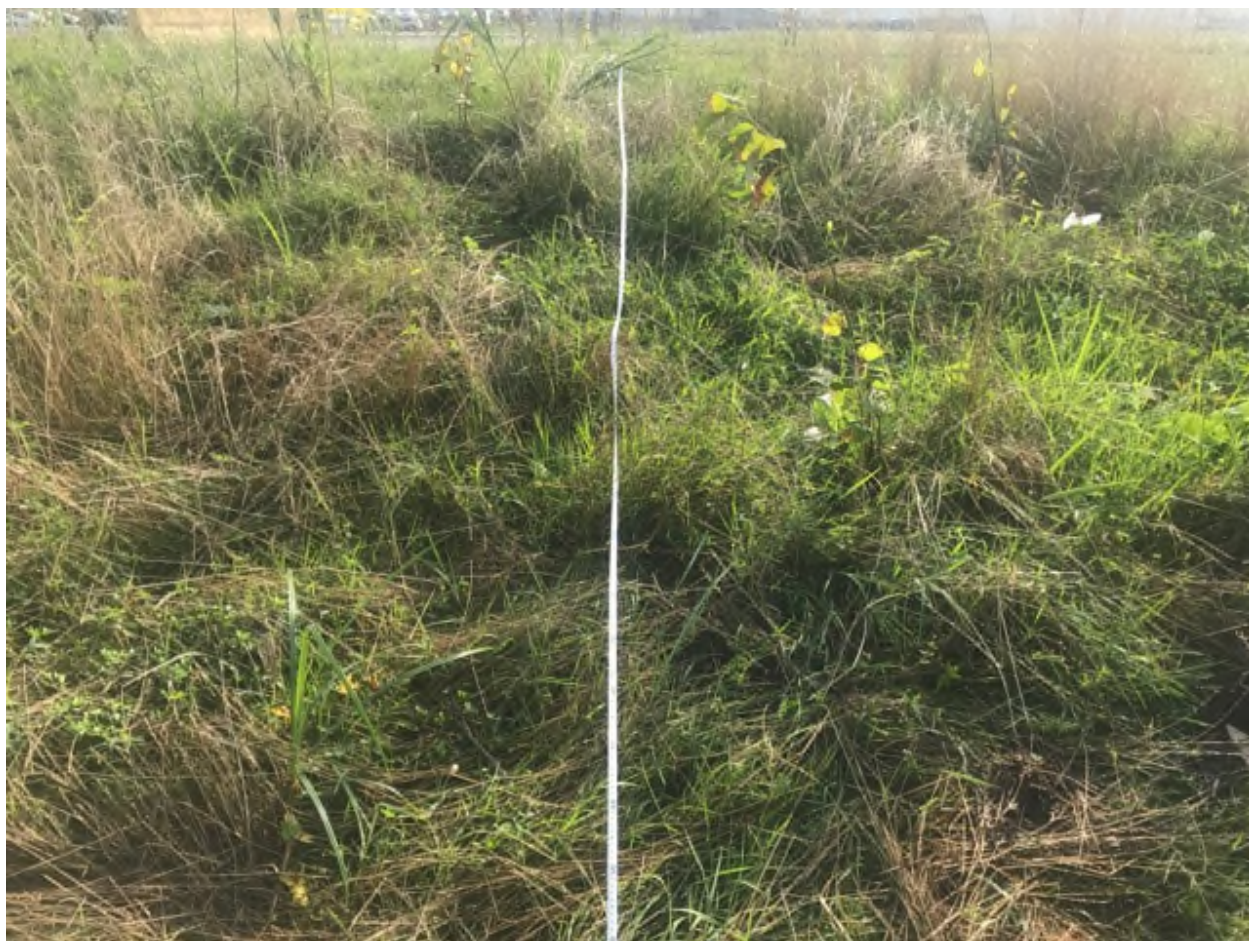
**Figure A-30. Floodplain transect at station 01+00, left bank, 0 feet to 38 feet from top of bank.**

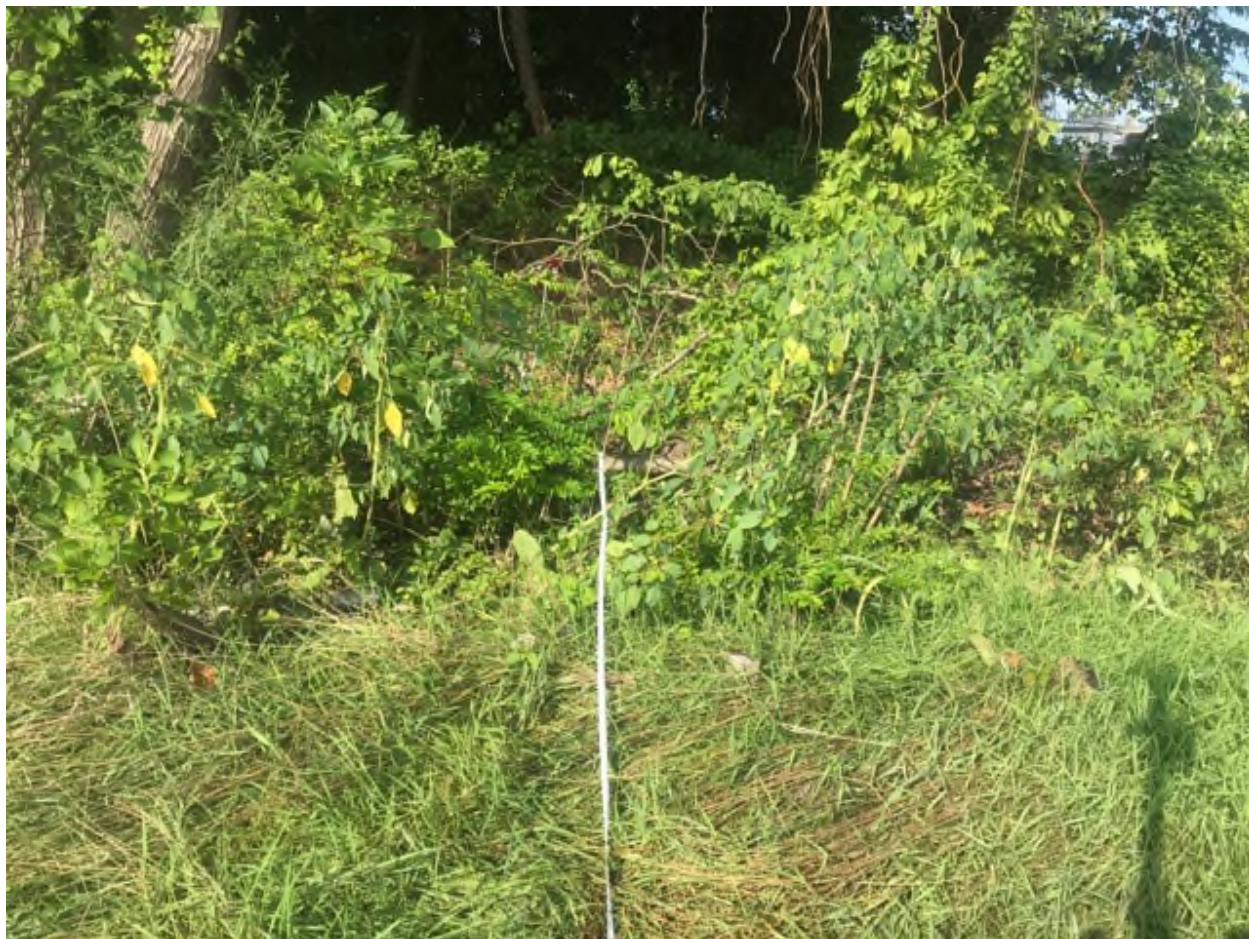
**Figure A-31. Floodplain transect at station 01+00, right bank, 0 feet to 9 feet from top of bank.**

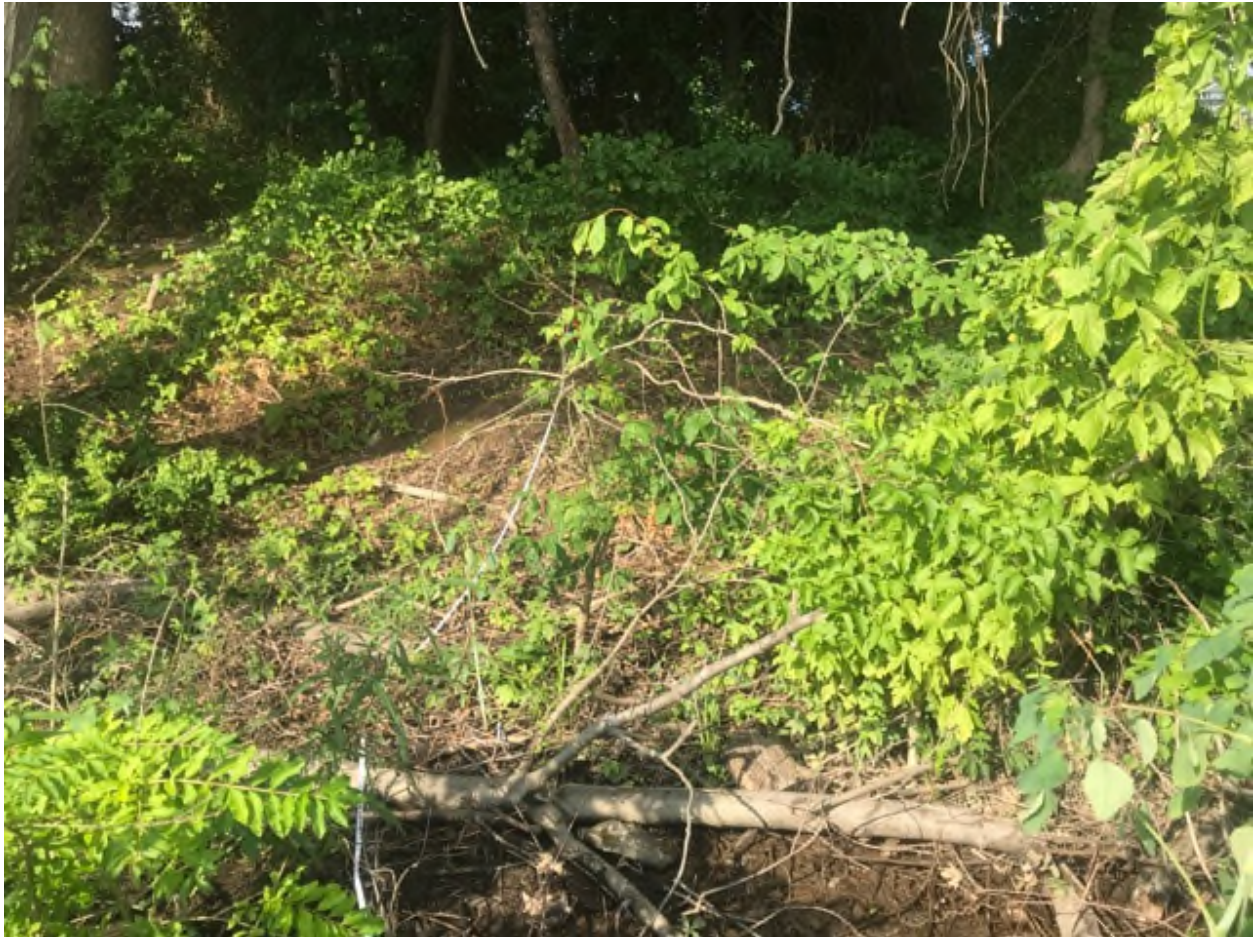
**Figure A-32. Floodplain transect at station 01+00, 9 feet to 29 feet from top of bank.**

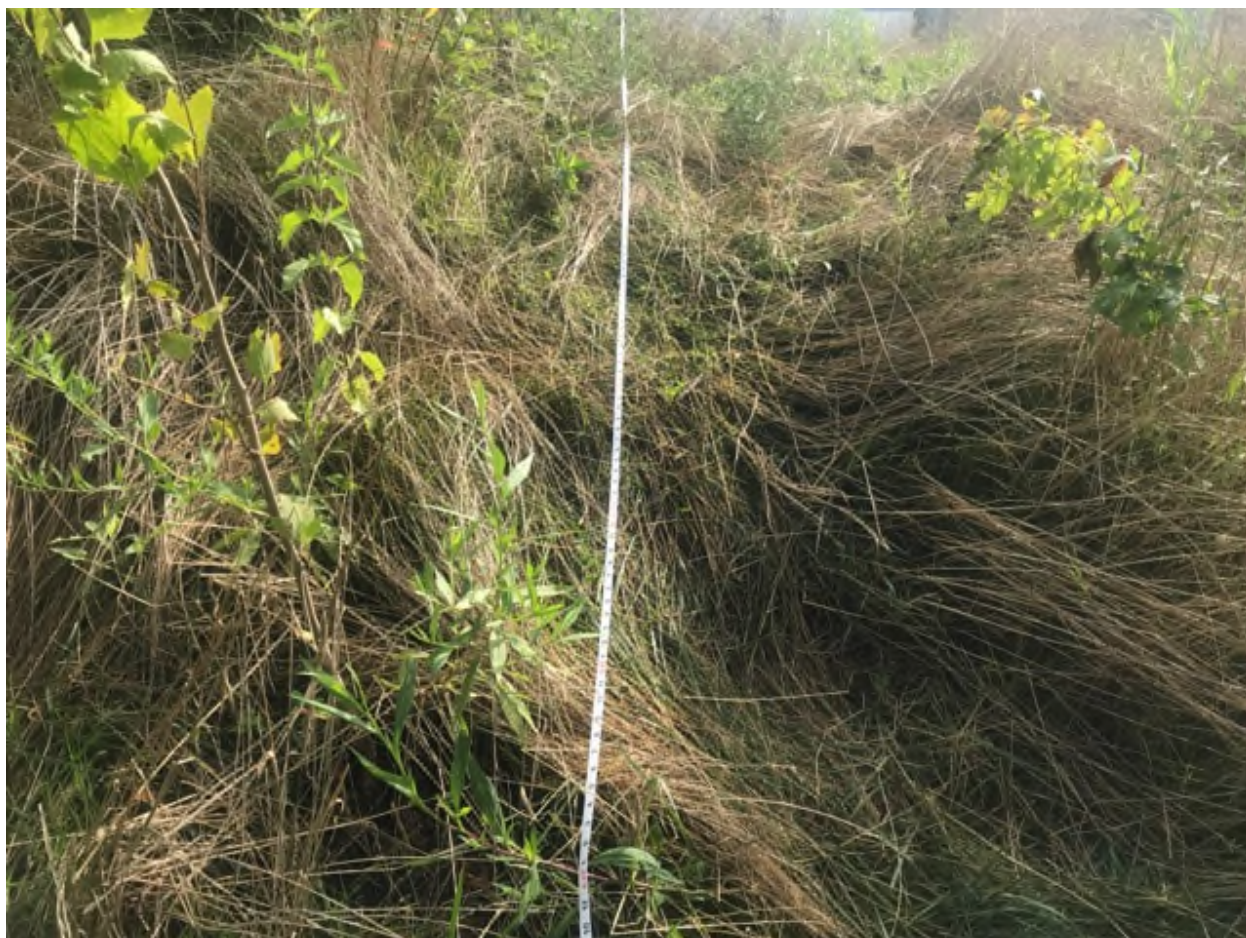
**Figure A-33. Floodplain transect at station 02+00, left bank, 0 feet to 4 feet from top of bank.**

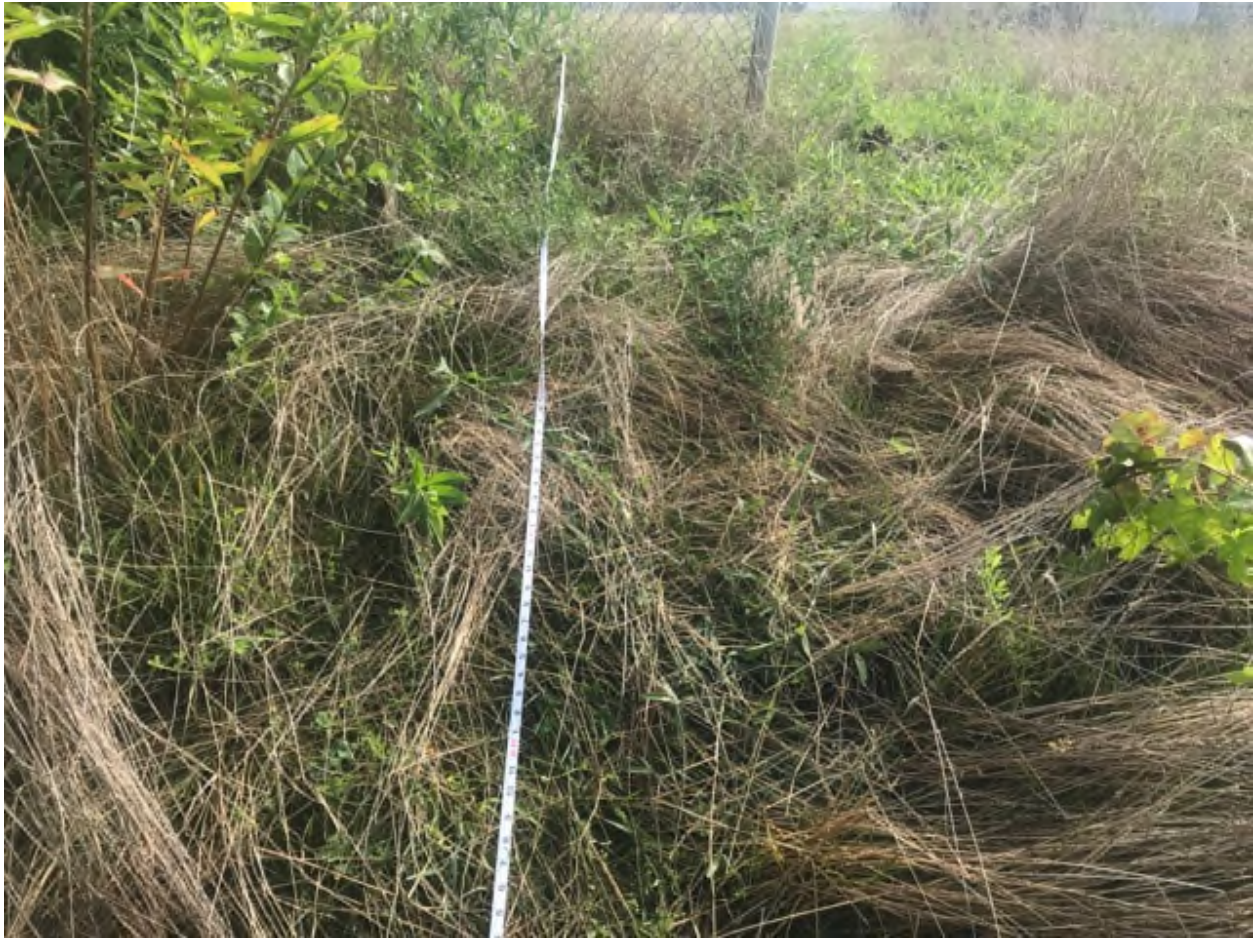
**Figure A-34. Floodplain transect at station 02+00, left bank, 4 feet to 35 feet from top of bank.**

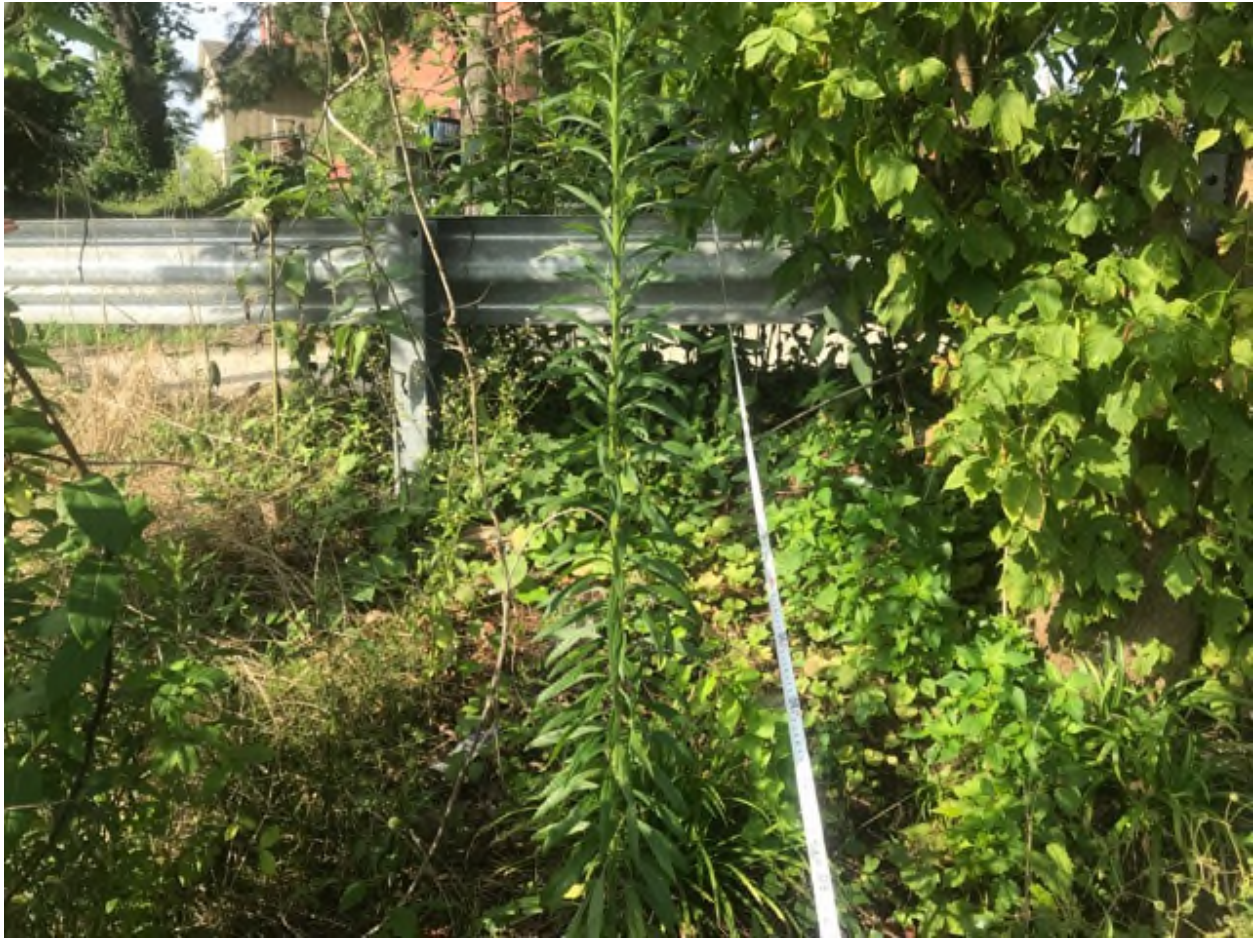
**Figure A-35. Floodplain transect at station 02+00, right bank, 0 feet to 10 feet from top of bank.**
