Subject: Transmittal of the Cow Pen Creek Bank Stabilization and Floodplain  
Reconstruction Monitoring: 2018 Report  
Lockheed Martin Corporation – Middle River Complex  
2323 Eastern Boulevard, Middle River, Baltimore County, Maryland

**COW PEN CREEK  
BANK STABILIZATION AND FLOODPLAIN  
RECONSTRUCTION MONITORING: 2018 REPORT  
LOCKHEED MARTIN MIDDLE RIVER COMPLEX  
2323 EASTERN BOULEVARD  
MIDDLE RIVER, MARYLAND**

December 2018

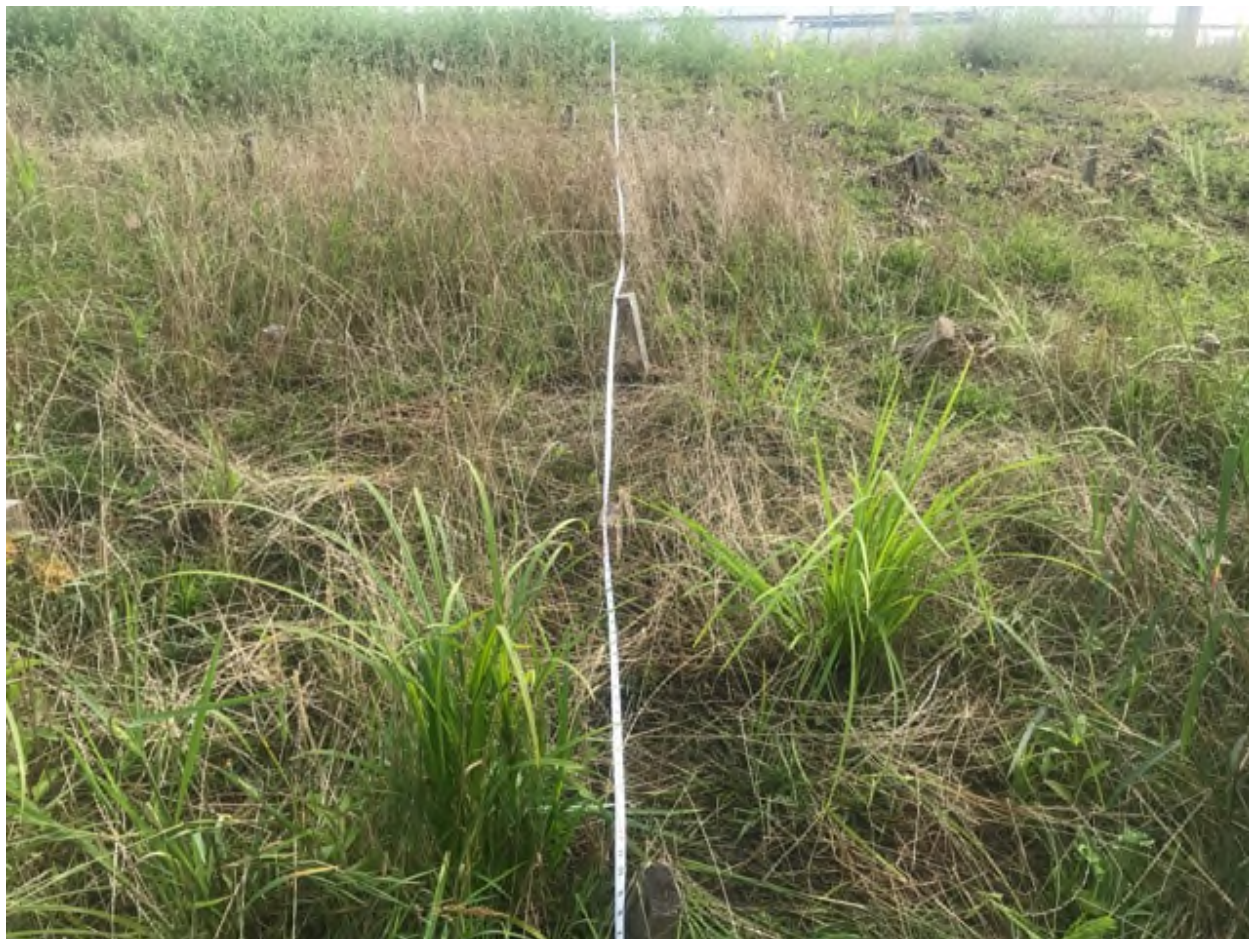
**Figure A-36. Floodplain transect at station 03+00, left bank, 0 feet to 34 feet from top of bank.**

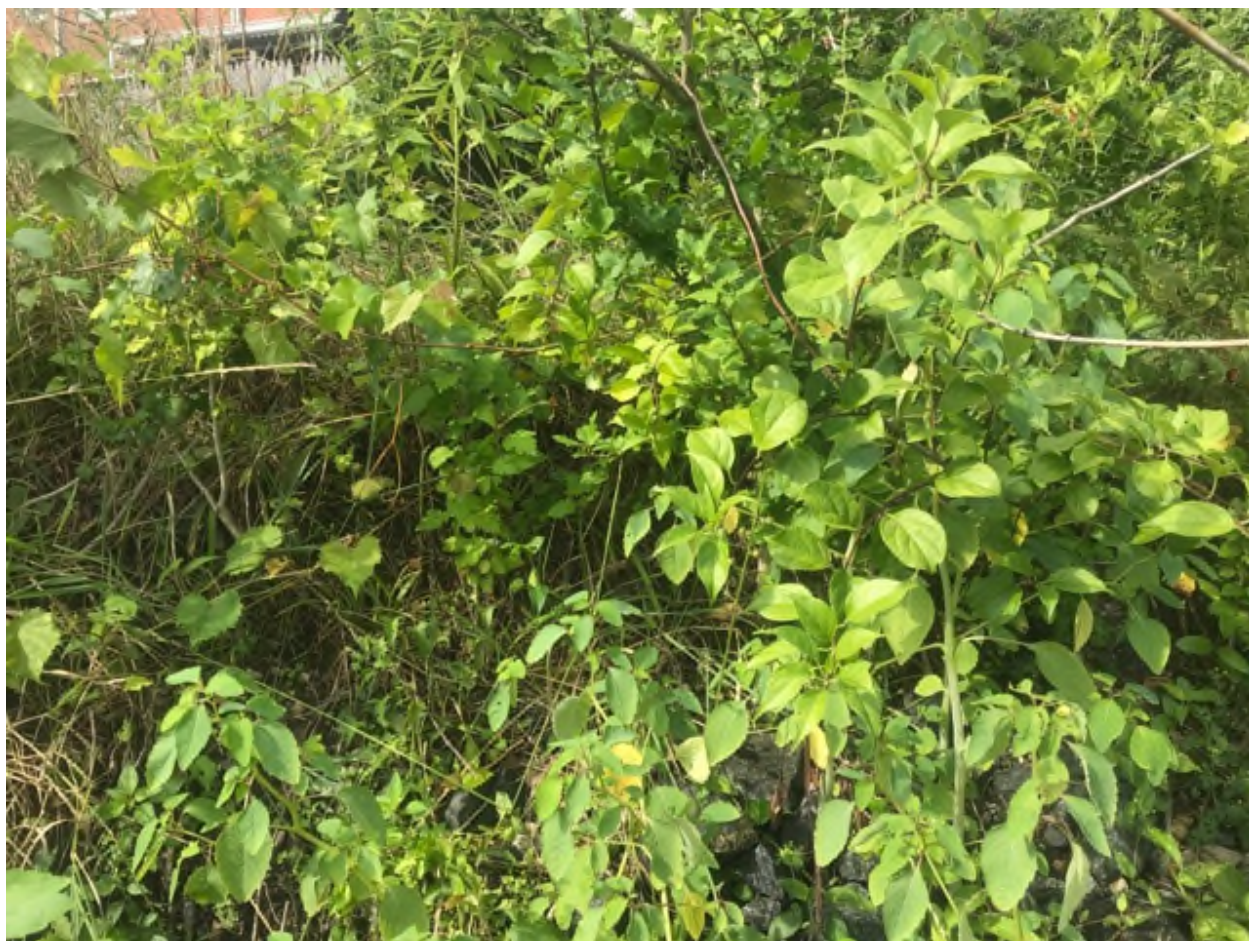
**Figure A-37. Floodplain transect at station 03+00, right bank, 0 feet to 7 feet from top of bank.**

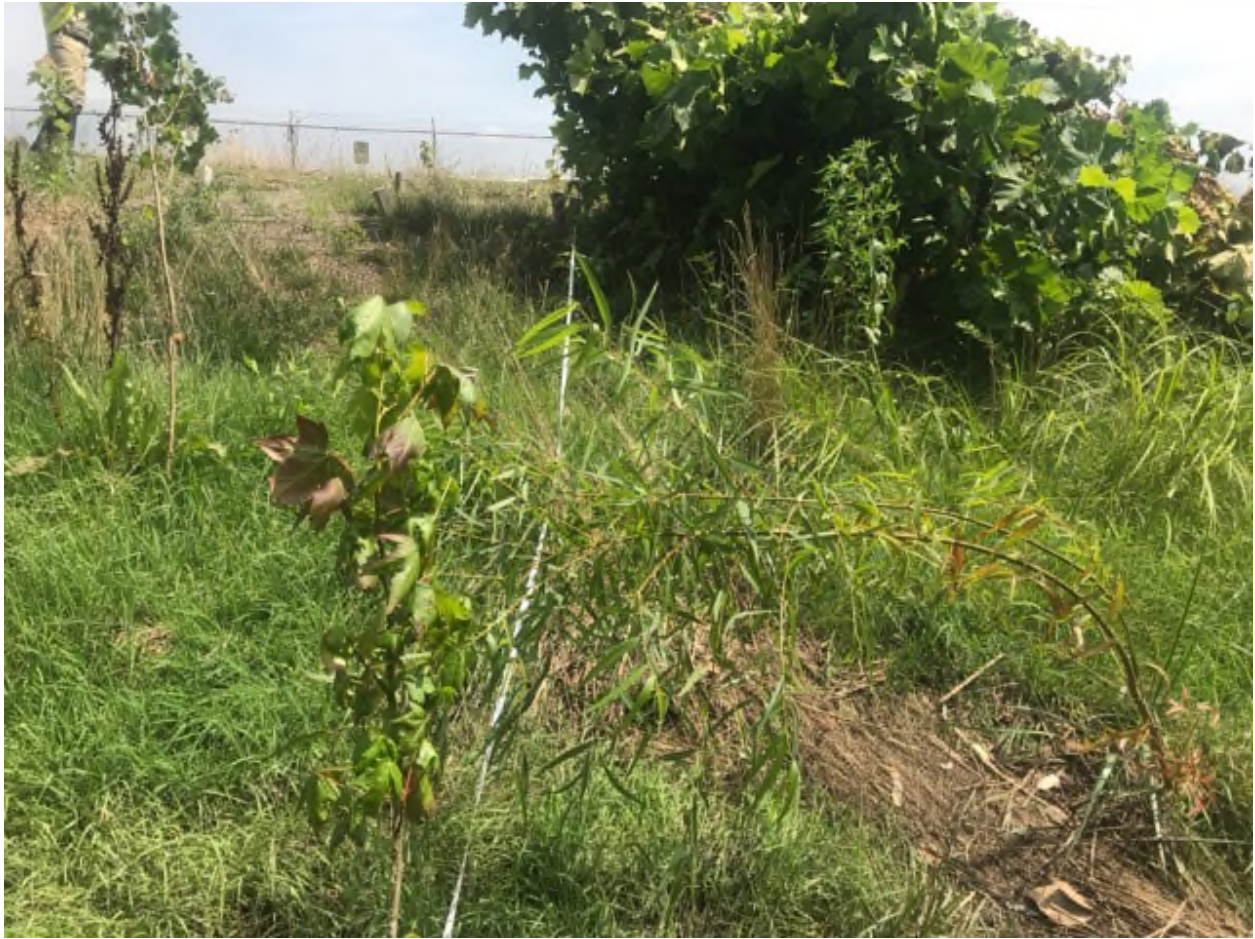
**Figure A-38. Floodplain transect at station 04+33, left bank, 0 feet to 50 feet from top of bank.**

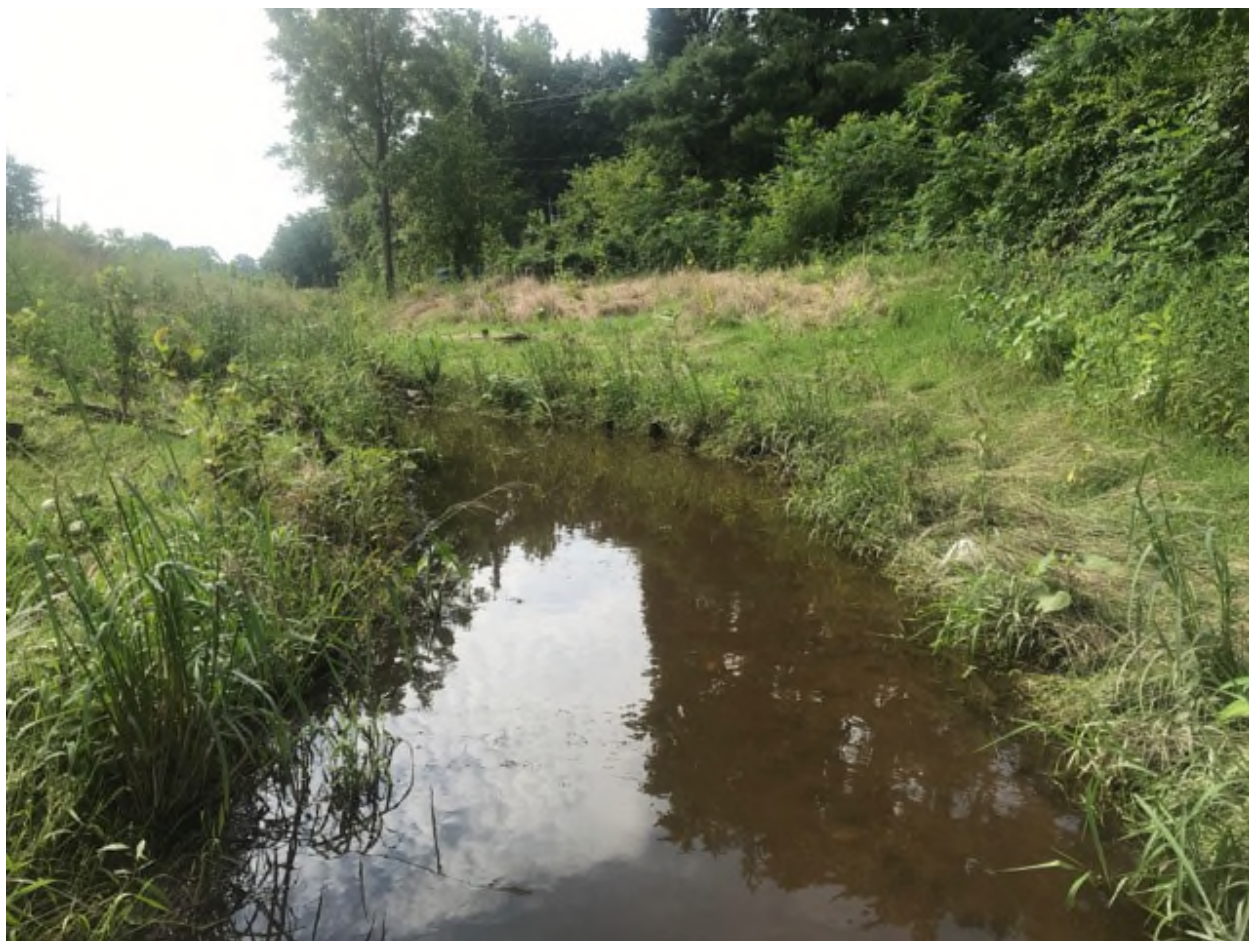
**Figure A-62. Bare spot on the right streambank at station 00+05.**

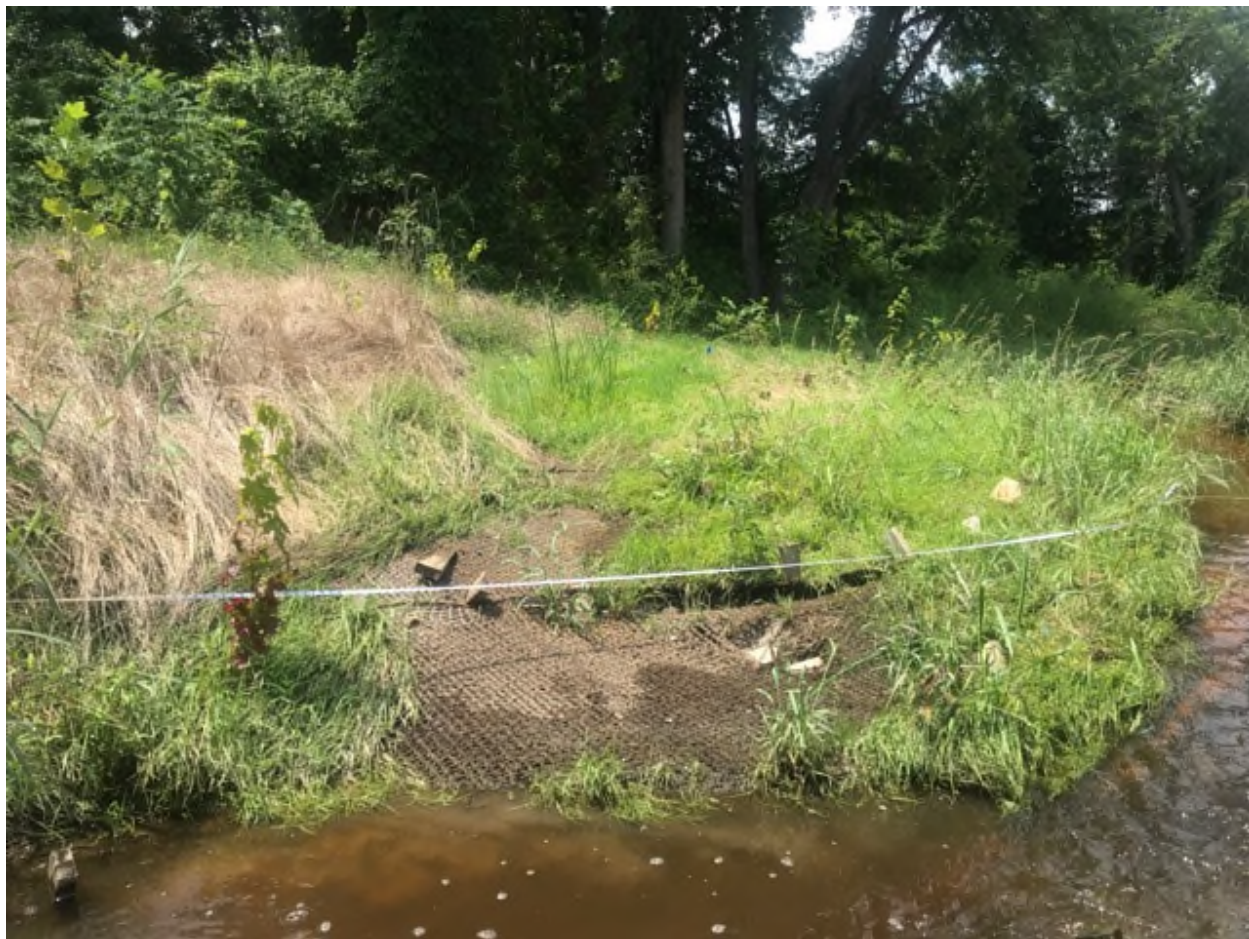
**Figure A-65. Soil eroding from under the matting on the lower left bank at station 01+55.**

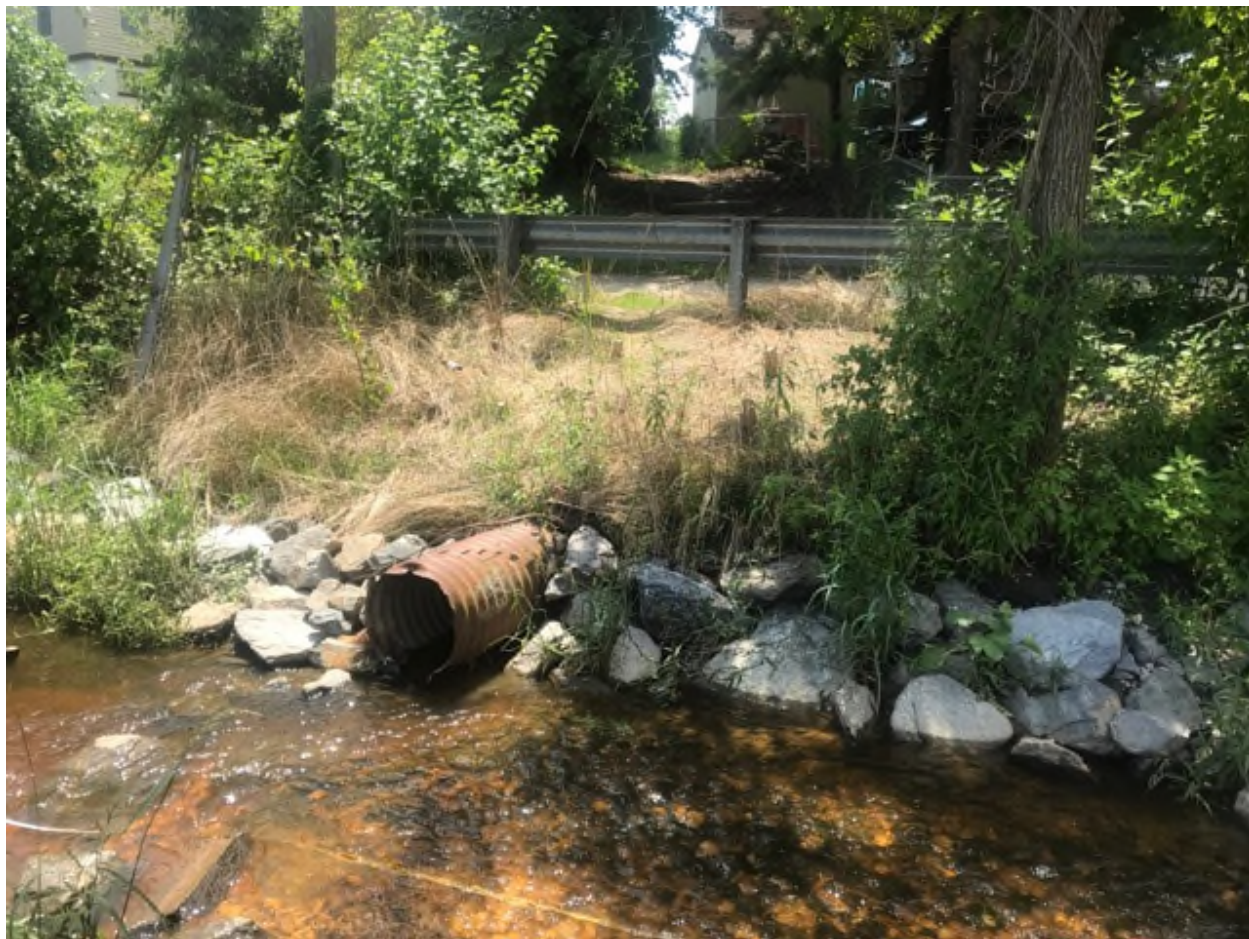
**Figure A-66. Soil eroding from under the matting on the right bank at station 01+67.**

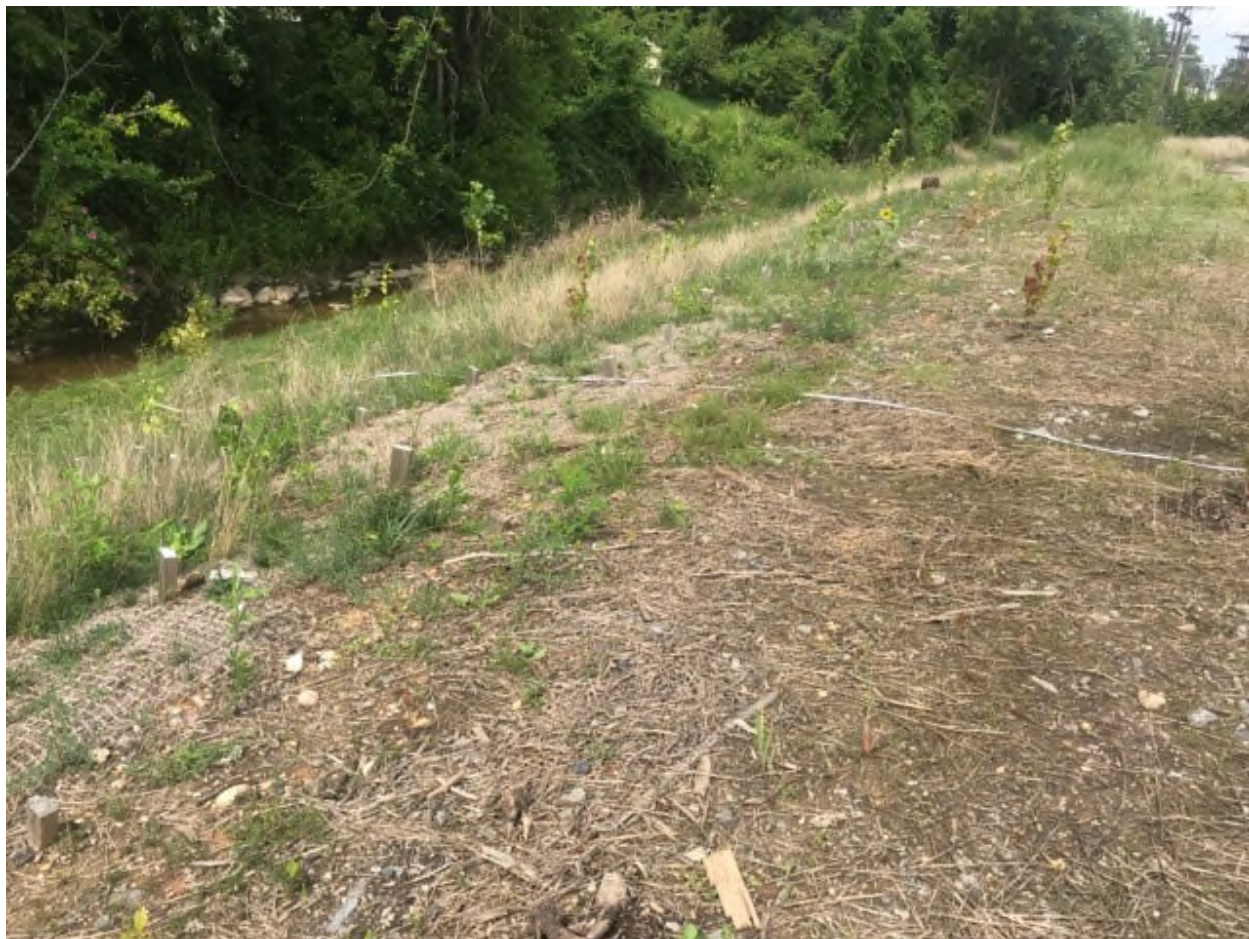
**Figure A-77. Barren floodplain area on the left streambank at station 04+15.**

- Revisit areas noted with phragmites, determine whether treatments to date have effectively controlled growth of phragmites, and spray as needed to eliminate spreading.
- Address bare patches identified along streambank and in floodplain areas by replanting or reseeding.
- Address tree mortality, particularly in wet areas near the lower end of project area. Revise stabilization approach and species list, as this area is likely wetter than was originally anticipated. See the wetlands monitoring report for further discussion of tree mortality.

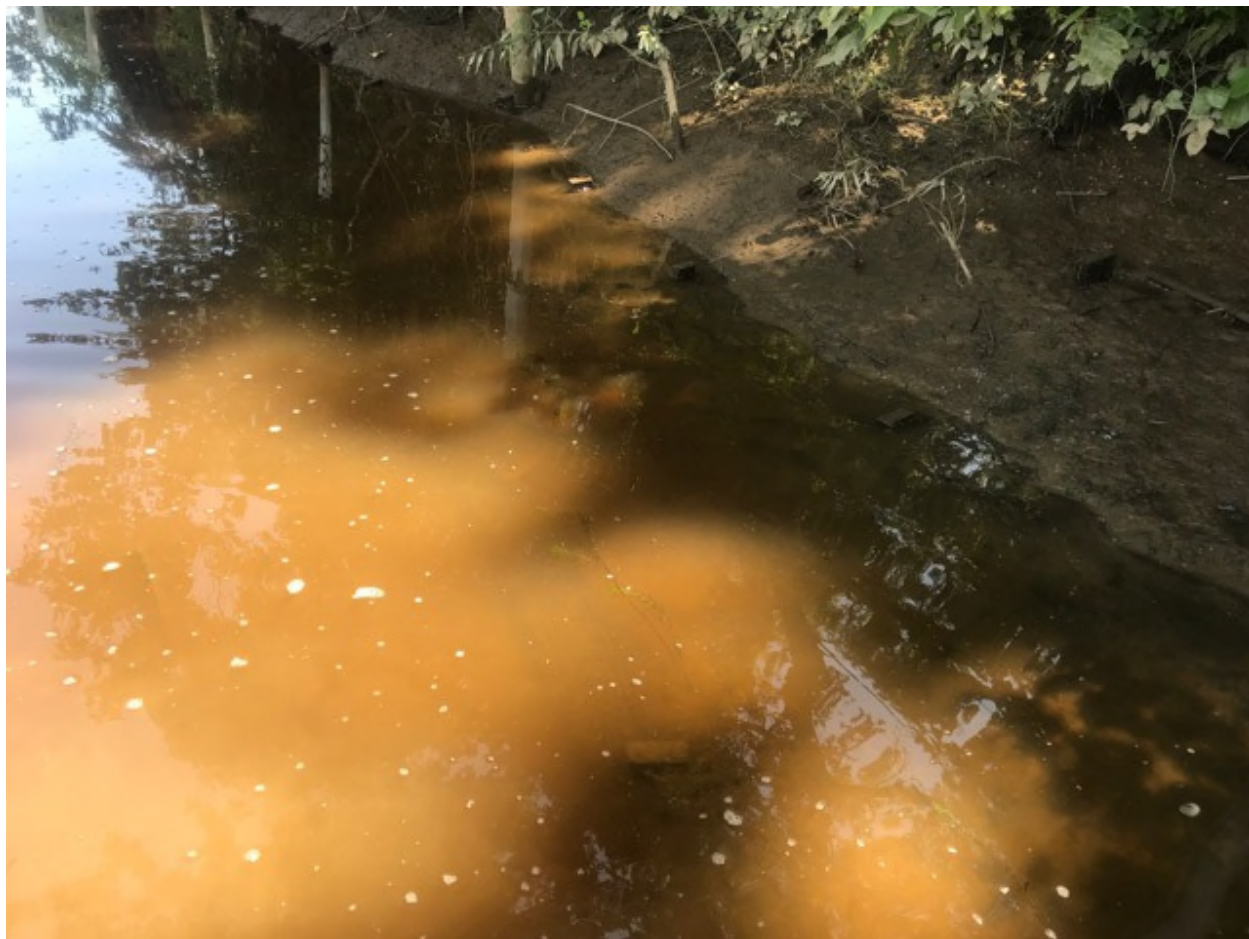
**Figure A-79. Barren right streambank at station 05+69.**

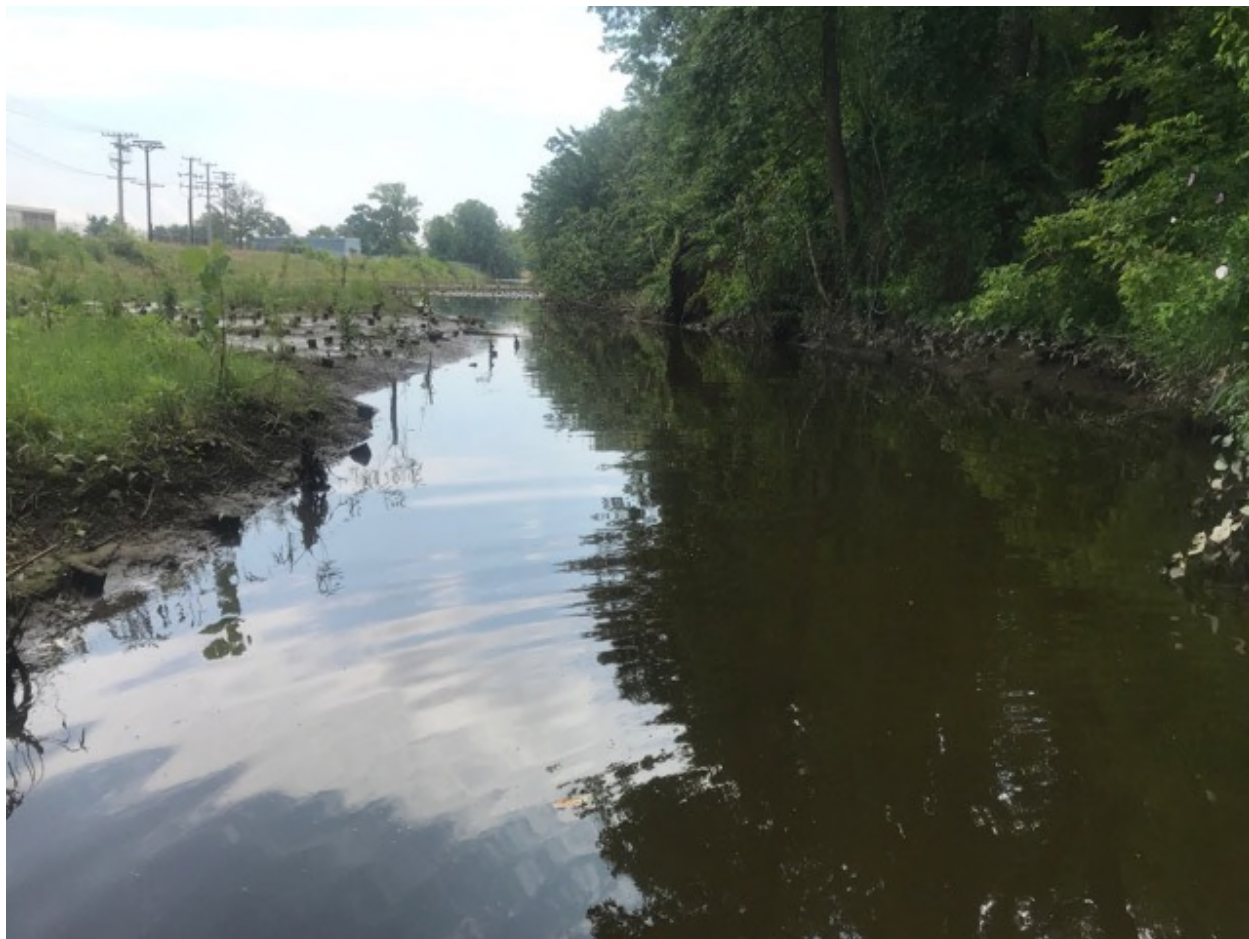
**Figure A-80. Downstream view from thalweg at station 05+67.**

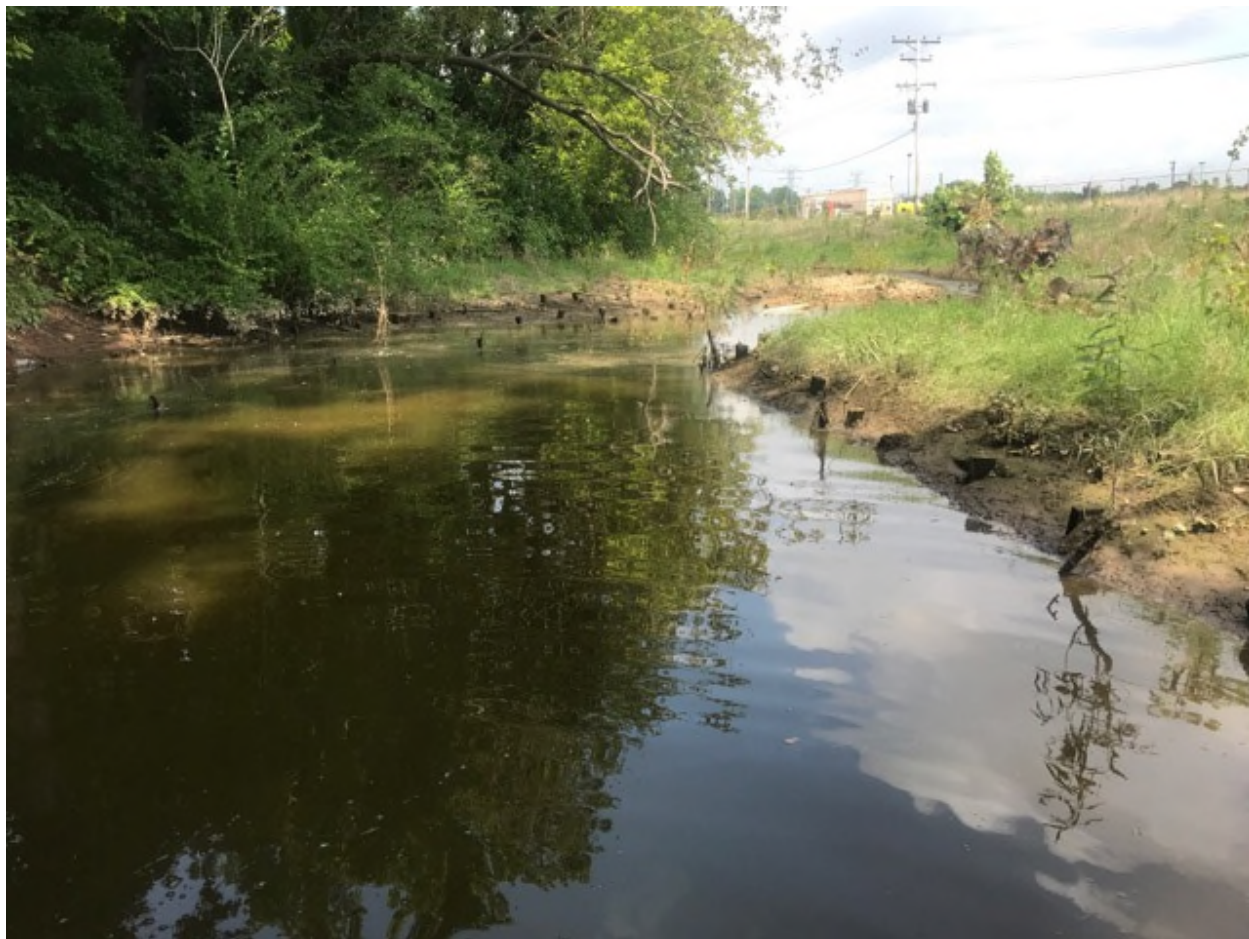
**Figure A-81. Upstream view from thalweg at station 05+67.**

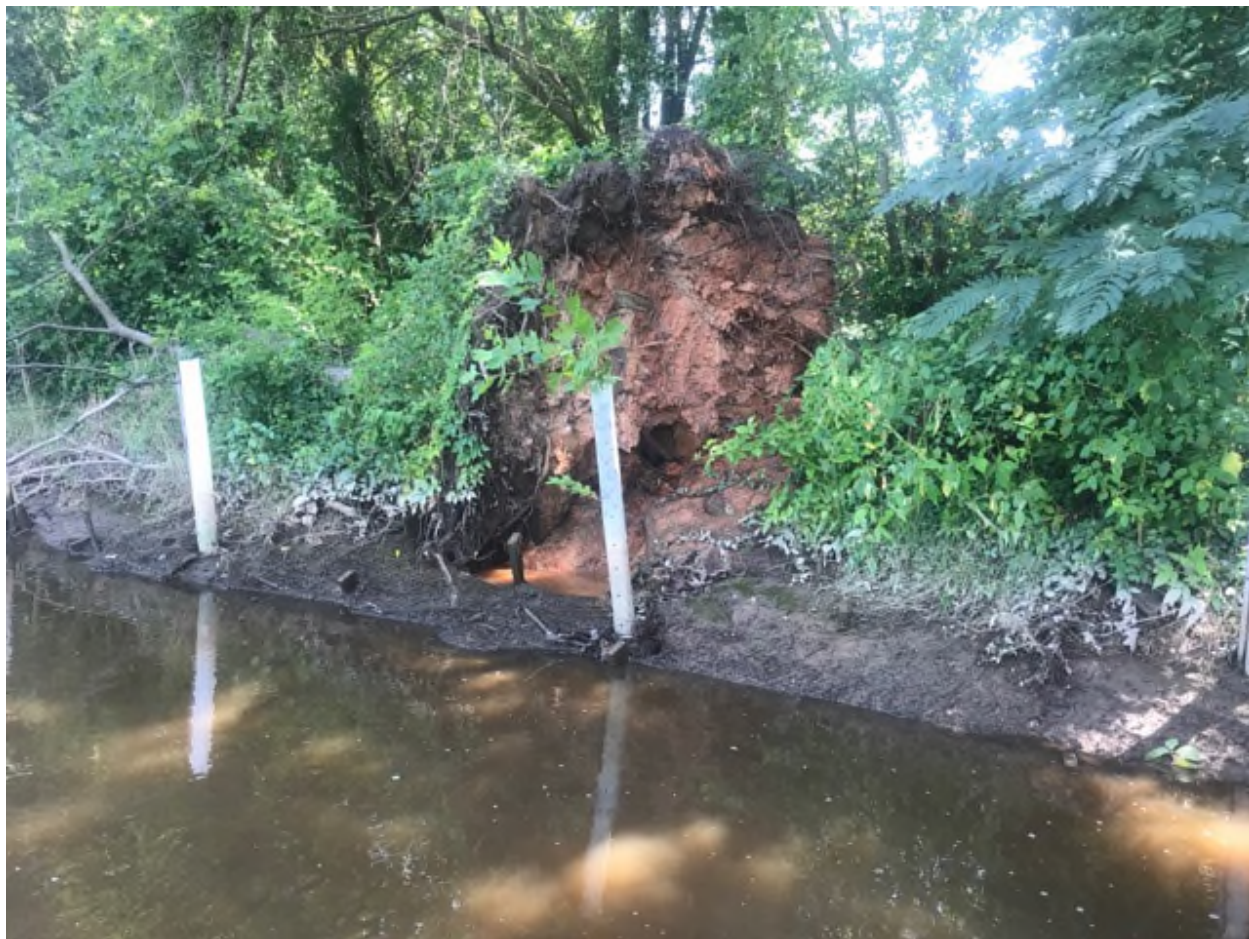
**Figure A-82. Barren right streambank and new tree fall at station 06+07.**

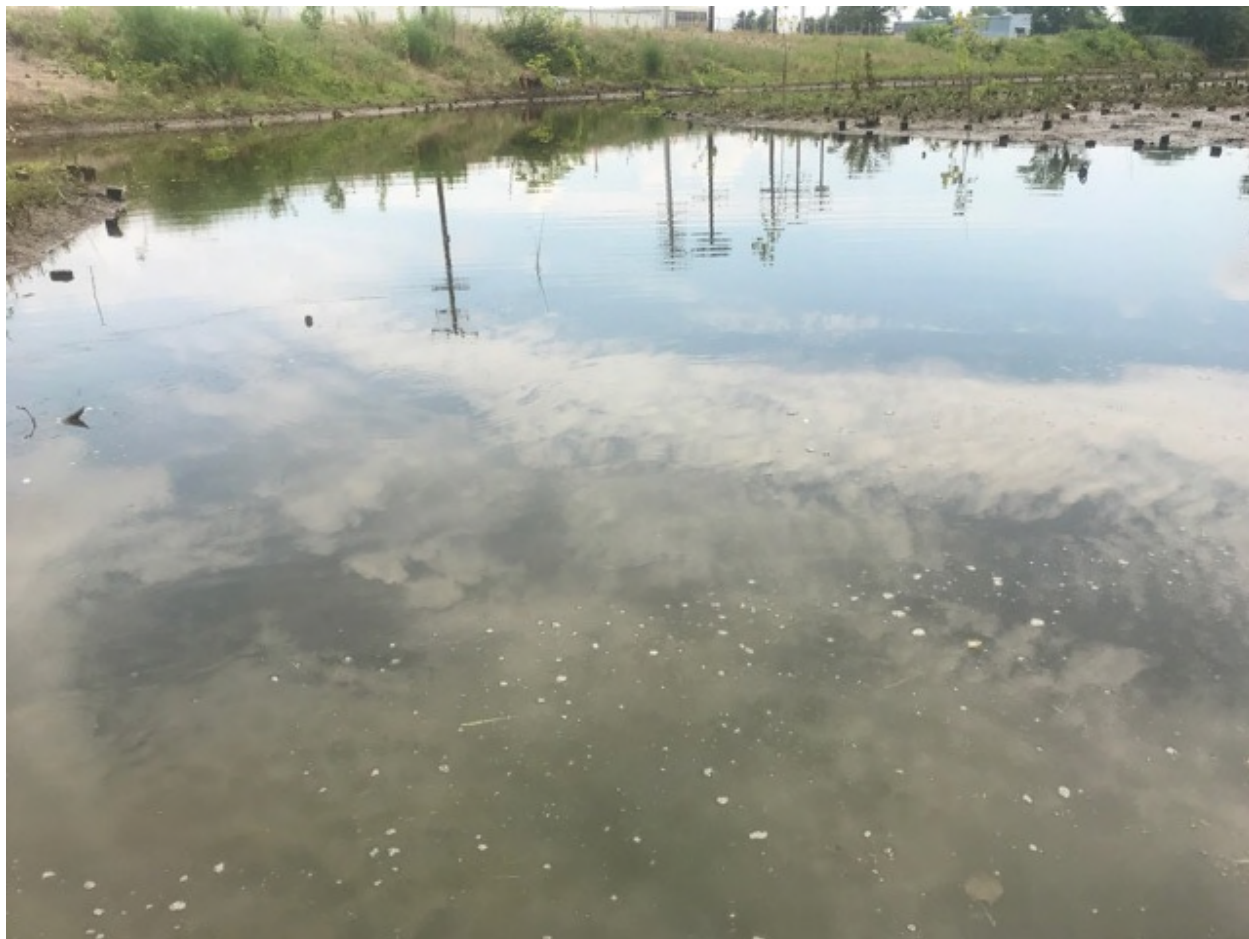
**Figure A-83. Downstream view from thalweg at station 07+00.**

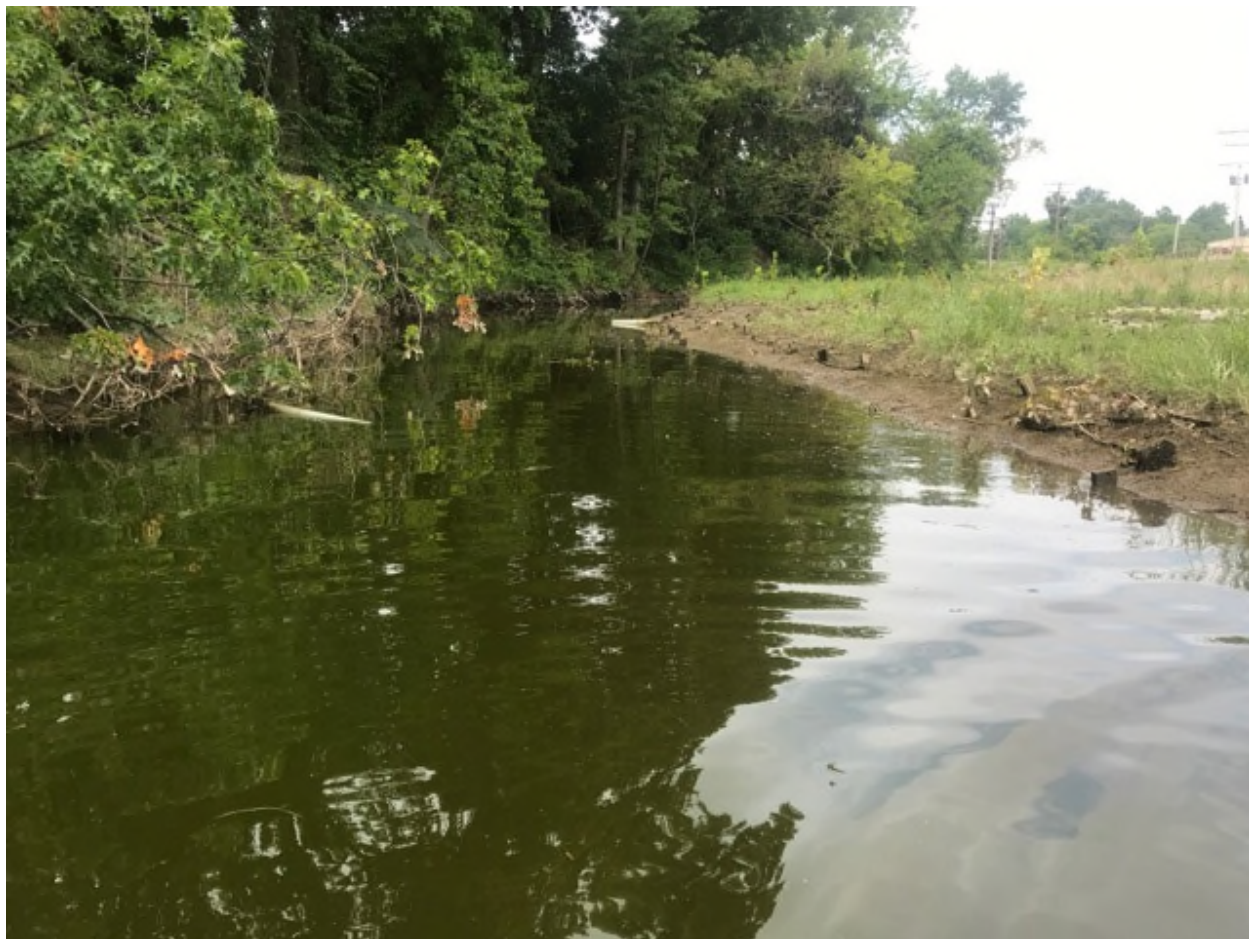
**Figure A-84. Upstream view from thalweg at station 07+00.**

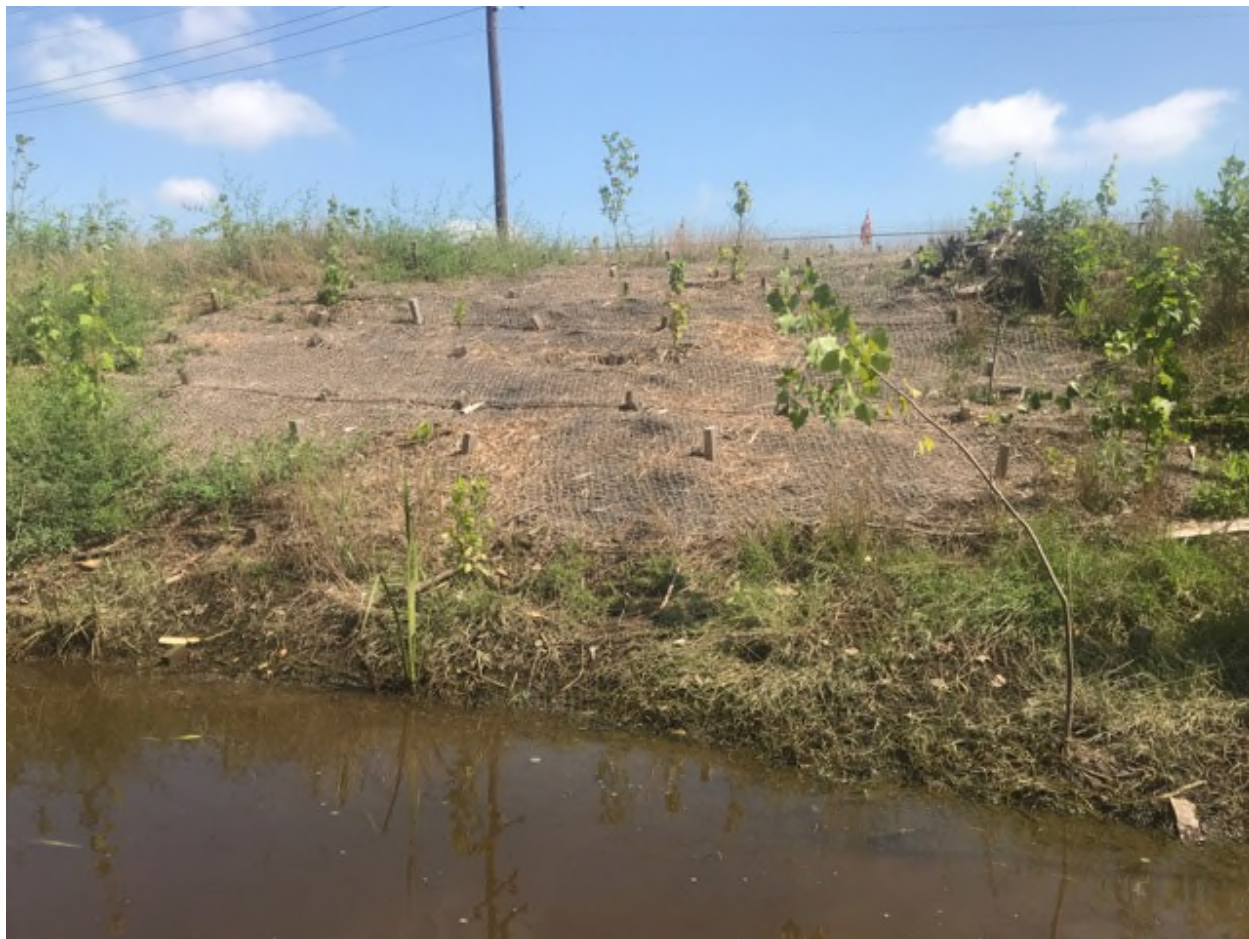
**Figure A-85. Barren floodplain area on the left streambank at station 07+71.**

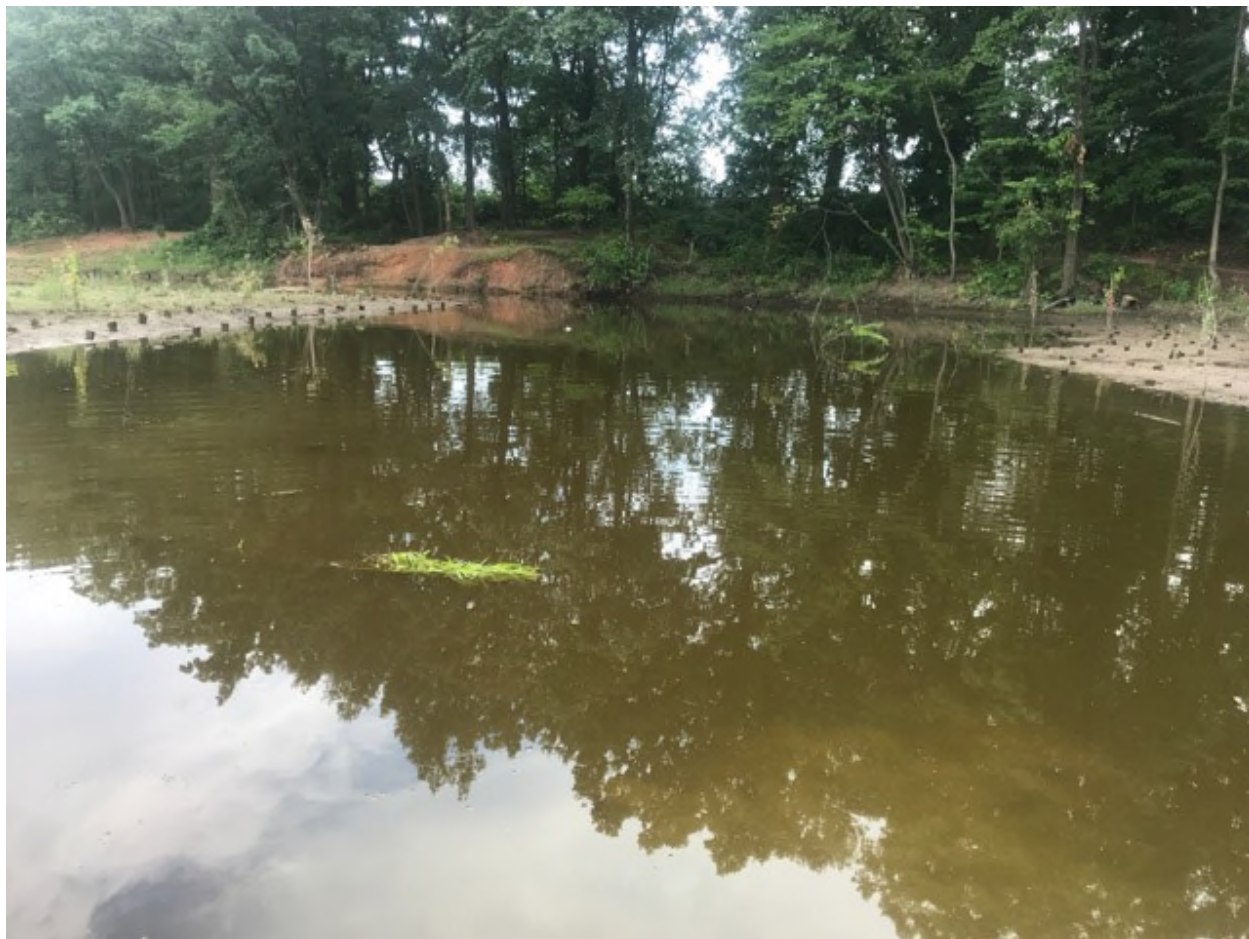
**Figure A-86. Downstream view from thalweg at station 08+33.**

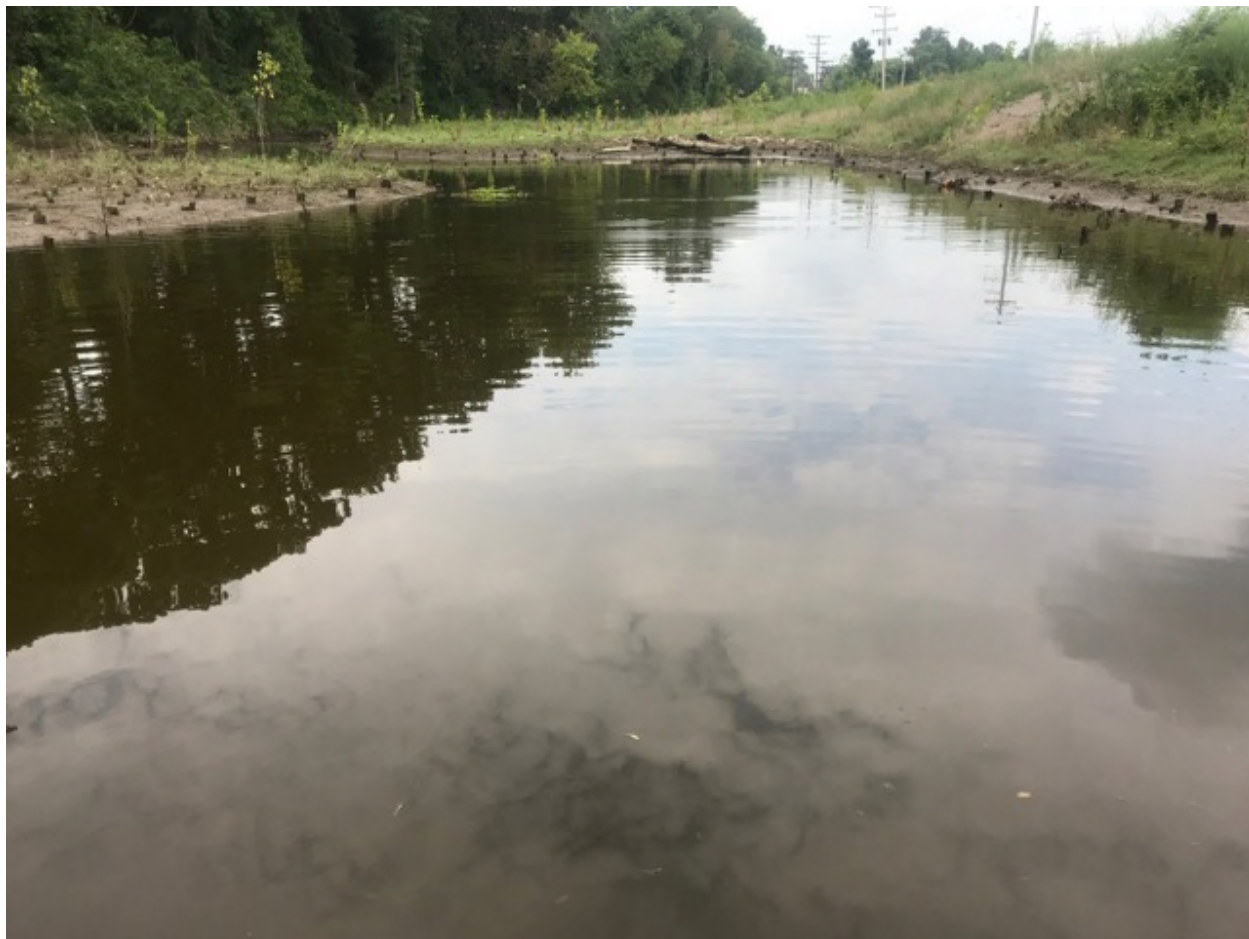
**Figure A-87. Upstream view from thalweg at station 08+33.**

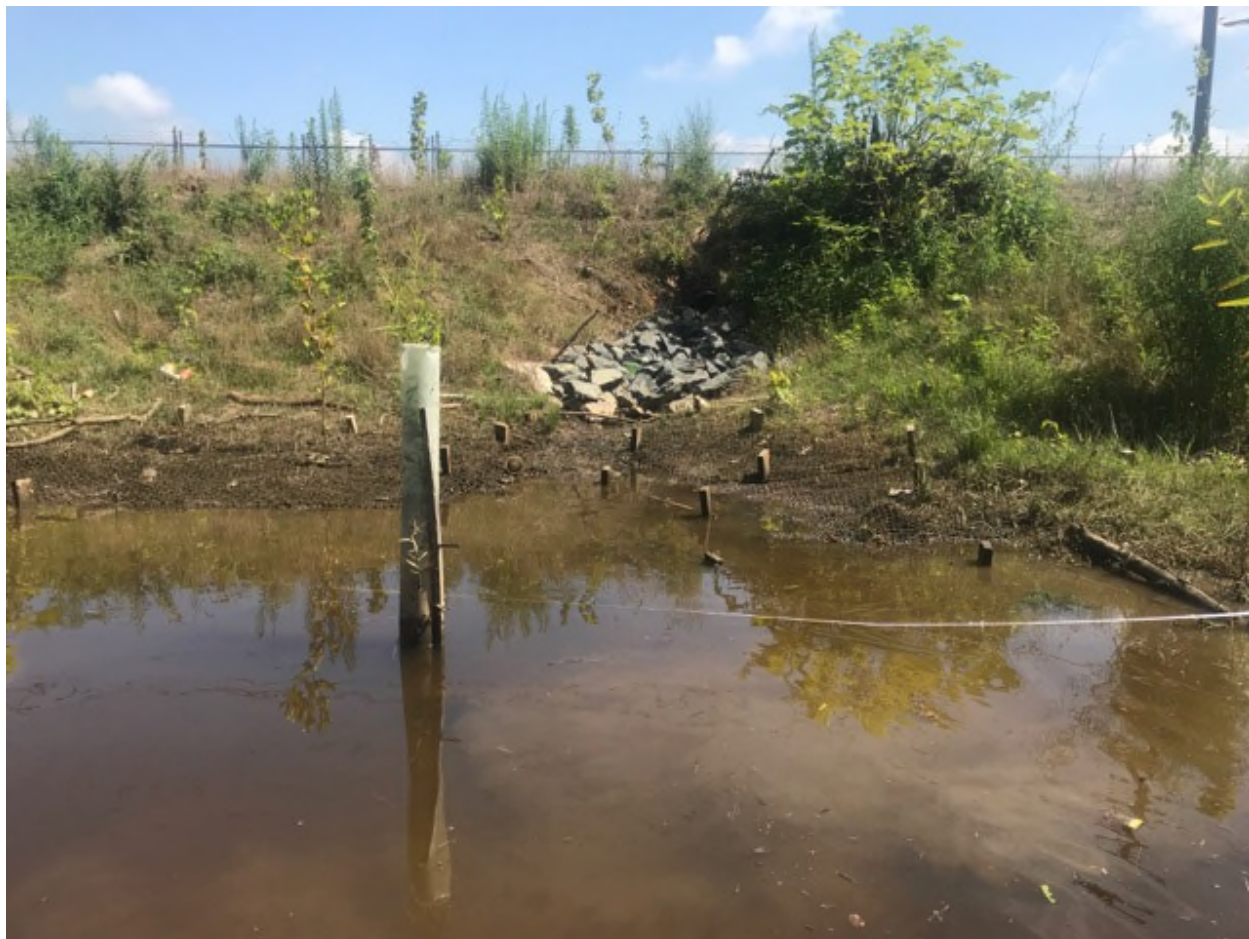
**Figure A-88. Outfall and barren area on left streambank at station 08+32.**

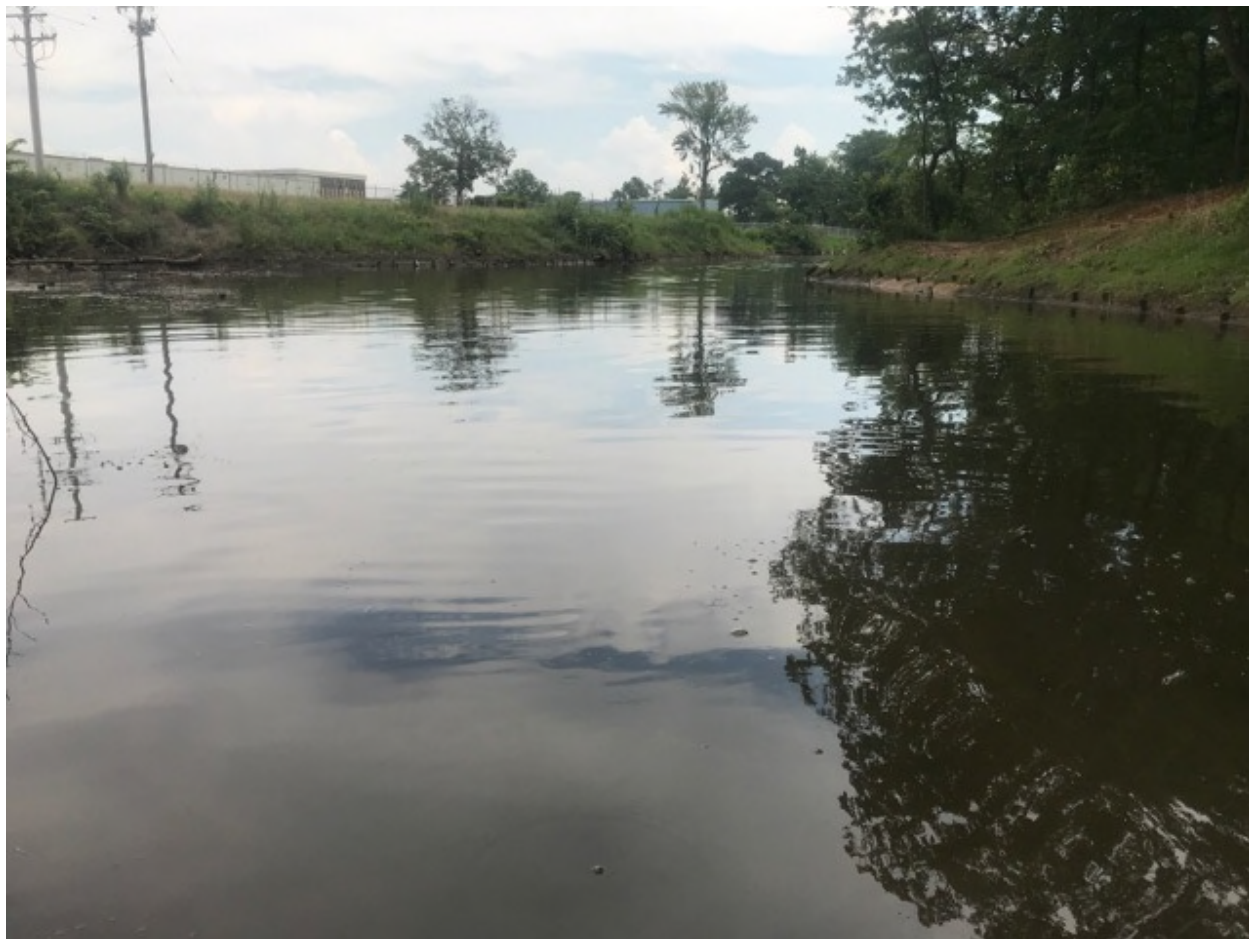
**Figure A-90. Downstream view from thalweg at station 09+67.**

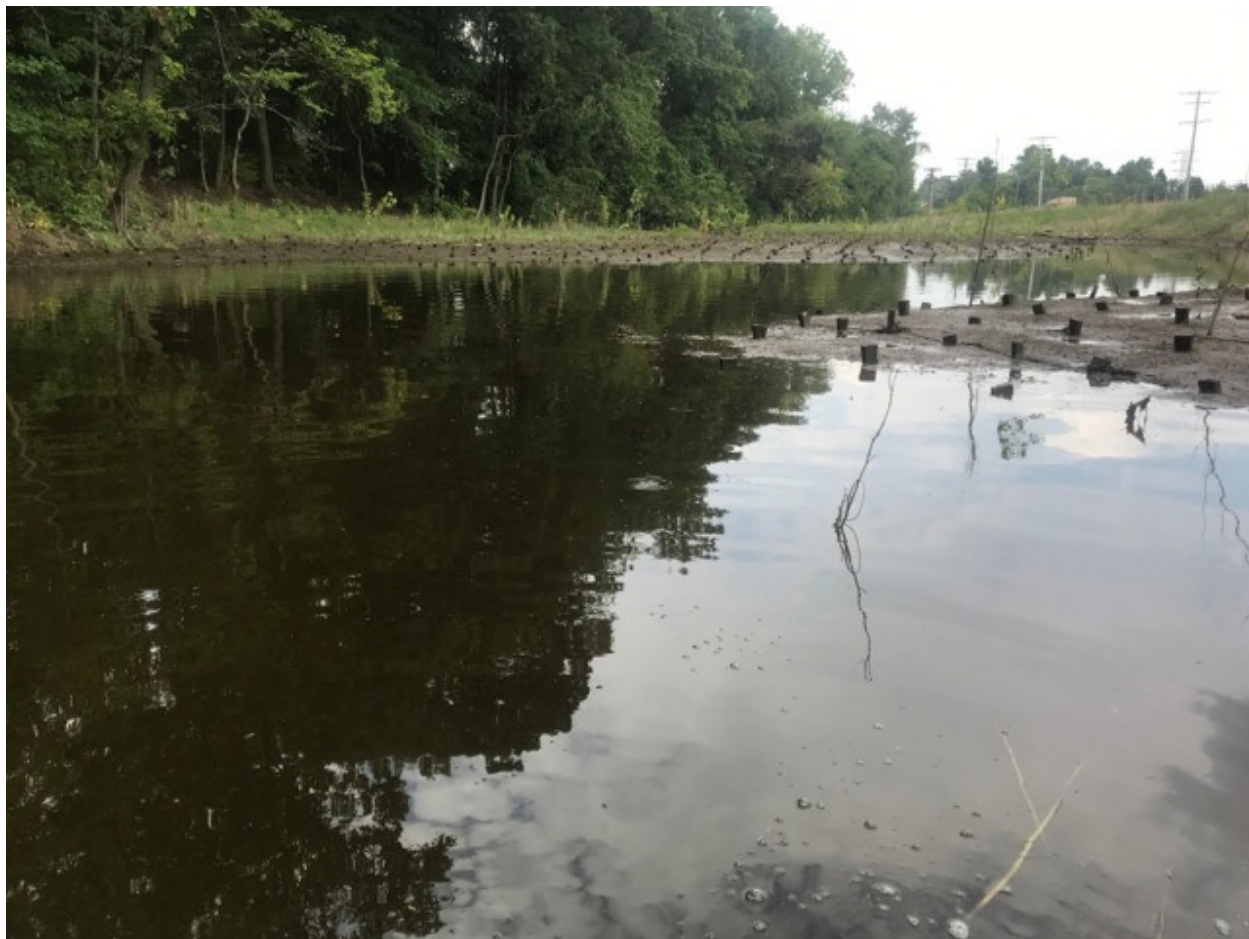
**Figure A-91. Upstream view from thalweg at station 09+67.**
