Subject: Transmittal of the Cow Pen Creek Bank Stabilization and Floodplain  
Reconstruction Monitoring: 2018 Report  
Lockheed Martin Corporation – Middle River Complex  
2323 Eastern Boulevard, Middle River, Baltimore County, Maryland

**COW PEN CREEK  
BANK STABILIZATION AND FLOODPLAIN  
RECONSTRUCTION MONITORING: 2018 REPORT  
LOCKHEED MARTIN MIDDLE RIVER COMPLEX  
2323 EASTERN BOULEVARD  
MIDDLE RIVER, MARYLAND**

December 2018

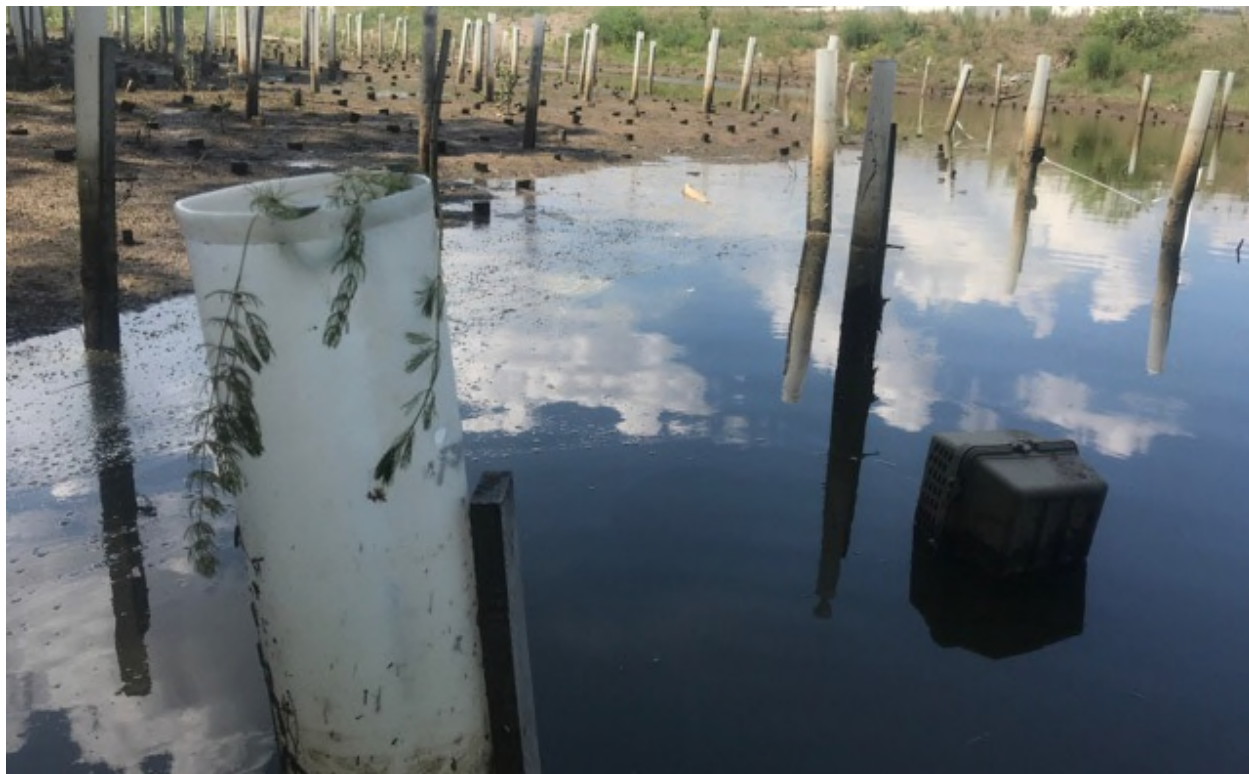
**Figure A-92. Inundated tree tubes on the right streambank at station 09+09.**

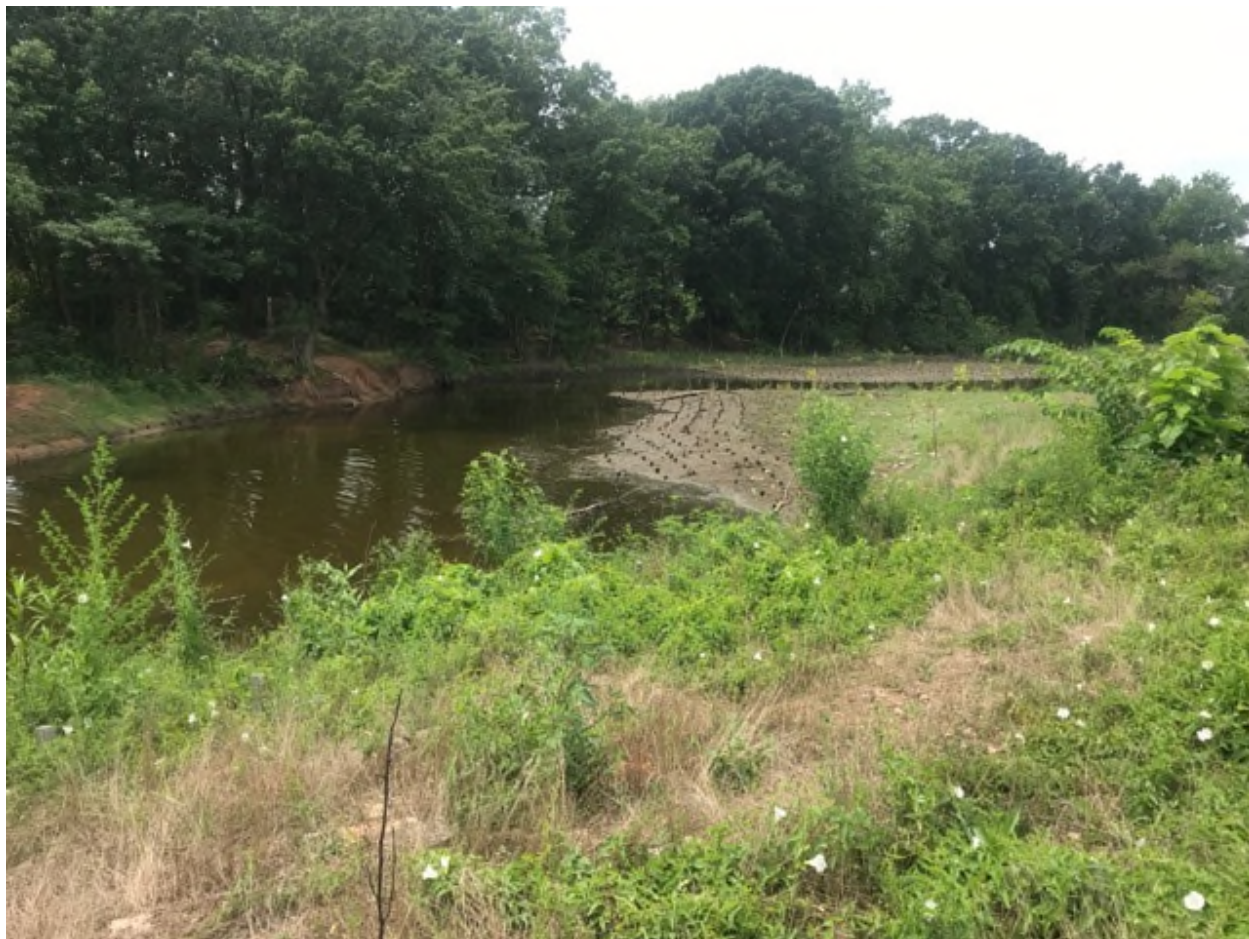
**Figure A-93. Upstream view of wetland area at station 10+00.**

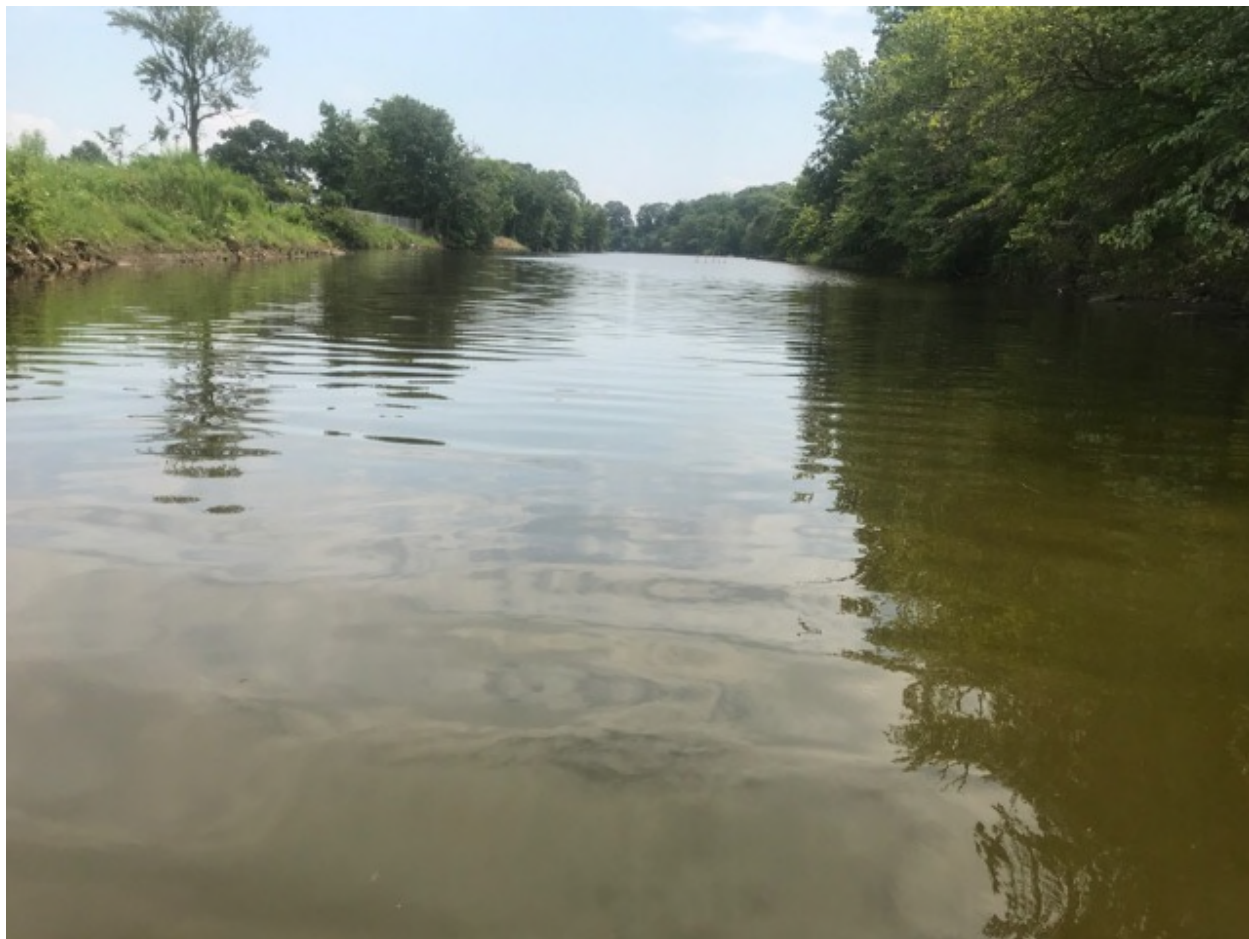
**Figure A-94. Downstream view from thalweg at station 11+00.**

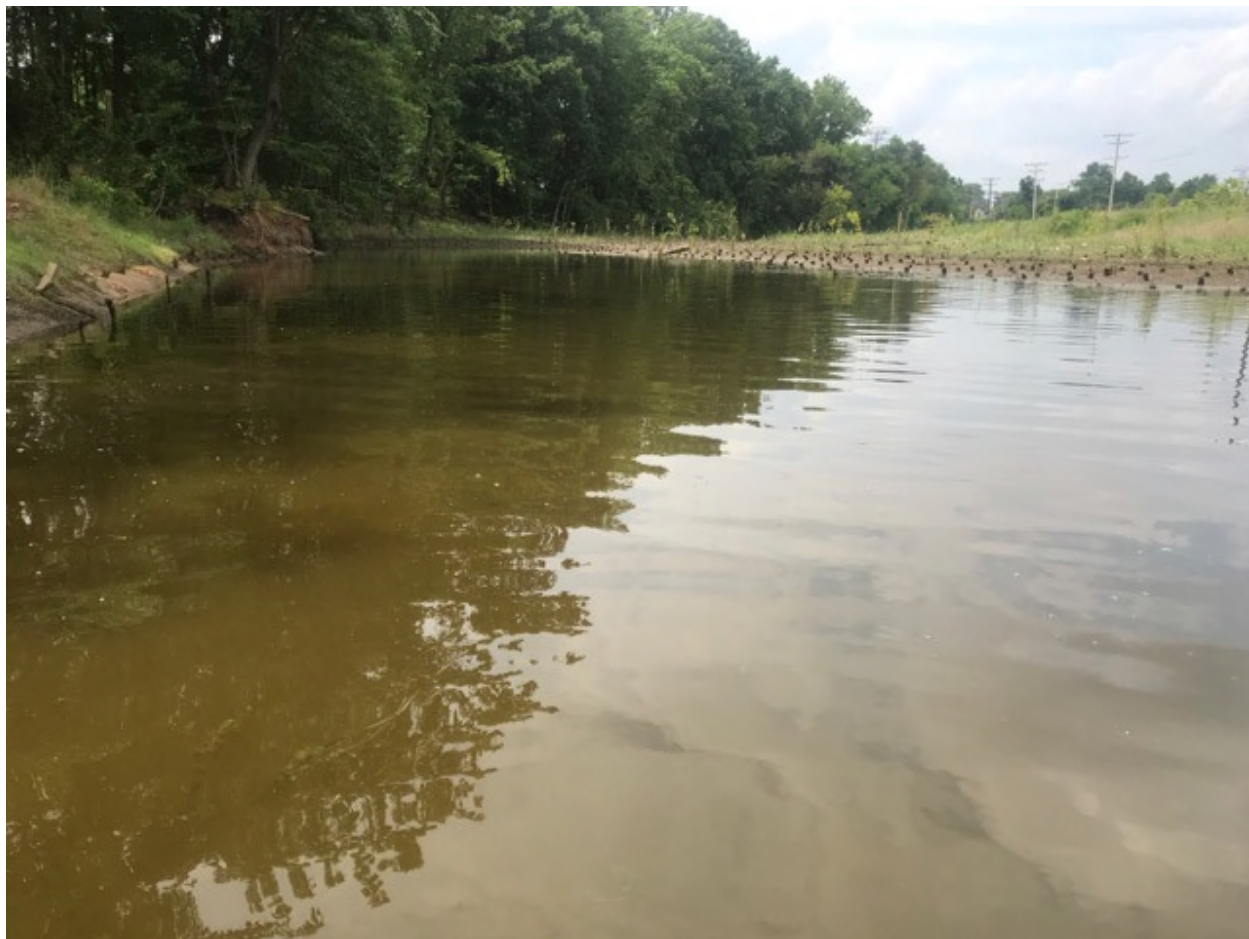
**Figure A-95. Upstream view from thalweg at station 11+00.**

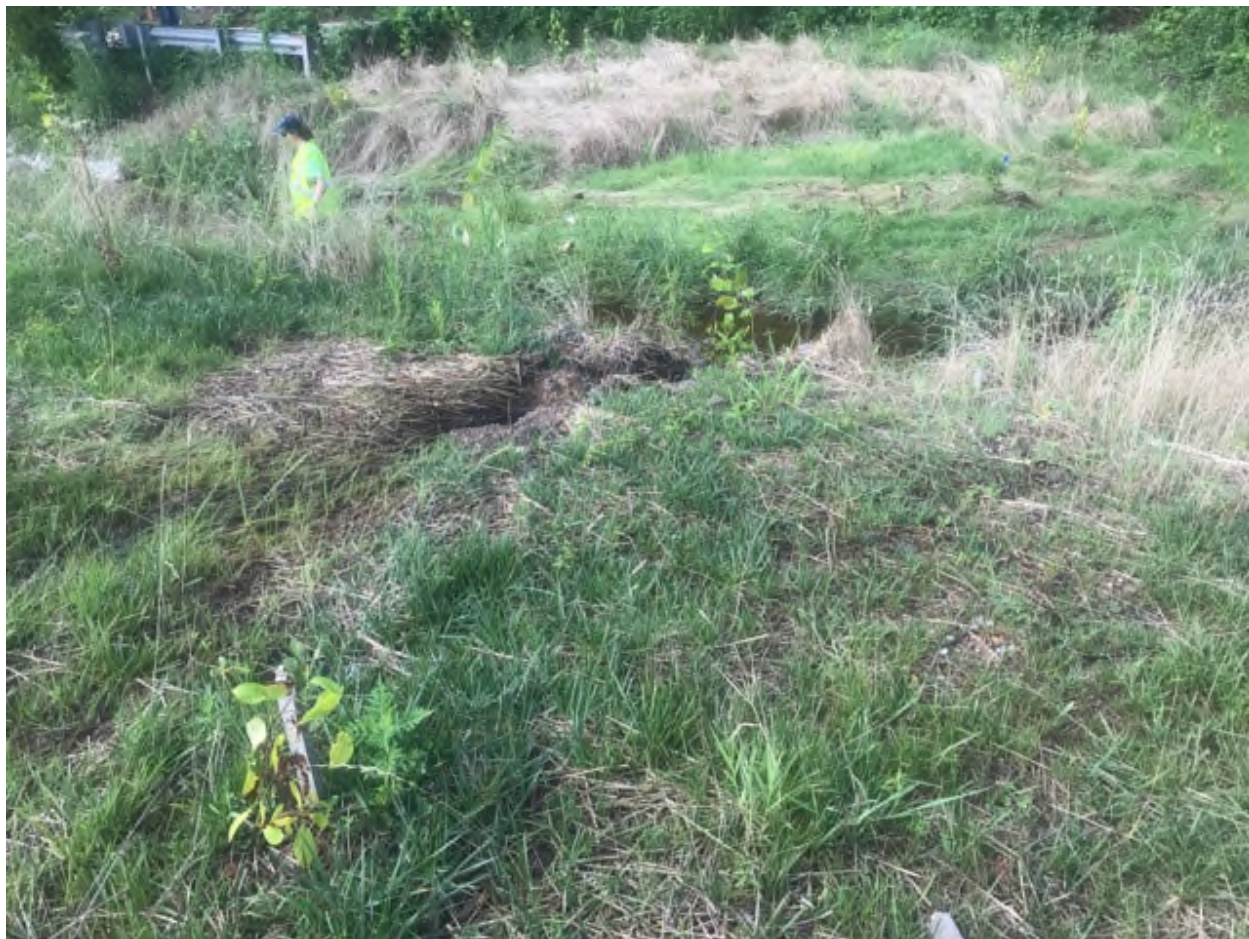
**Figure A-96. View from top of floodplain, left streambank at station 01+30.**

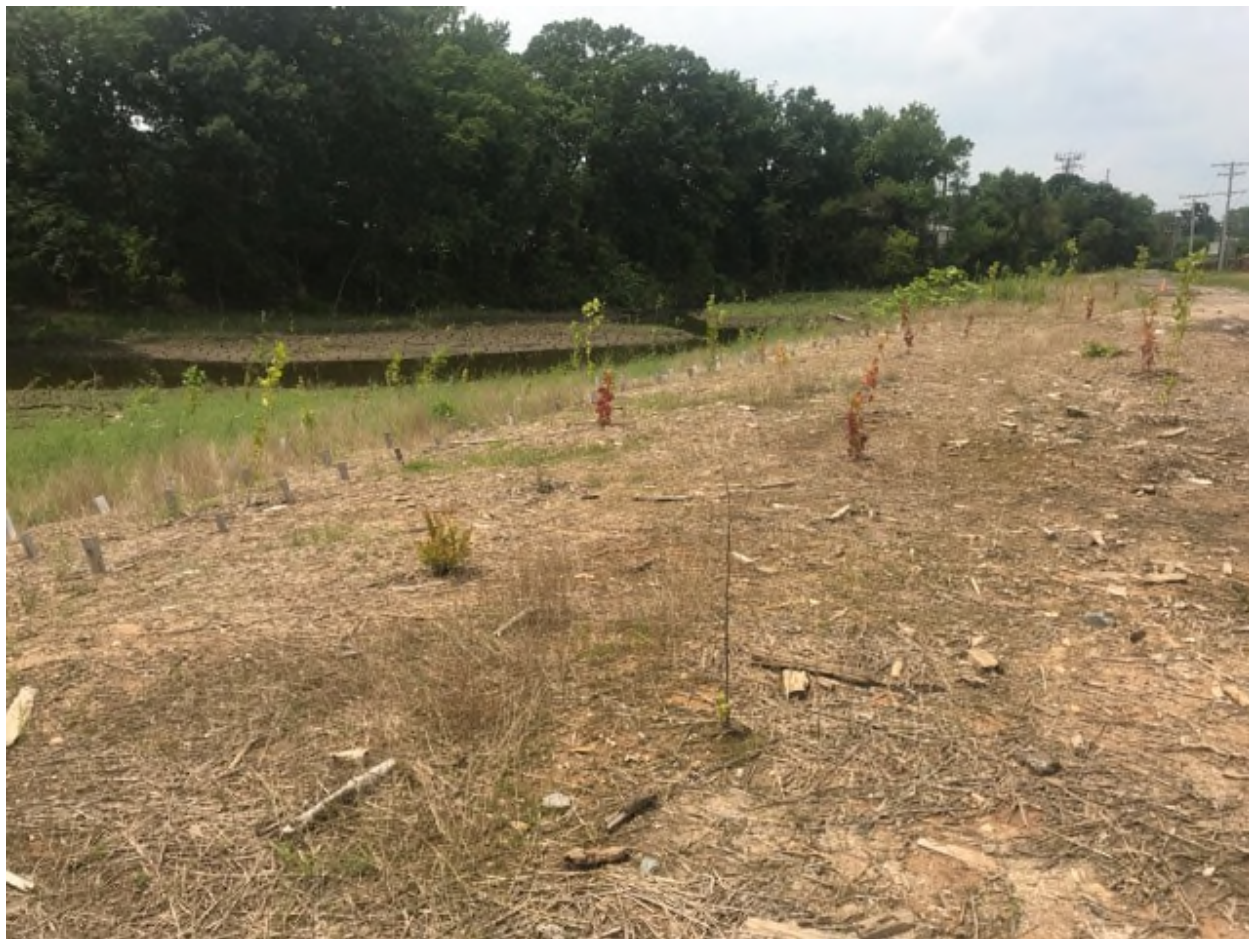
**Figure A-97. Upstream view from top of floodplain, left streambank at station 10+70.**
