Subject: Transmittal of the Cow Pen Creek Bank Stabilization and Floodplain Reconstruction Monitoring:
2019 Report
Lockheed Martin Corporation – Middle River Complex
2323 Eastern Boulevard, Middle River, Baltimore County, Maryland

**COW PEN CREEK
BANK STABILIZATION AND FLOODPLAIN
RECONSTRUCTION MONITORING: 2019 REPORT
LOCKHEED MARTIN MIDDLE RIVER COMPLEX
2323 EASTERN BOULEVARD
MIDDLE RIVER, MARYLAND**

Prepared by:
Tetra Tech, Inc.

January 2020

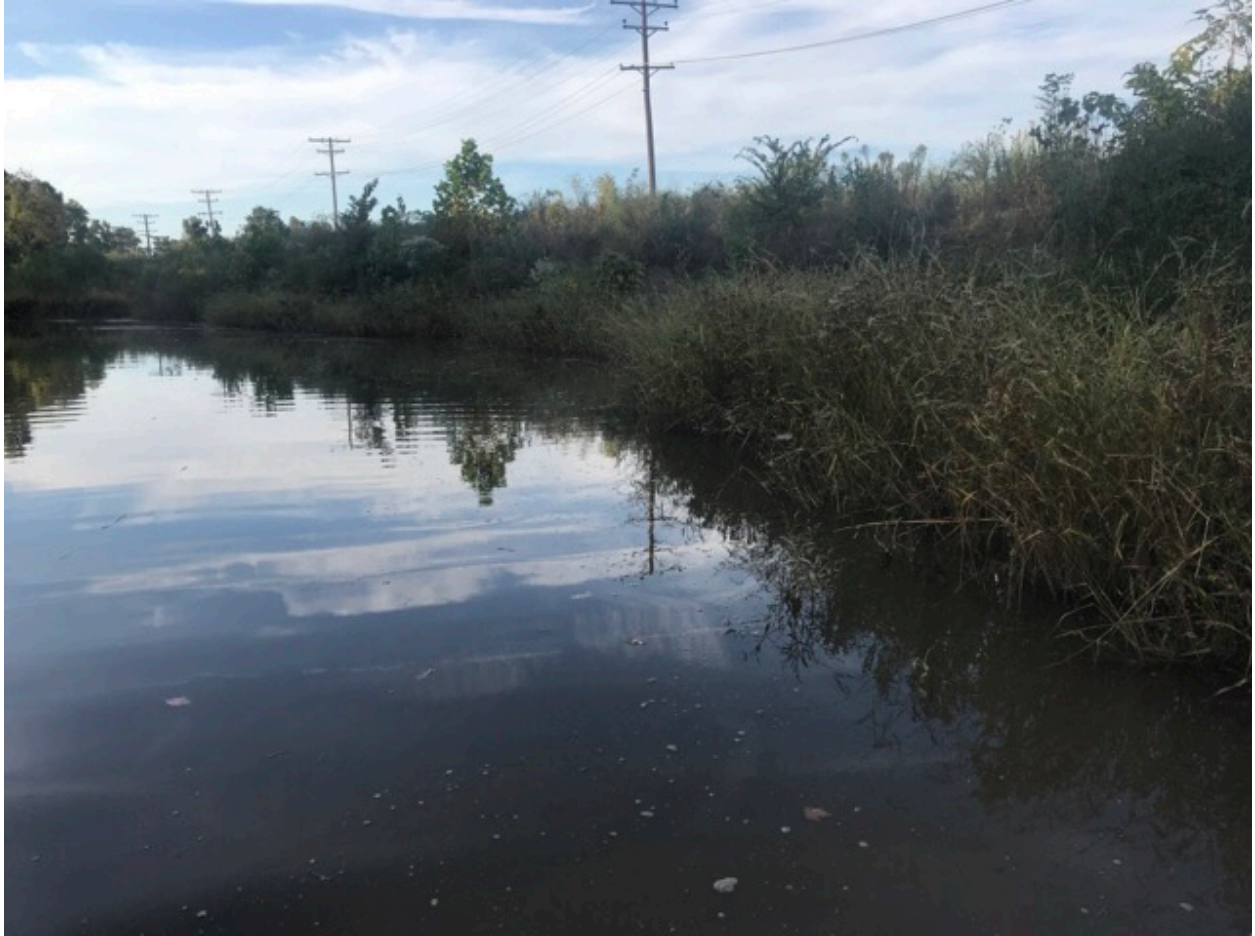
Figure A-30. Left streambank, upstream view at Station 08+55.

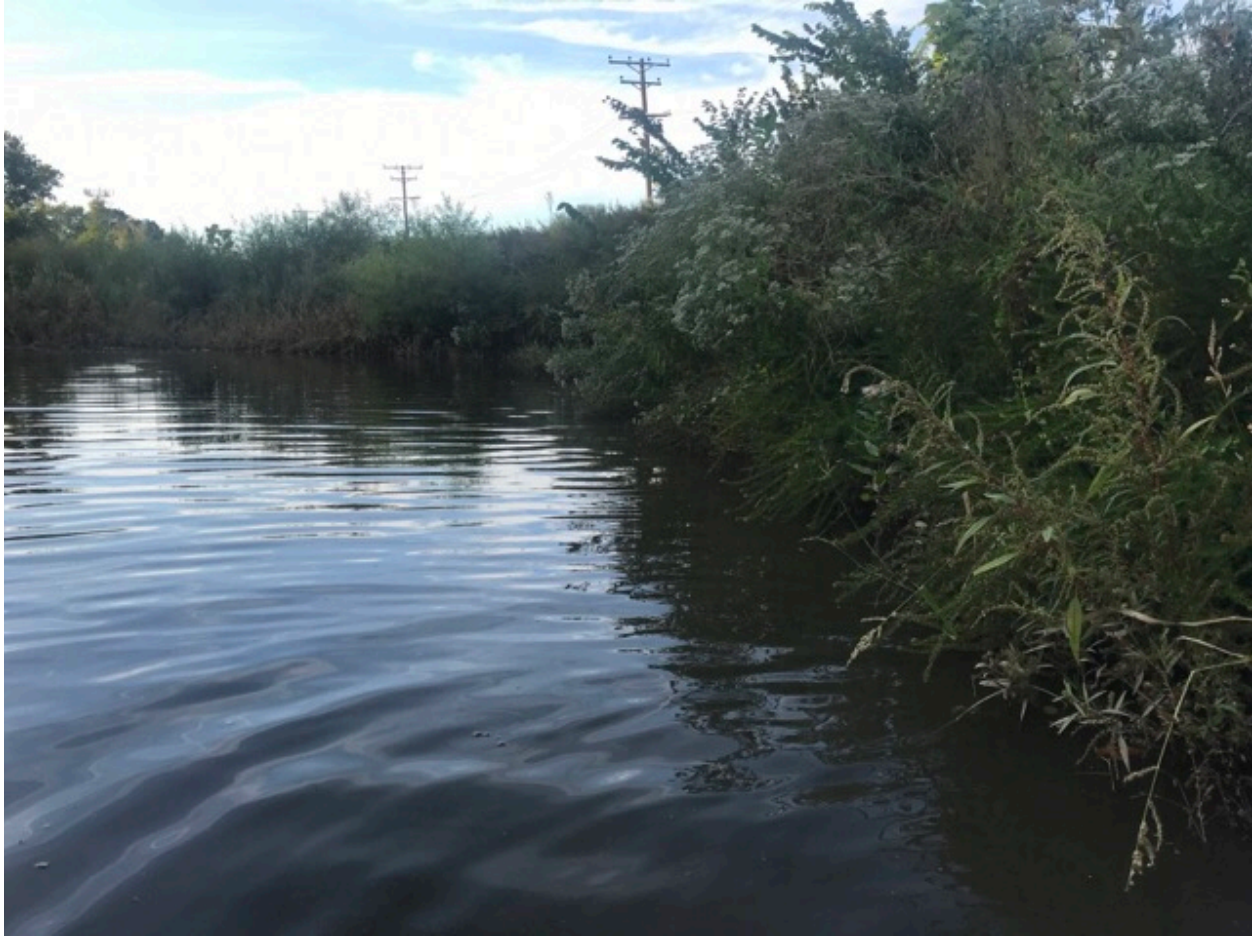
Figure A-35. Left streambank, upstream view at Station 11+00.

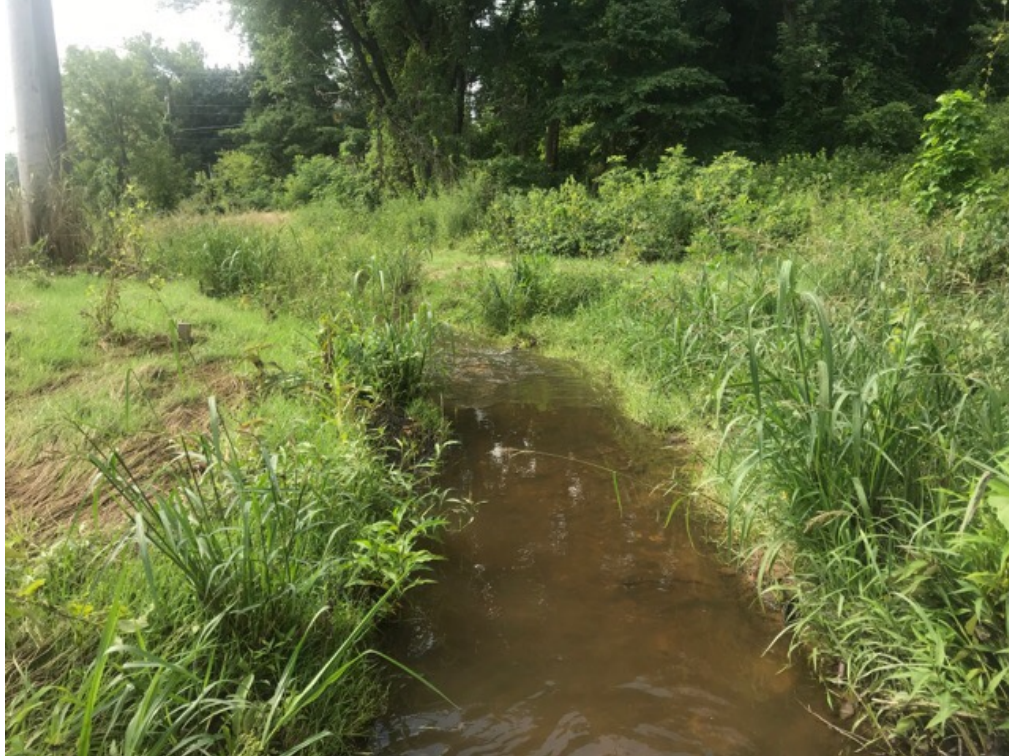
Figure A-67. Downstream view from thalweg at Station 00+00, 2018 (top) and 2019 (bottom).

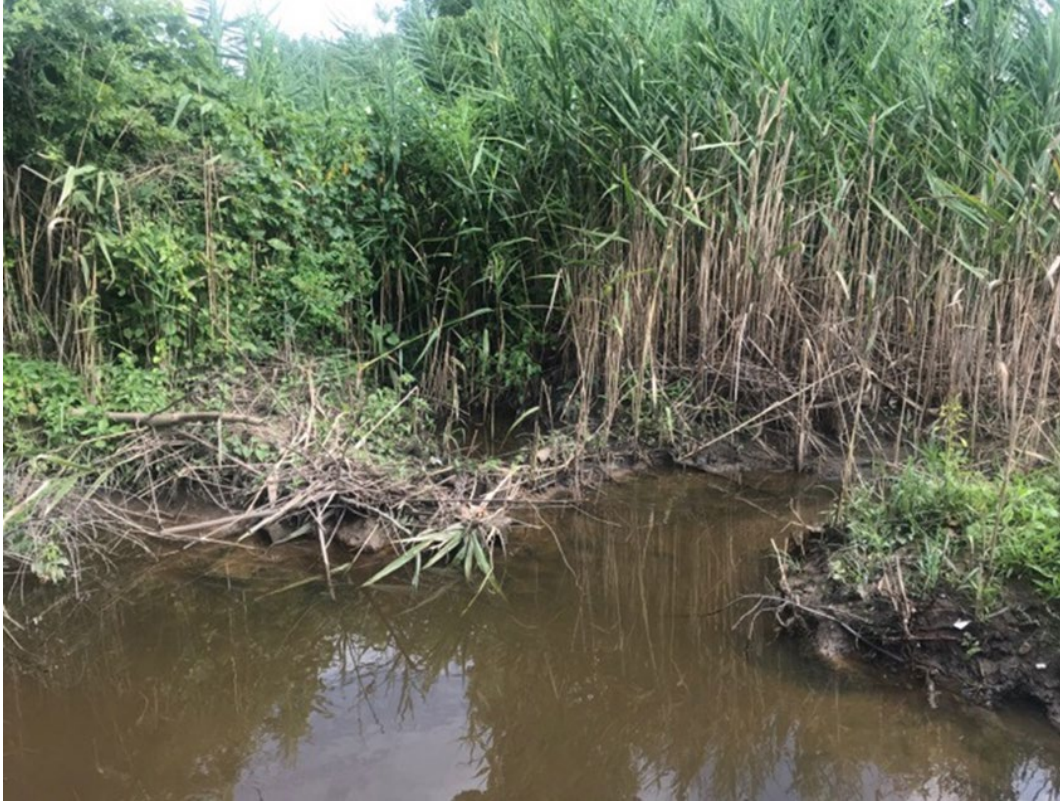
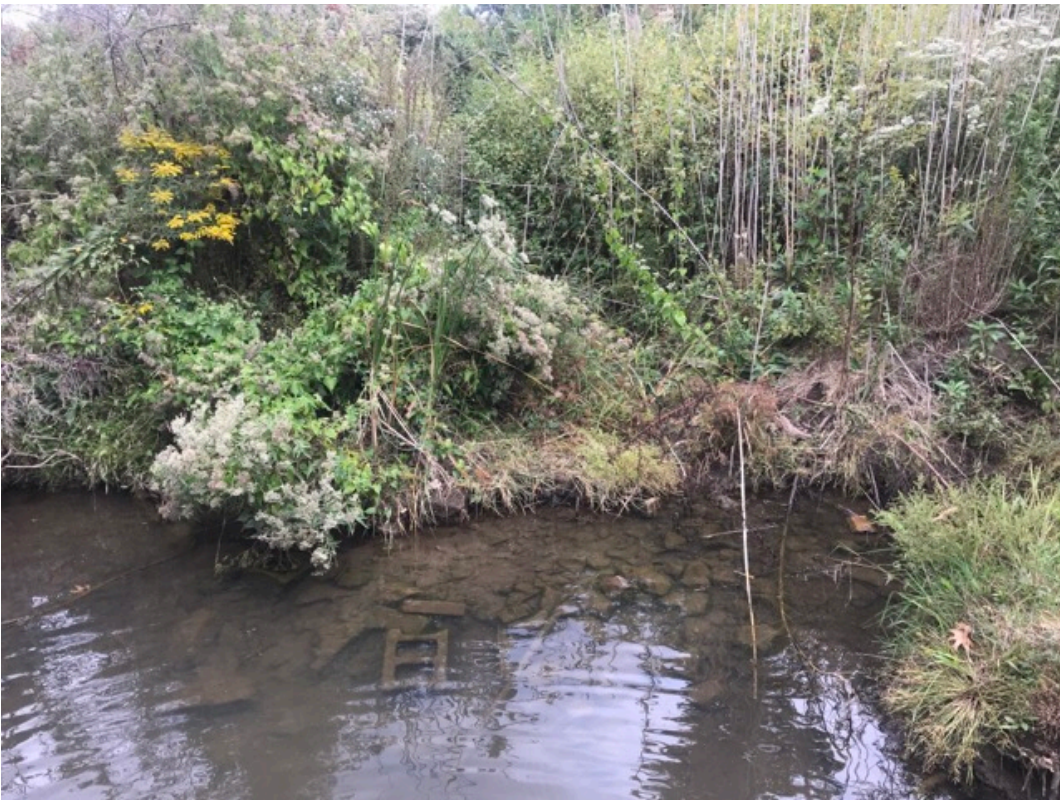
Figure A-68. Upstream view from thalweg at Station 00+00, 2018 (top) and 2019 (bottom).

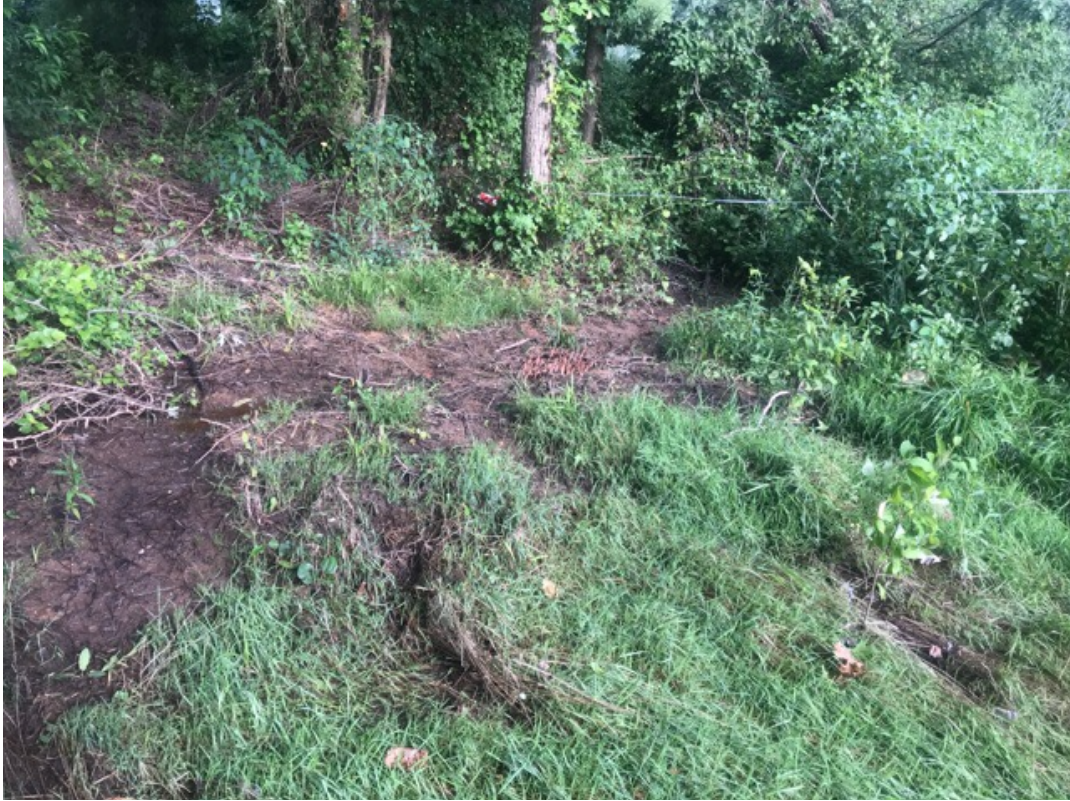
Figure A-69. Bare spot on the right streambank at Station 00+05, 2018 (top) and 2019 (bottom).

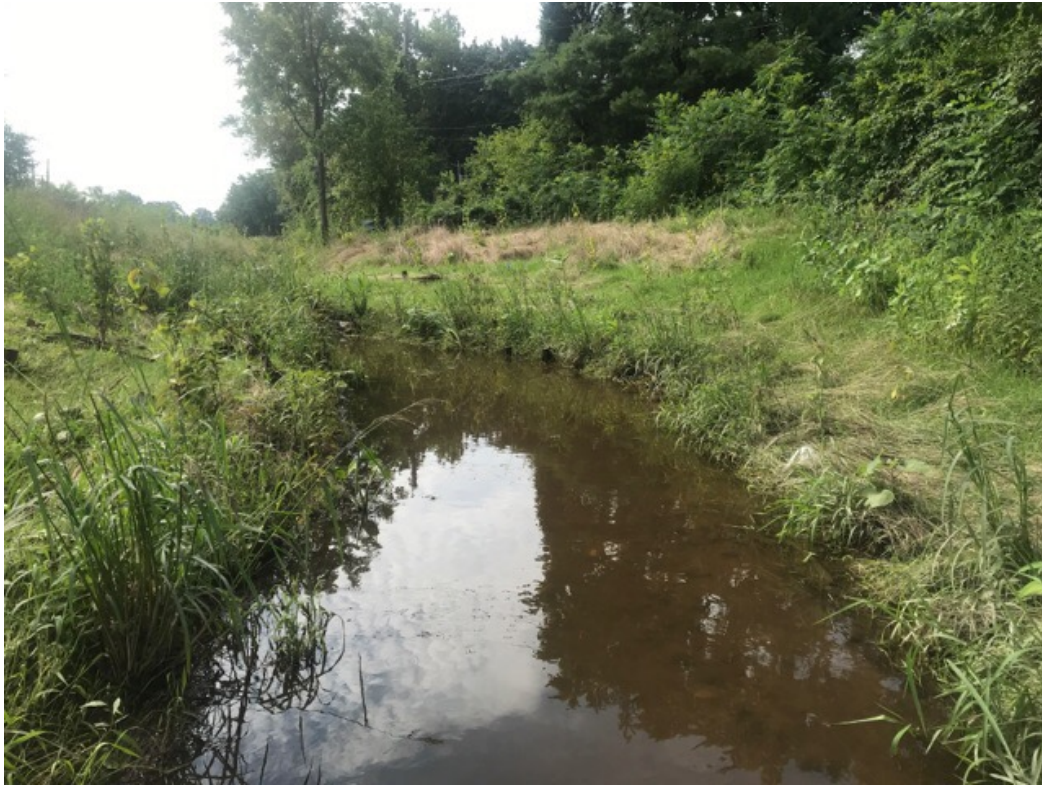
Figure A-70. Downstream view from thalweg at Station 01+00, 2018 (top) and 2019 (bottom).

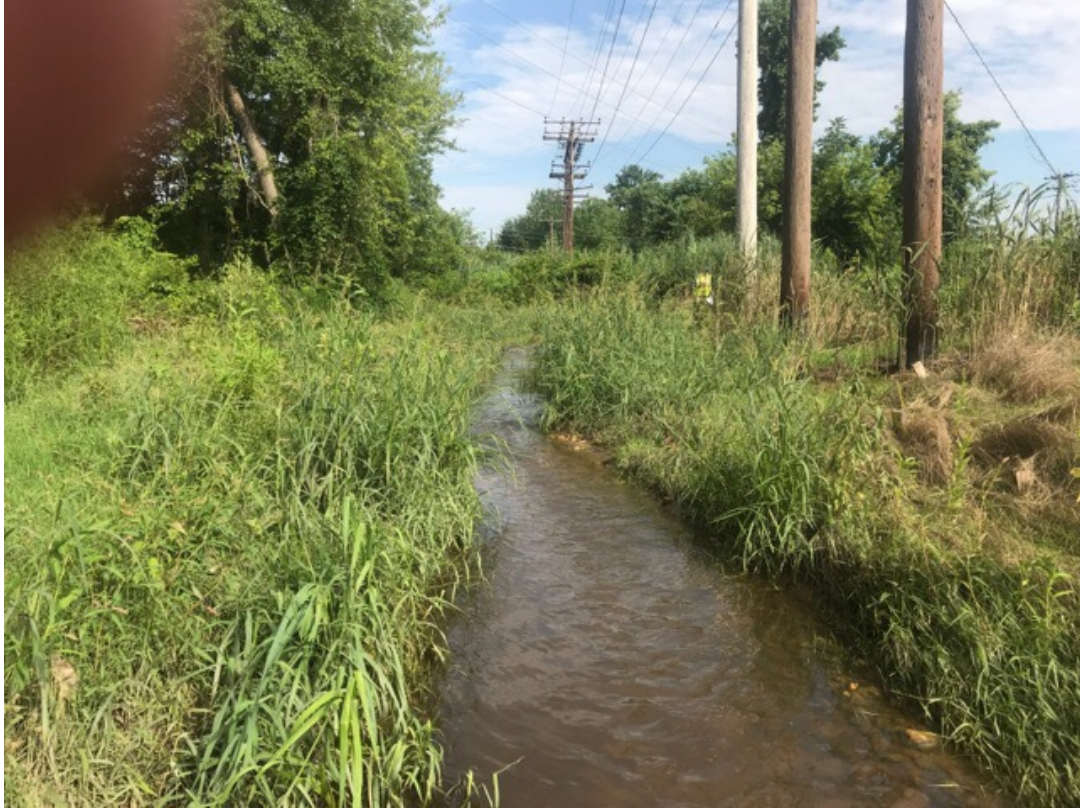
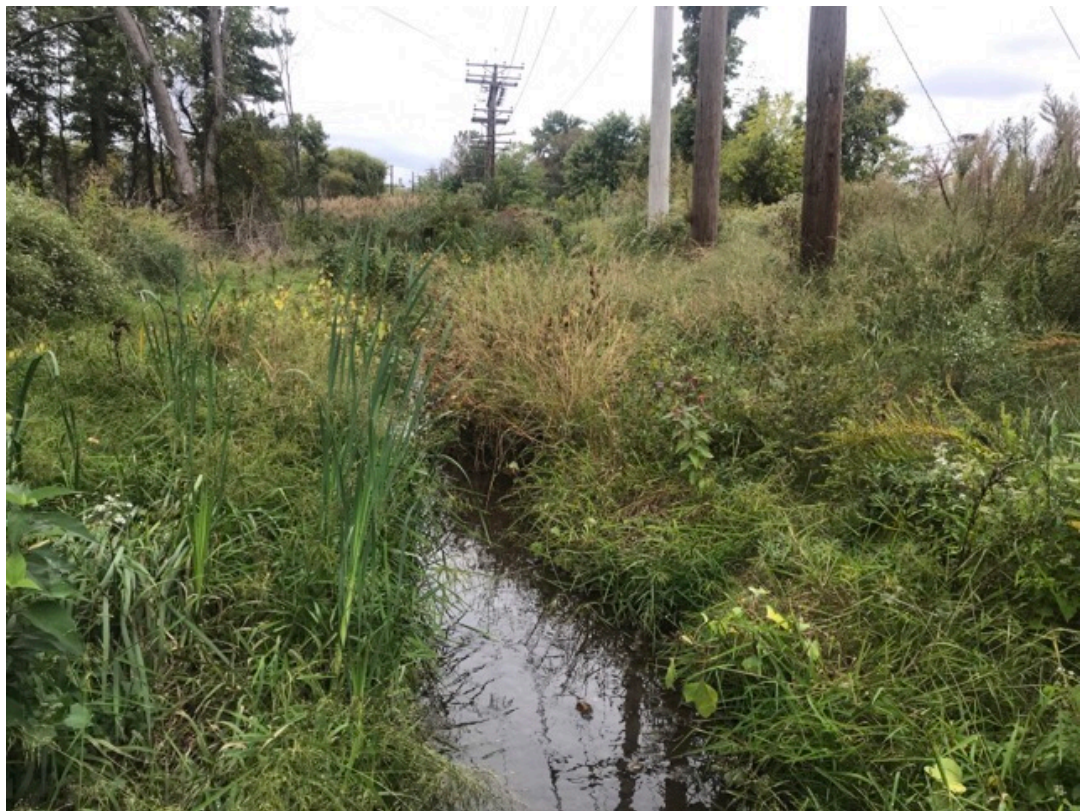
Figure A-71. Upstream view from thalweg at Station 01+00, 2018 (top) and 2019 (bottom).

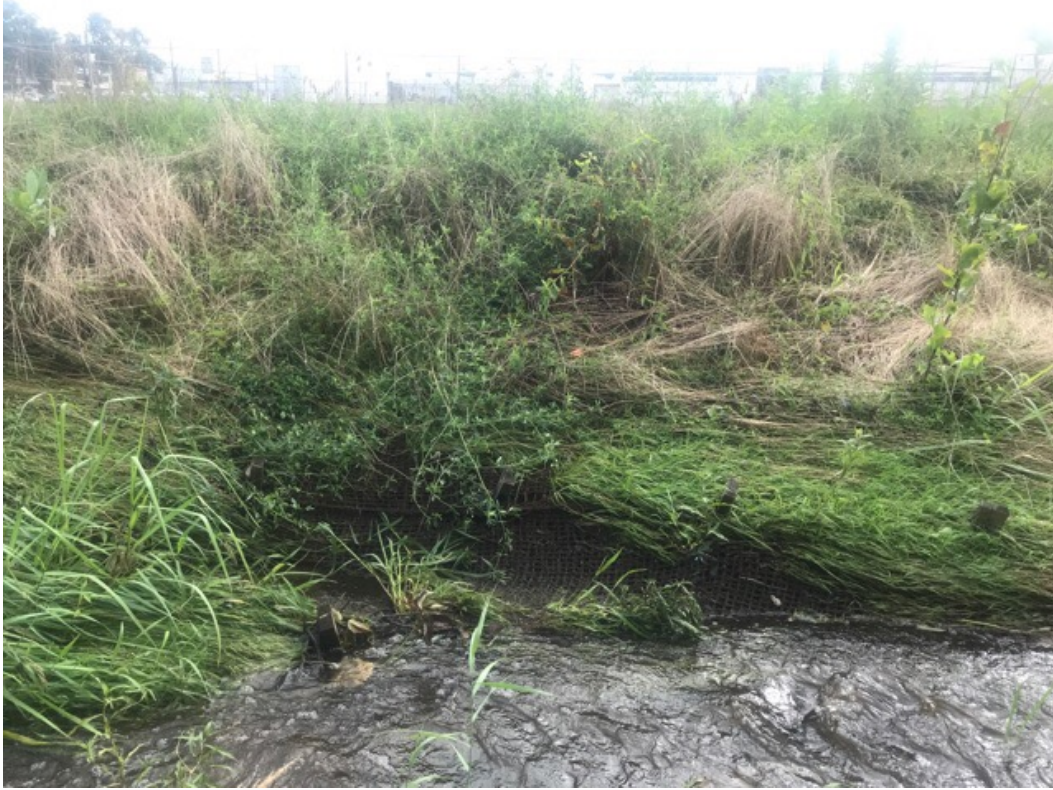
Figure A-72. Soil eroding from under the matting on the lower left bank at Station 01+55, 2018 (top) and 2019 (bottom).

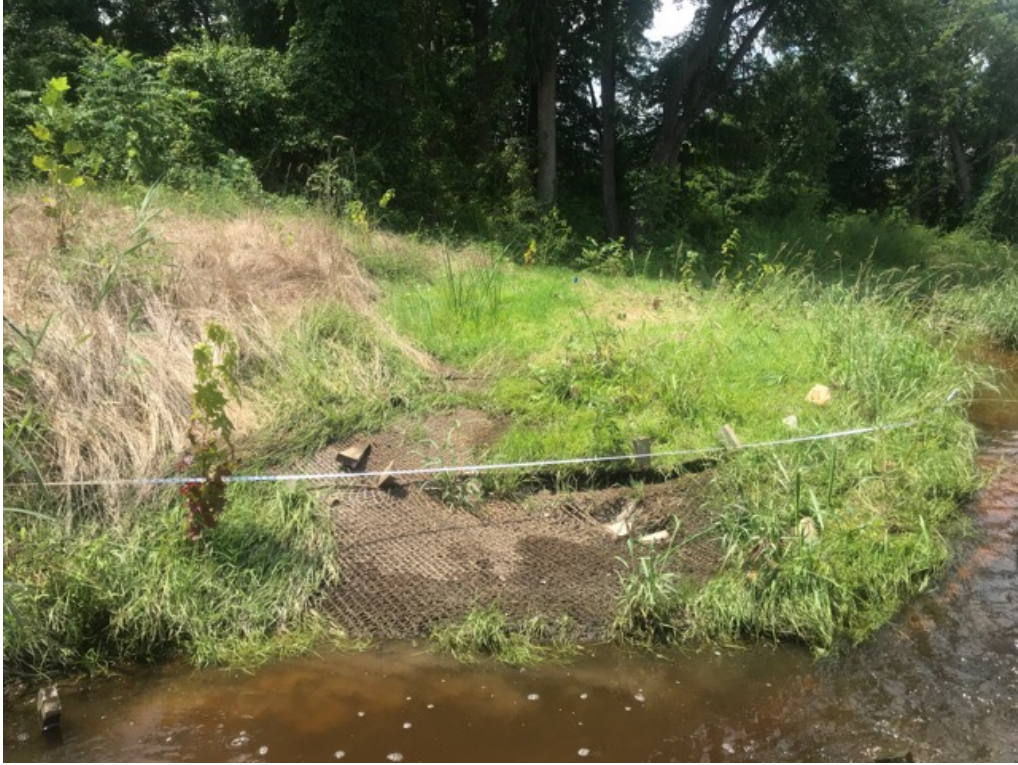
Figure A-73. Soil eroding from under the matting on the right bank at Station 01+67, 2018 (top) and 2019 (bottom).

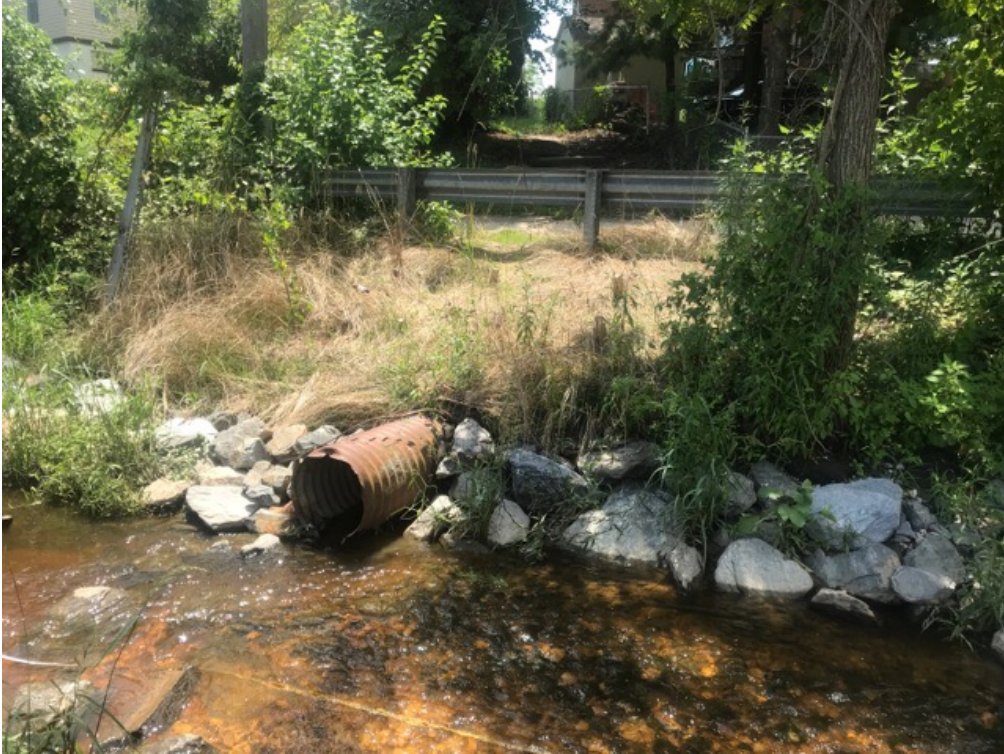
Figure A-74. Outfall and guard rail on the right bank at Station 01+99, 2018 (top) and 2019 (bottom).

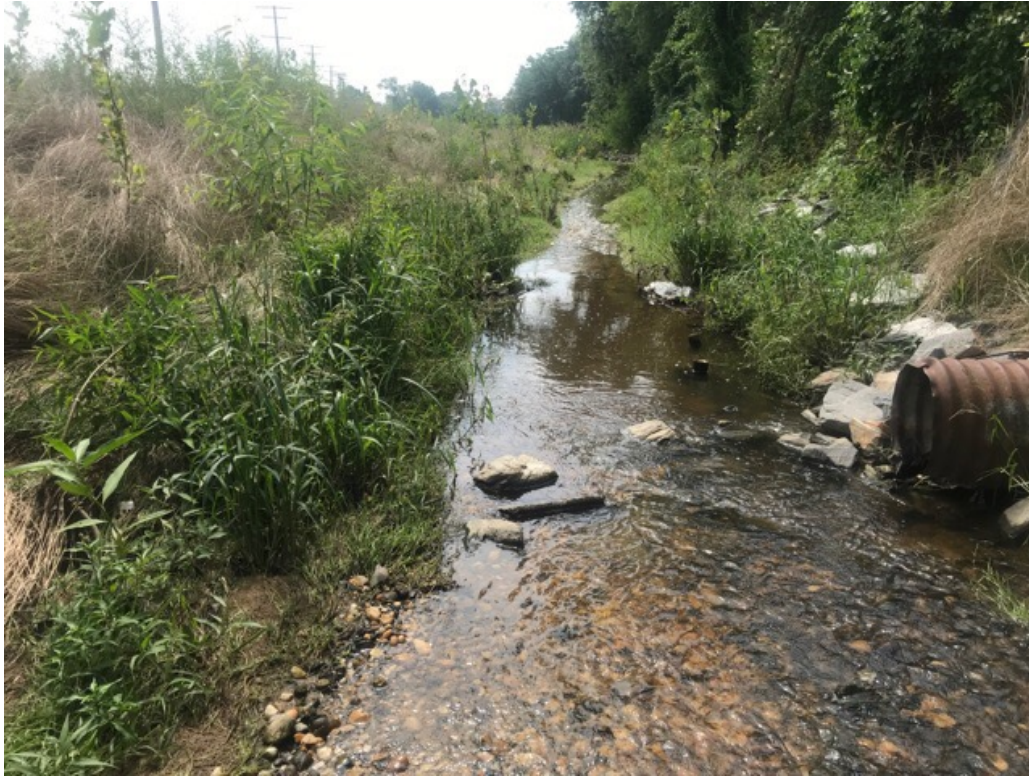
Figure A-75. Downstream view from thalweg at Station 02+00, 2018 (top) and 2019 (bottom).

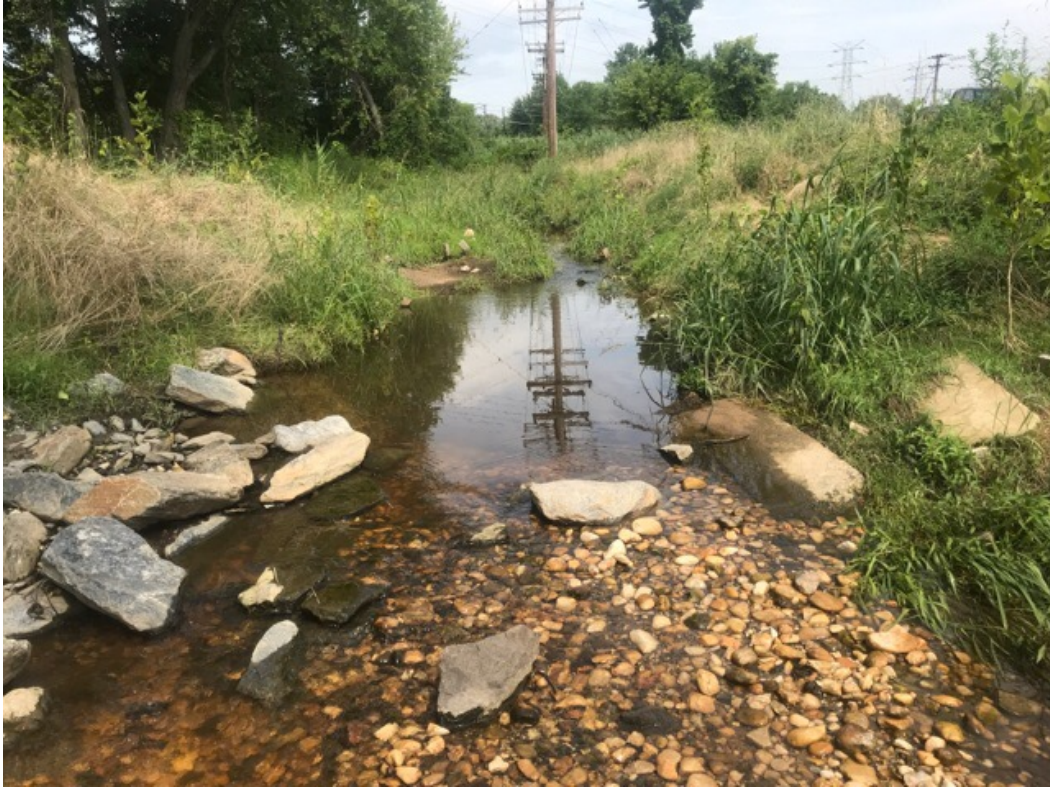
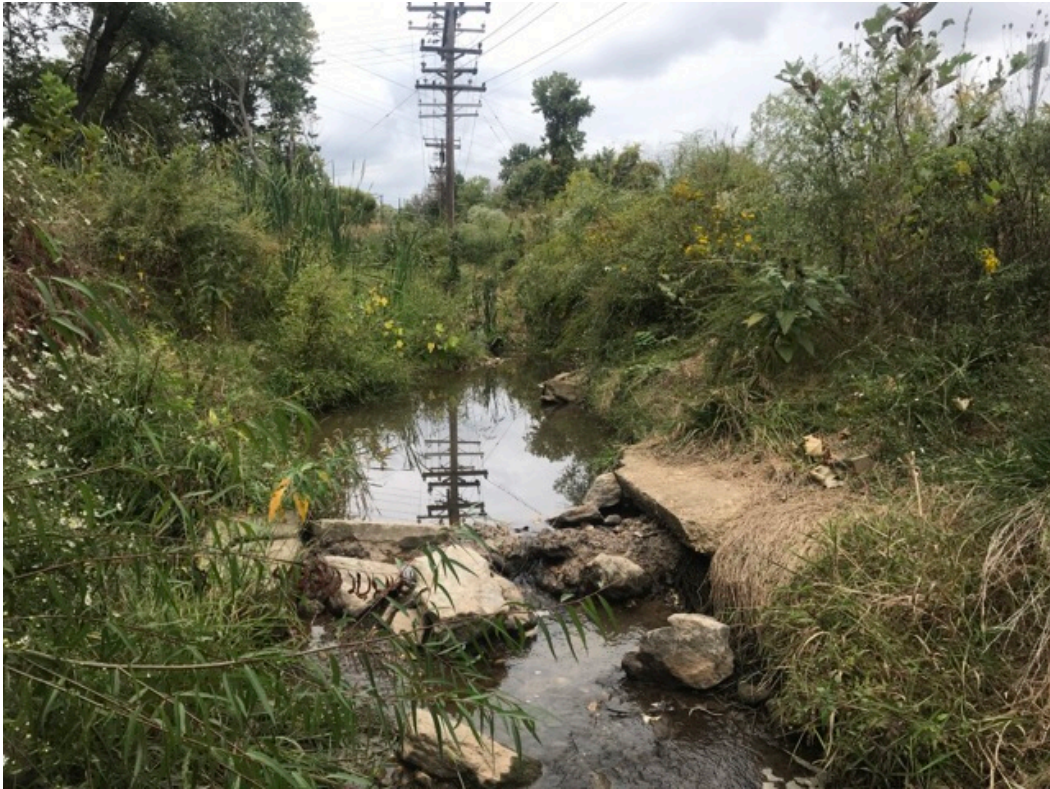
Figure A-76. Upstream view from thalweg at Station 02+00, 2018 (top) and 2019 (bottom).

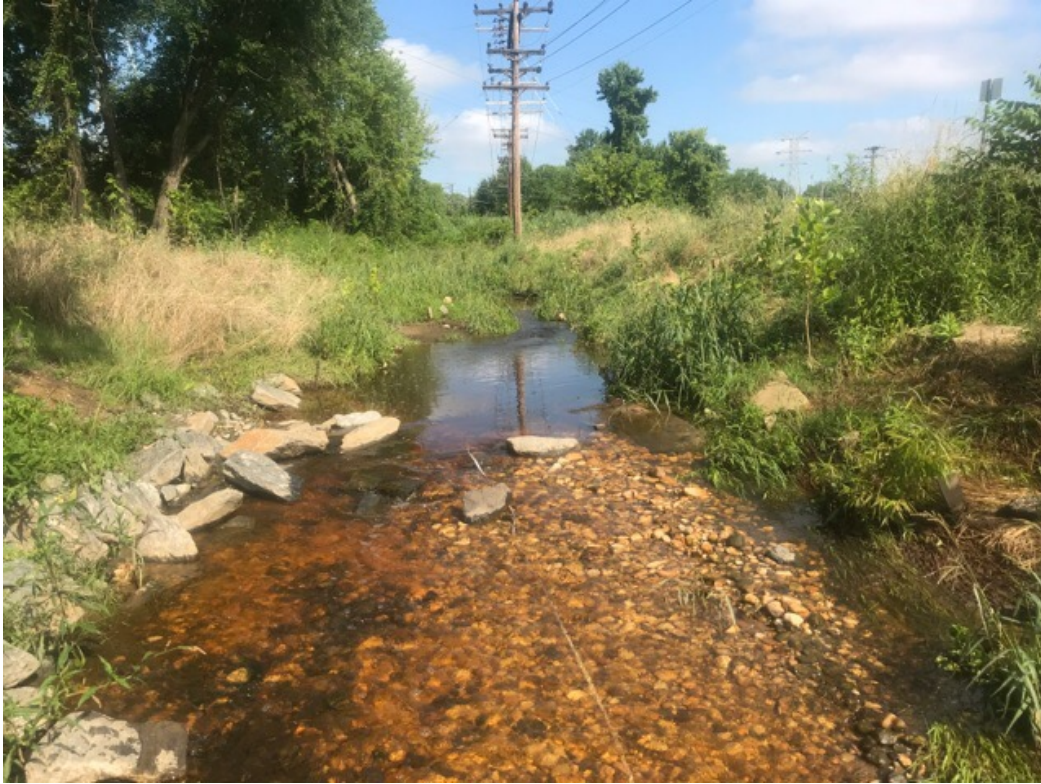
Figure A-77. Upstream view of both streambanks at Station 02+01, 2018 (top) and 2019 (bottom).

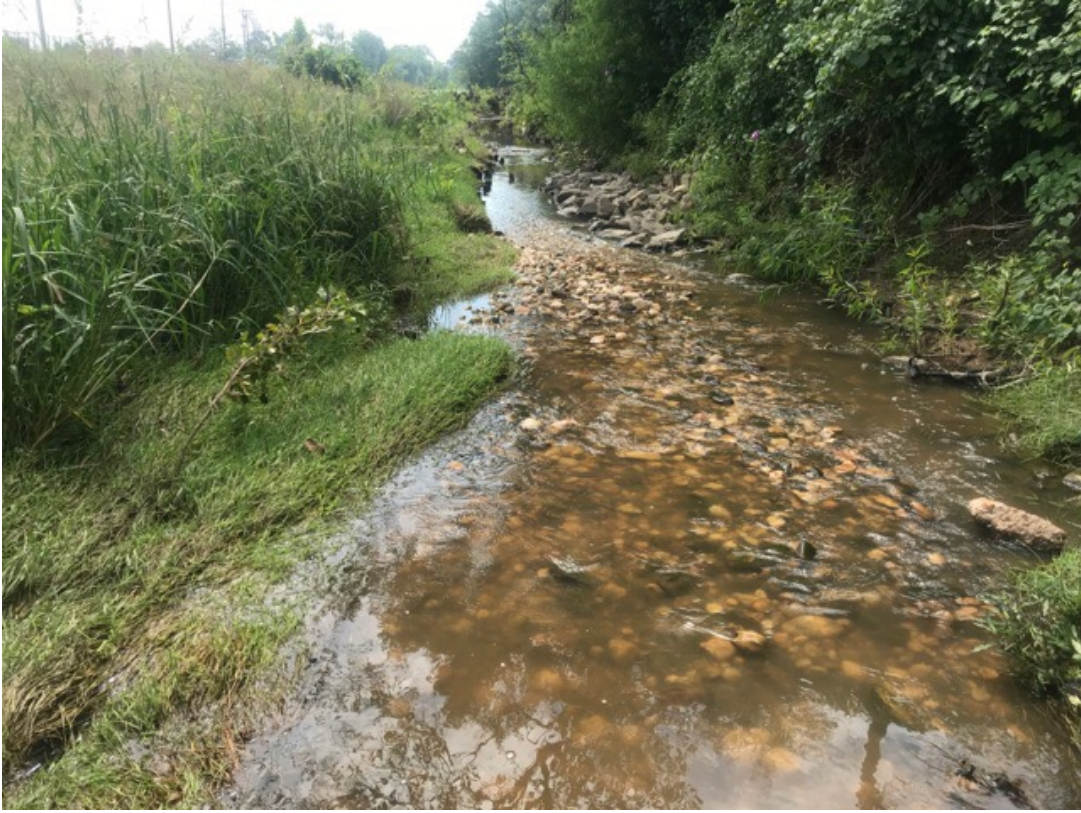
Figure A-78. Downstream view from thalweg at Station 03+00, 2018 (top) and 2019 (bottom).

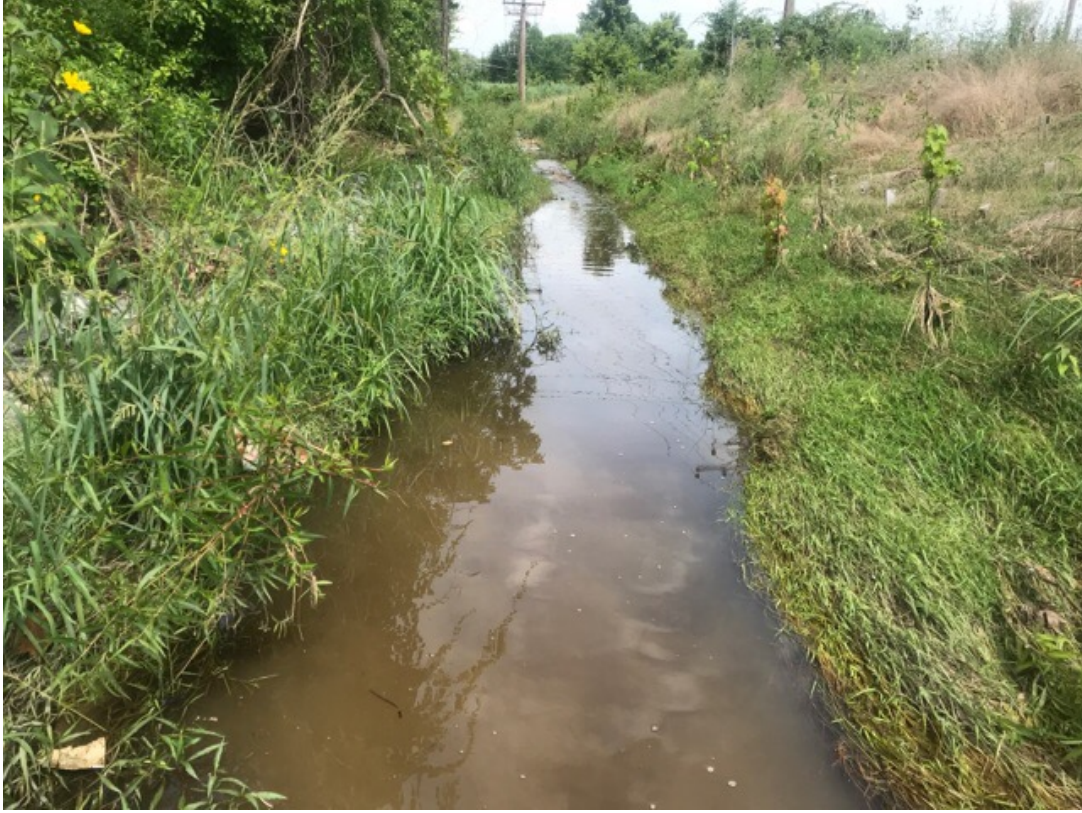
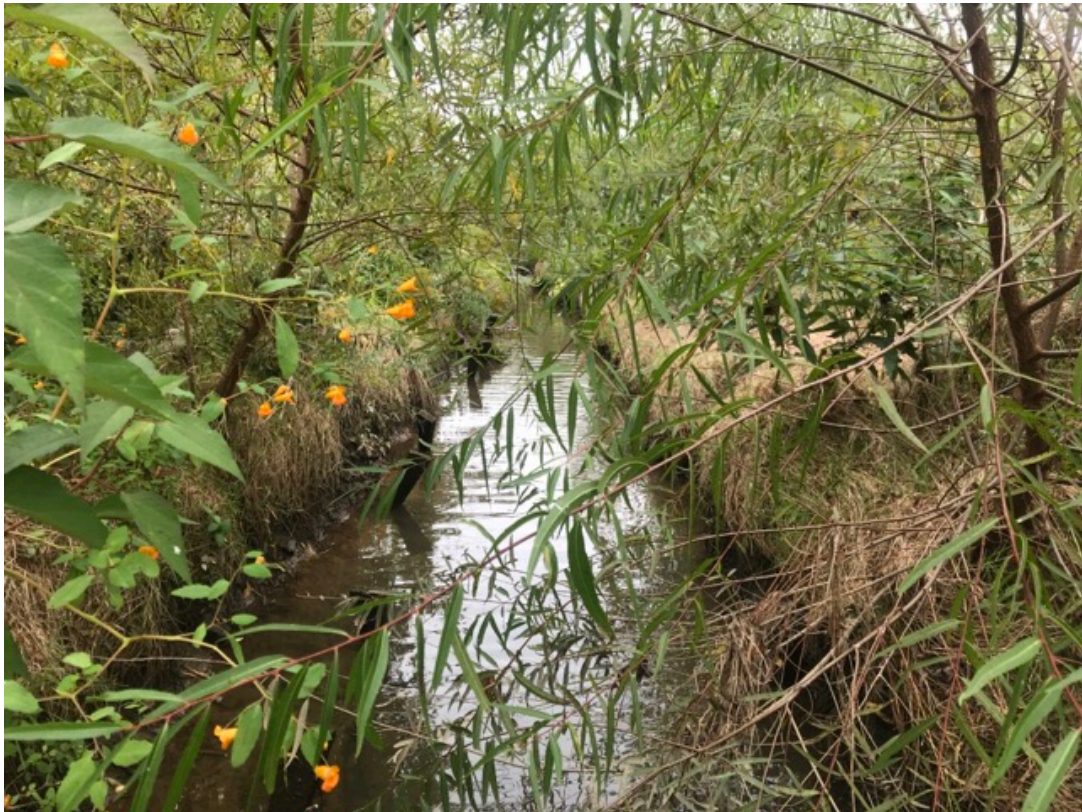
Figure A-79. Upstream view from thalweg at Station 03+00, 2018 (top) and 2019 (bottom).

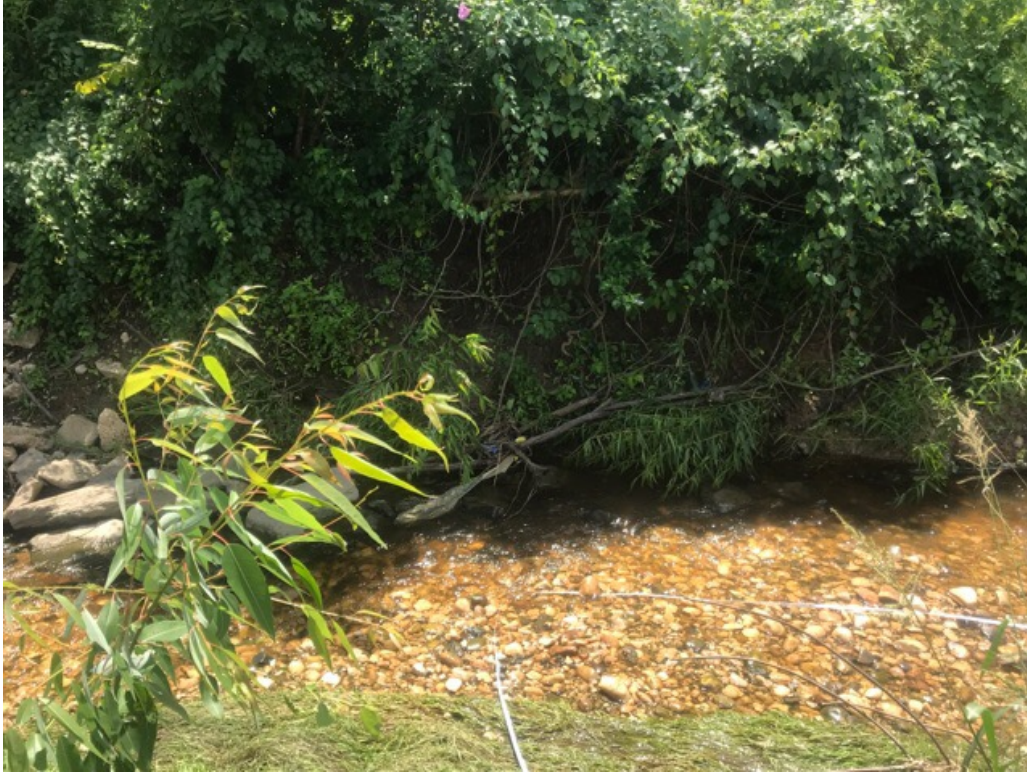
Figure A-80. Right streambank at Station 03+20, 2018 (top) and 2019 (bottom).

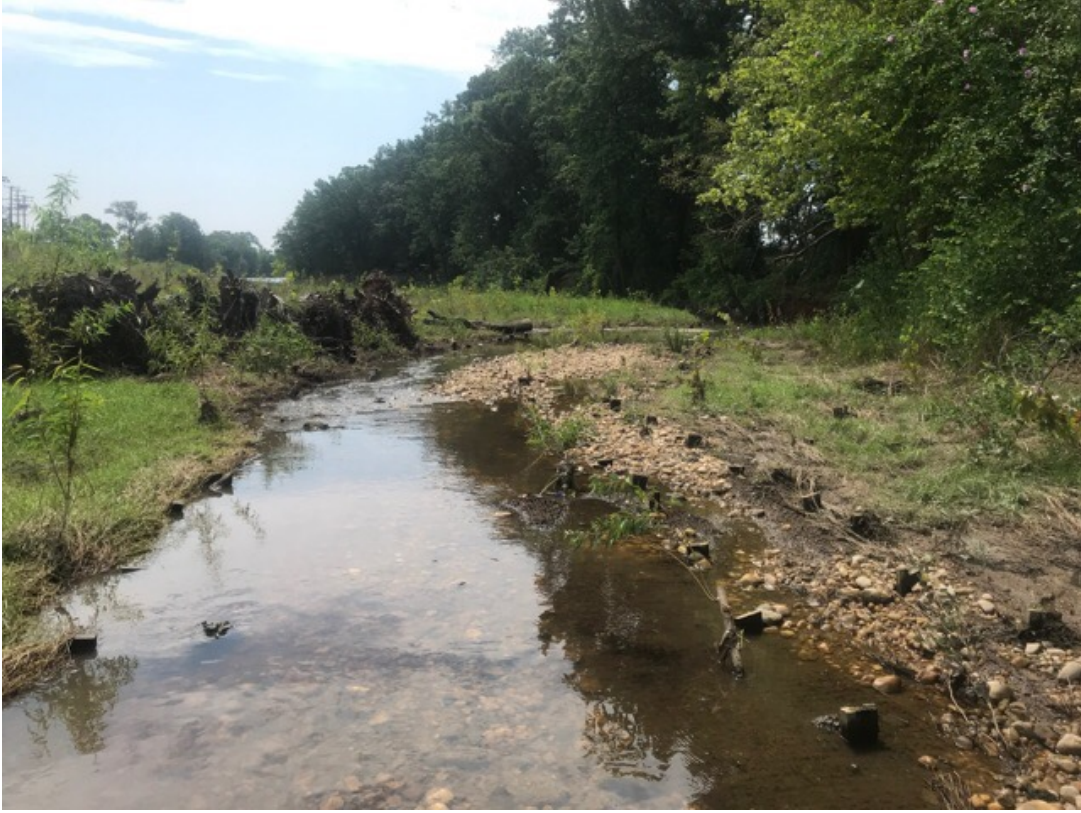
Figure A-81. Downstream view from thalweg at Station 04+33, 2018 (top) and 2019 (bottom).

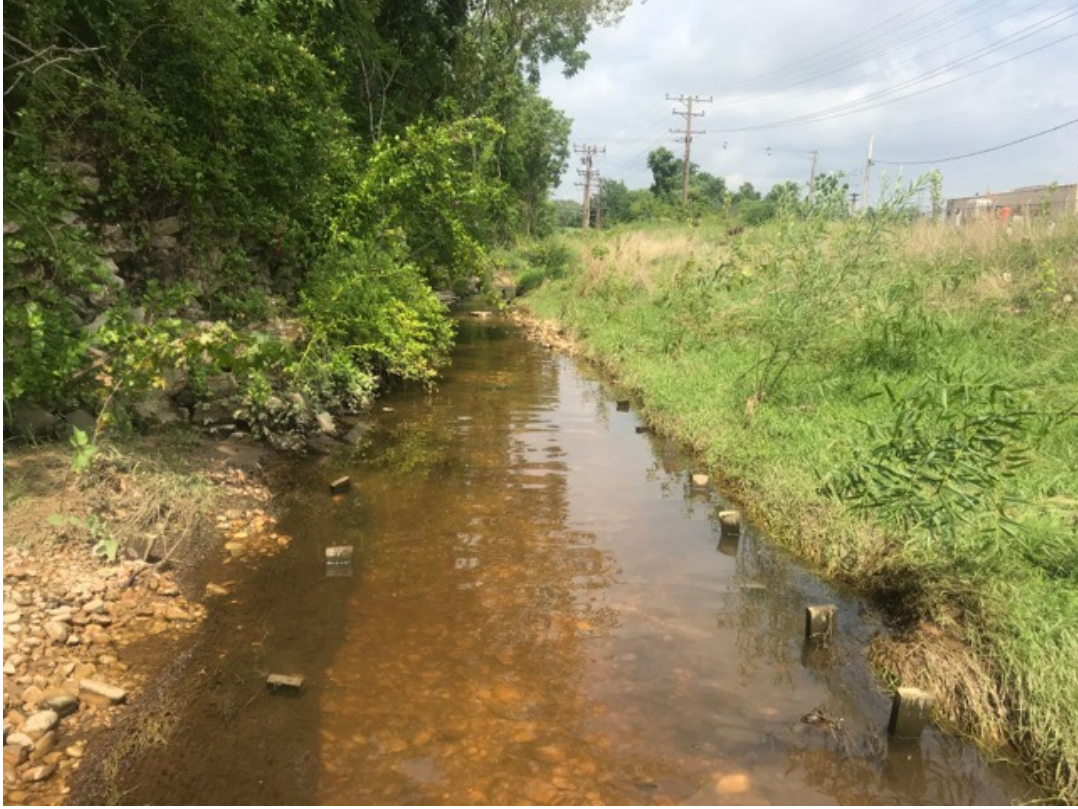
Figure A-82. Upstream view from the thalweg at Station 04+33, 2018 (top) and 2019 (bottom).

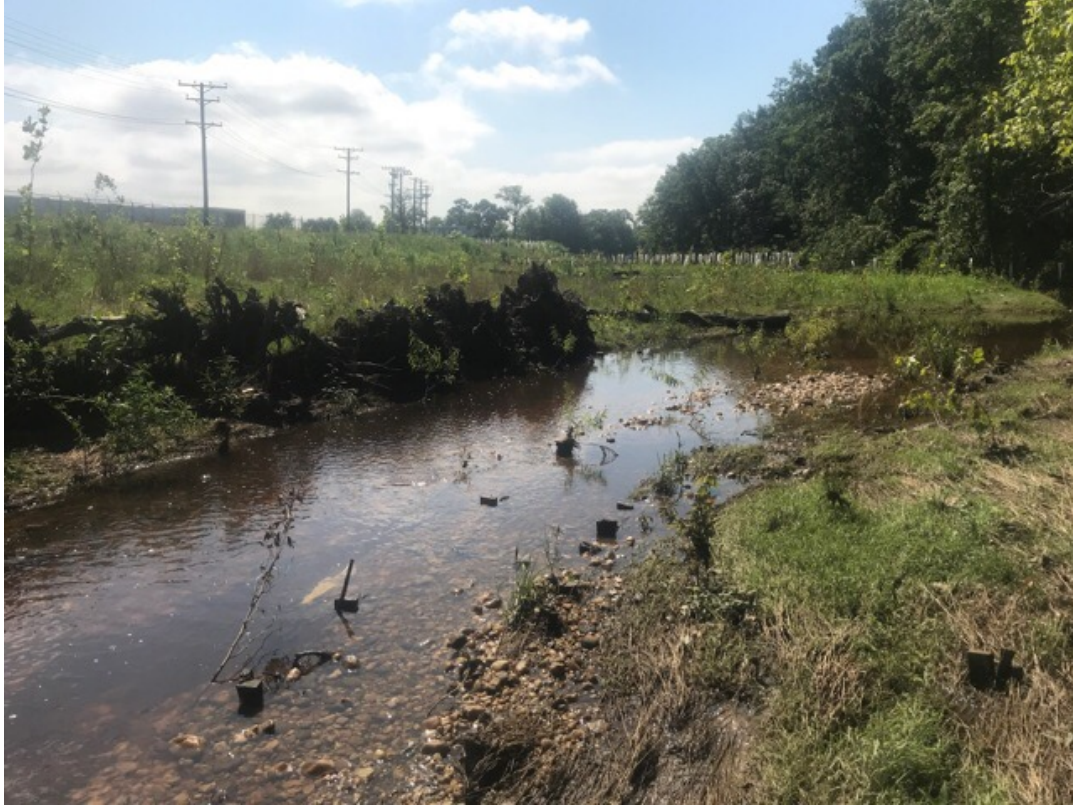
Figure A-83. View of root wad and left bank from Station 04+50, 2018 (top) and 2019 (bottom).

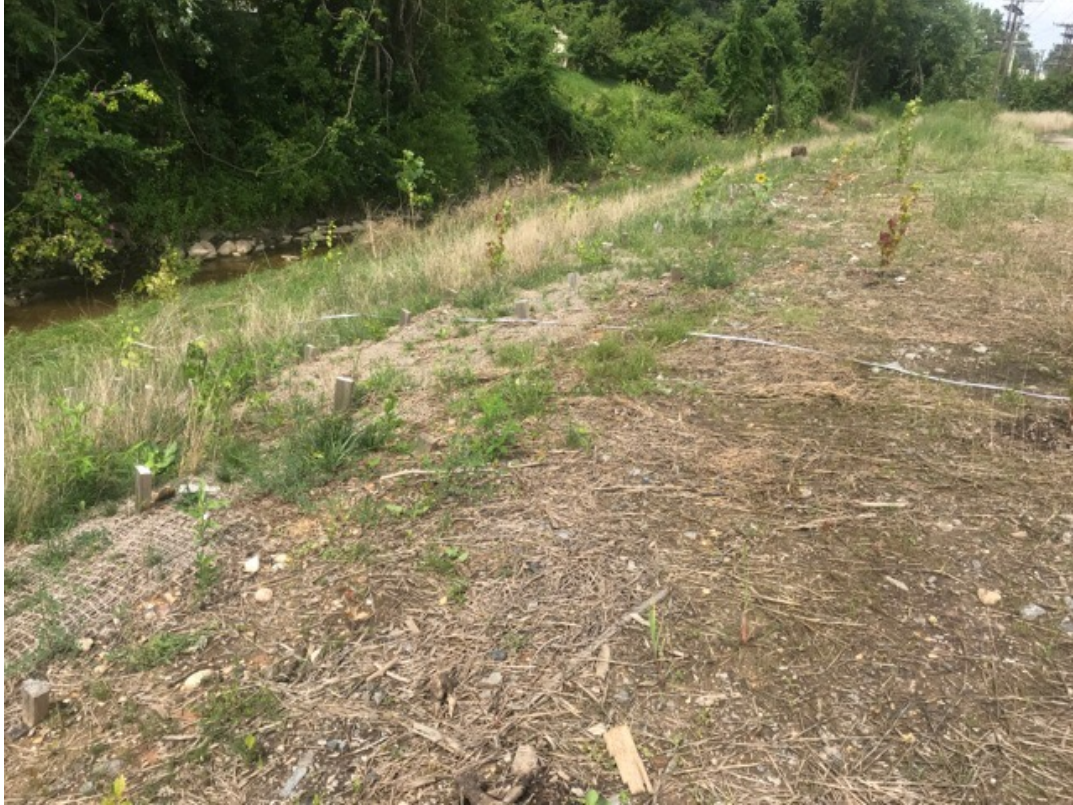
Figure A-84. Barren floodplain area on the left streambank at Station 04+15, 2018 (top) and 2019 (bottom).

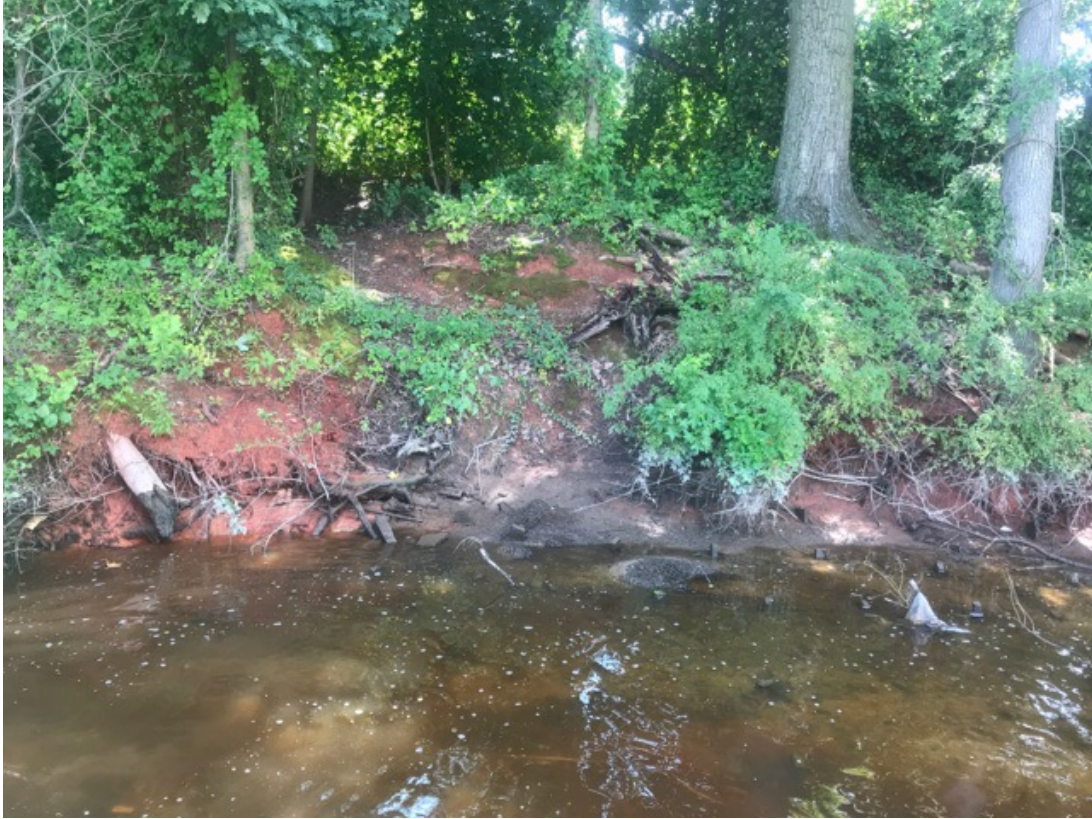
Figure A-85. Barren area on the right streambank at Station 05+25, 2018 (top) and 2019 (bottom).

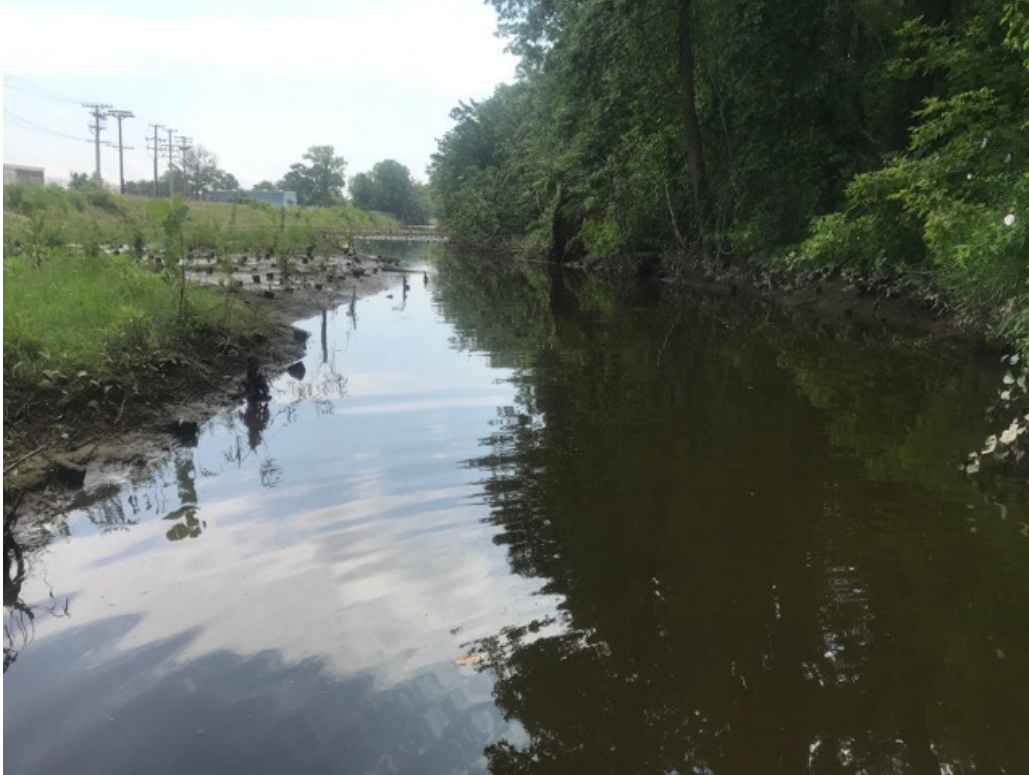
Figure A-86. Downstream view from thalweg at Station 05+67, 2018 (top) and 2019 (bottom).
