Subject: Transmittal of the Cow Pen Creek Bank Stabilization and Floodplain Reconstruction Monitoring:
2019 Report
Lockheed Martin Corporation – Middle River Complex
2323 Eastern Boulevard, Middle River, Baltimore County, Maryland

**COW PEN CREEK
BANK STABILIZATION AND FLOODPLAIN
RECONSTRUCTION MONITORING: 2019 REPORT
LOCKHEED MARTIN MIDDLE RIVER COMPLEX
2323 EASTERN BOULEVARD
MIDDLE RIVER, MARYLAND**

Prepared by:
Tetra Tech, Inc.

January 2020

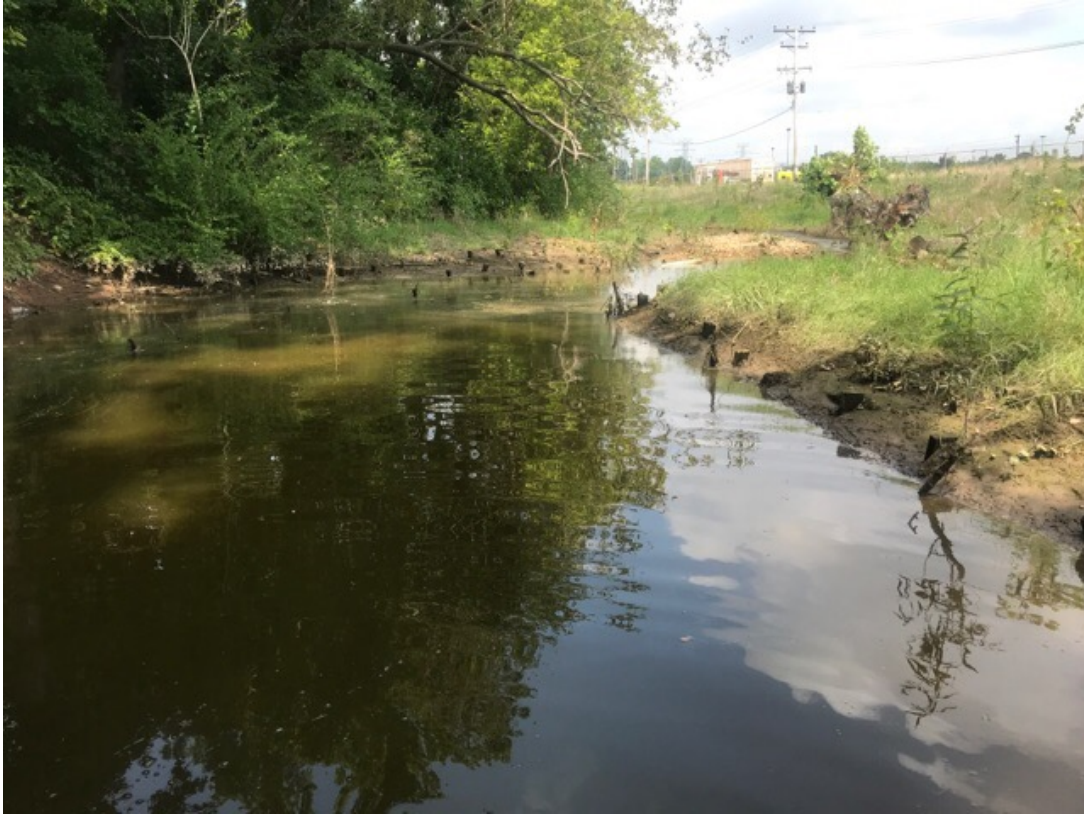
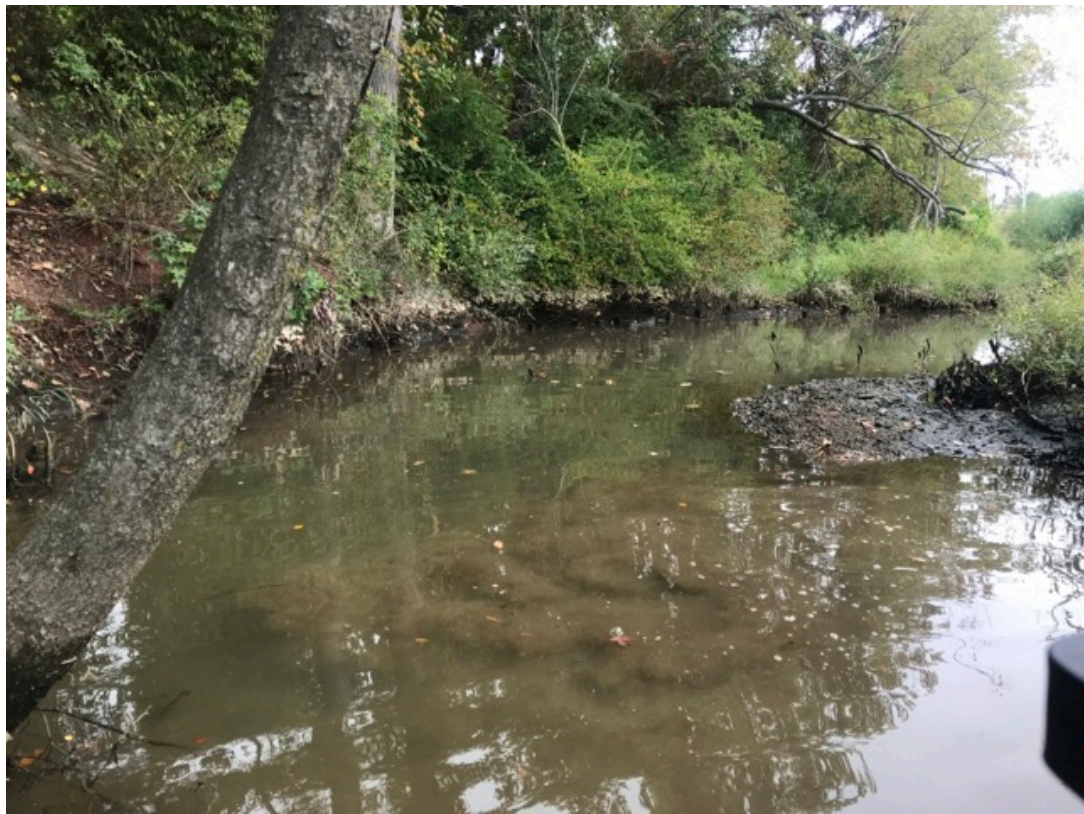
Figure A-87. Upstream view from thalweg at Station 05+67, 2018 (top) and 2019 (bottom).

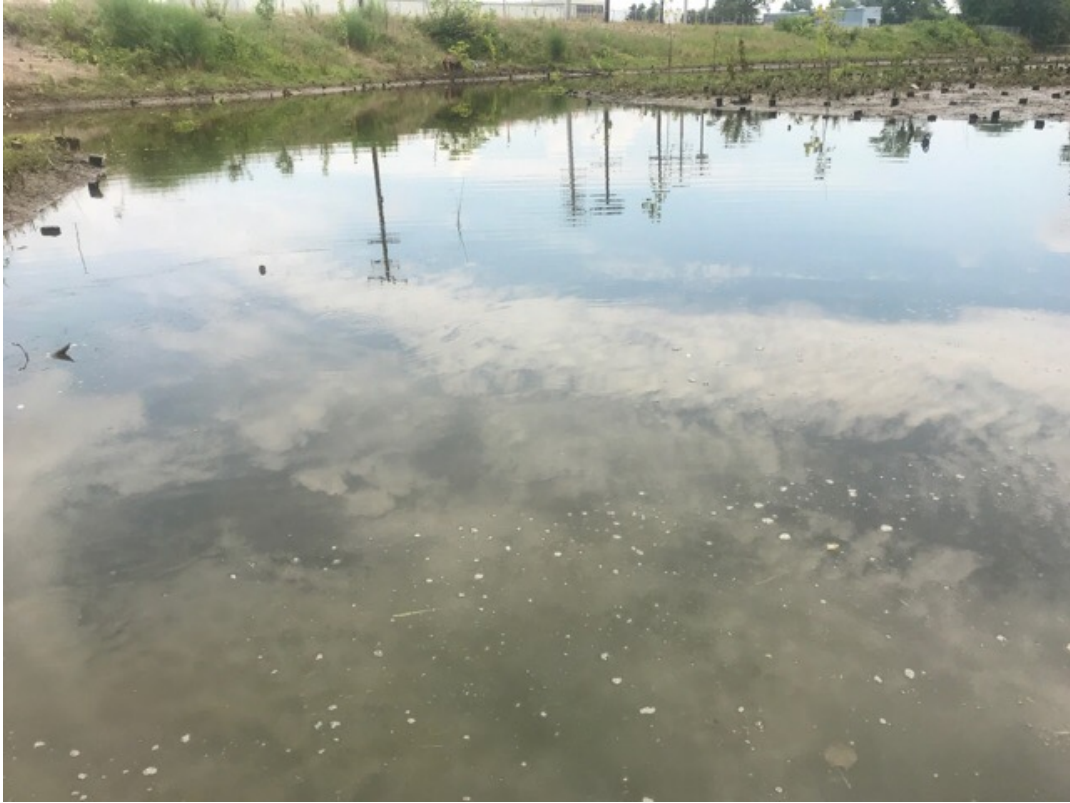
Figure A-88. Downstream view from thalweg at Station 07+00, 2018 (top) and 2019 (bottom).

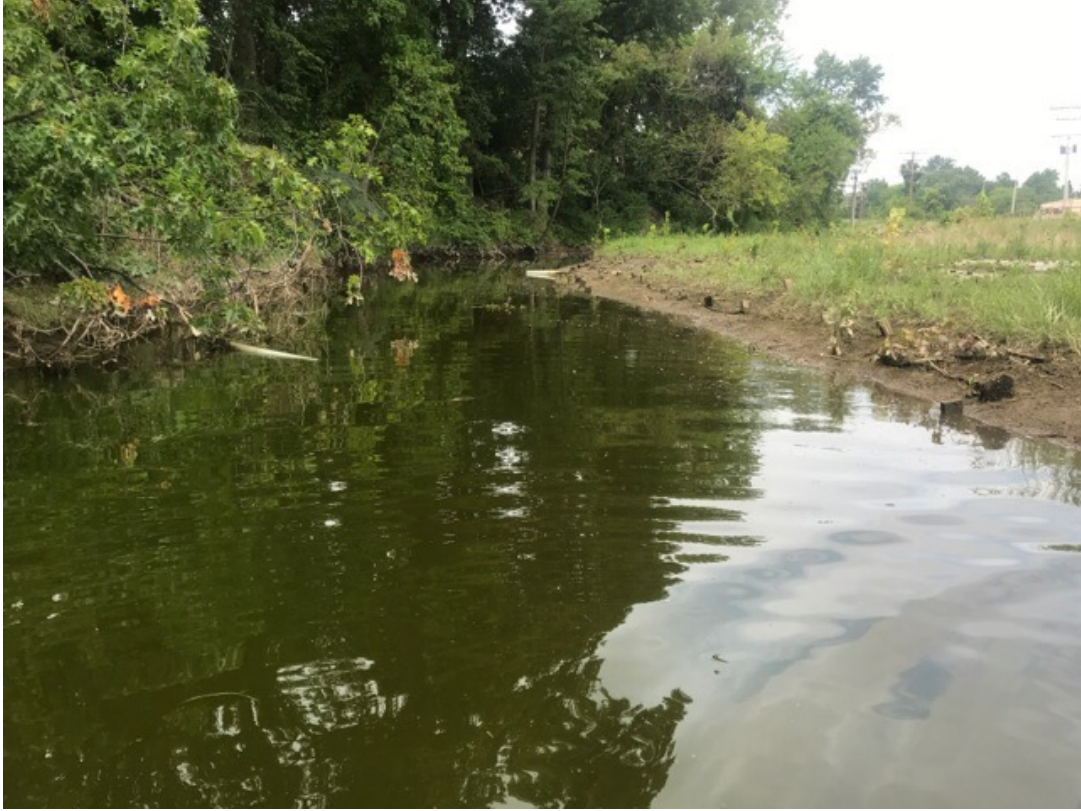
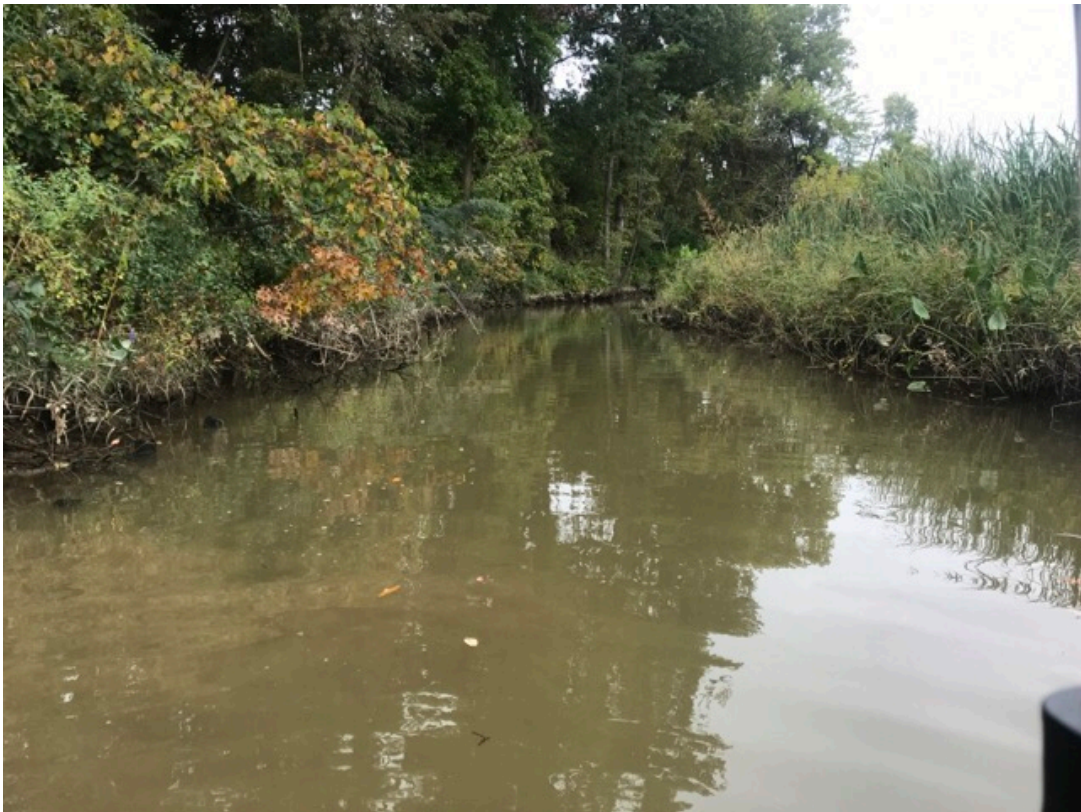
Figure A-89. Upstream view from thalweg at Station 07+00, 2018 (top) and 2019 (bottom).

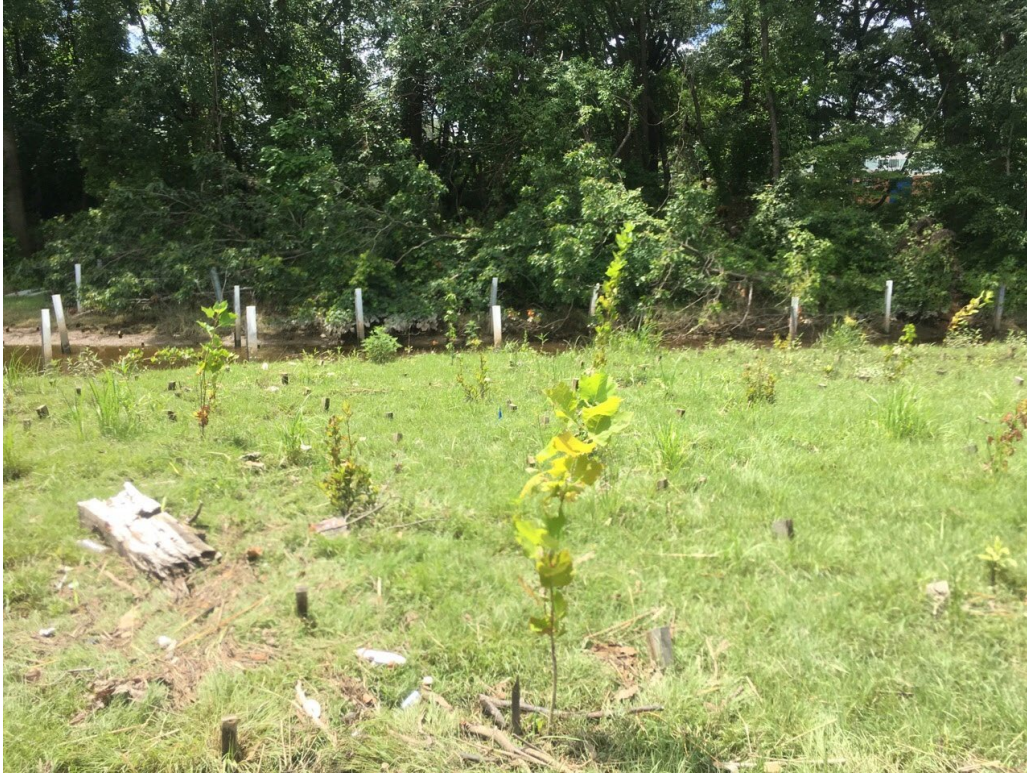
Figure A-90. Tree tubes and new vegetation on left bank at Station 07+03, 2018 (top) and 2019 (bottom).

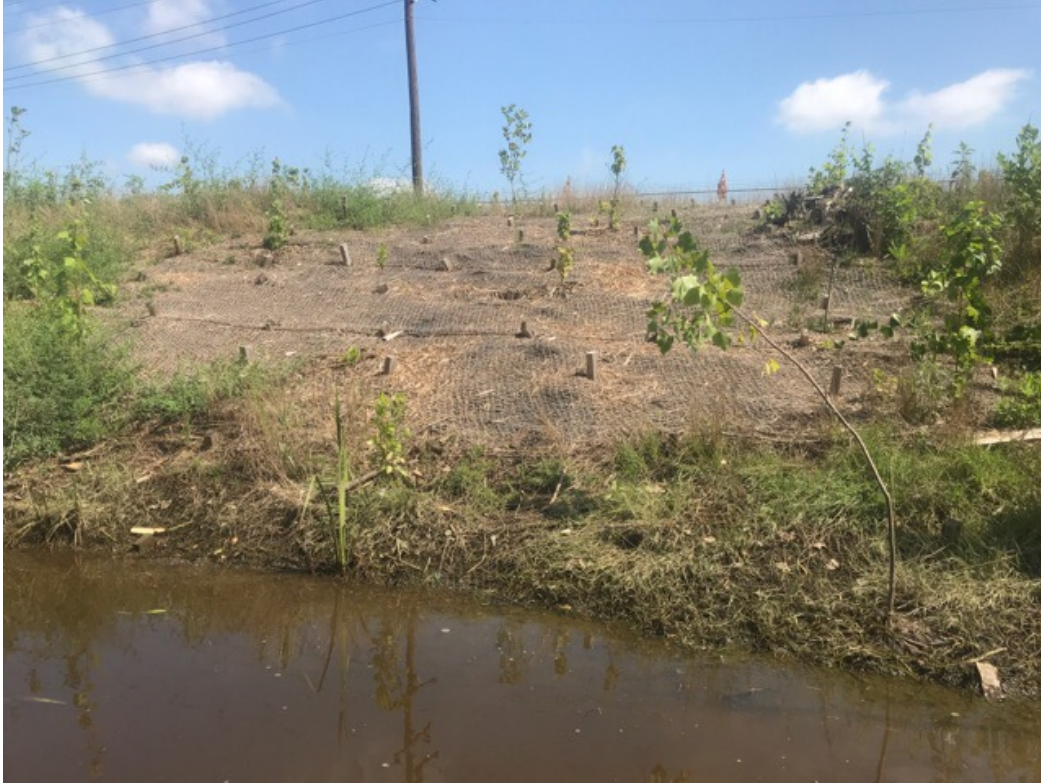
Figure A-91. Barren floodplain area and new vegetation on the left streambank at Station 07+71, 2018 (top) and 2019 (bottom).

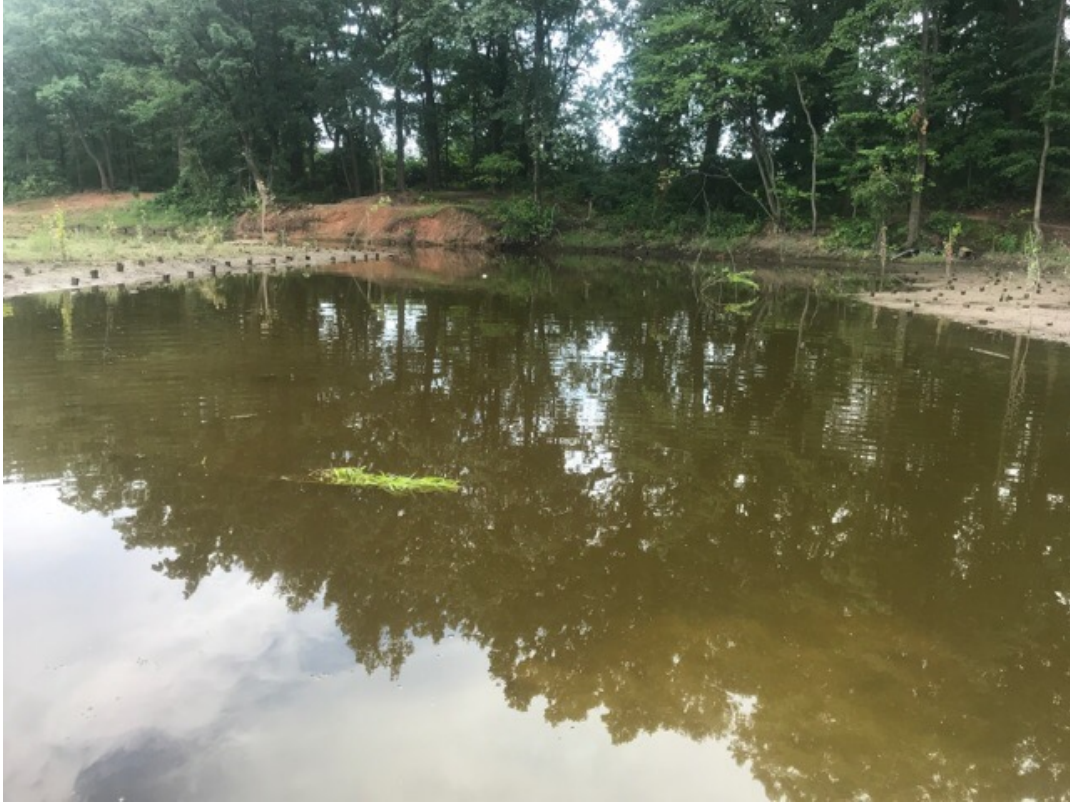
Figure A-92. Downstream view from thalweg at Station 08+33, 2018 (top) and 2019 (bottom).

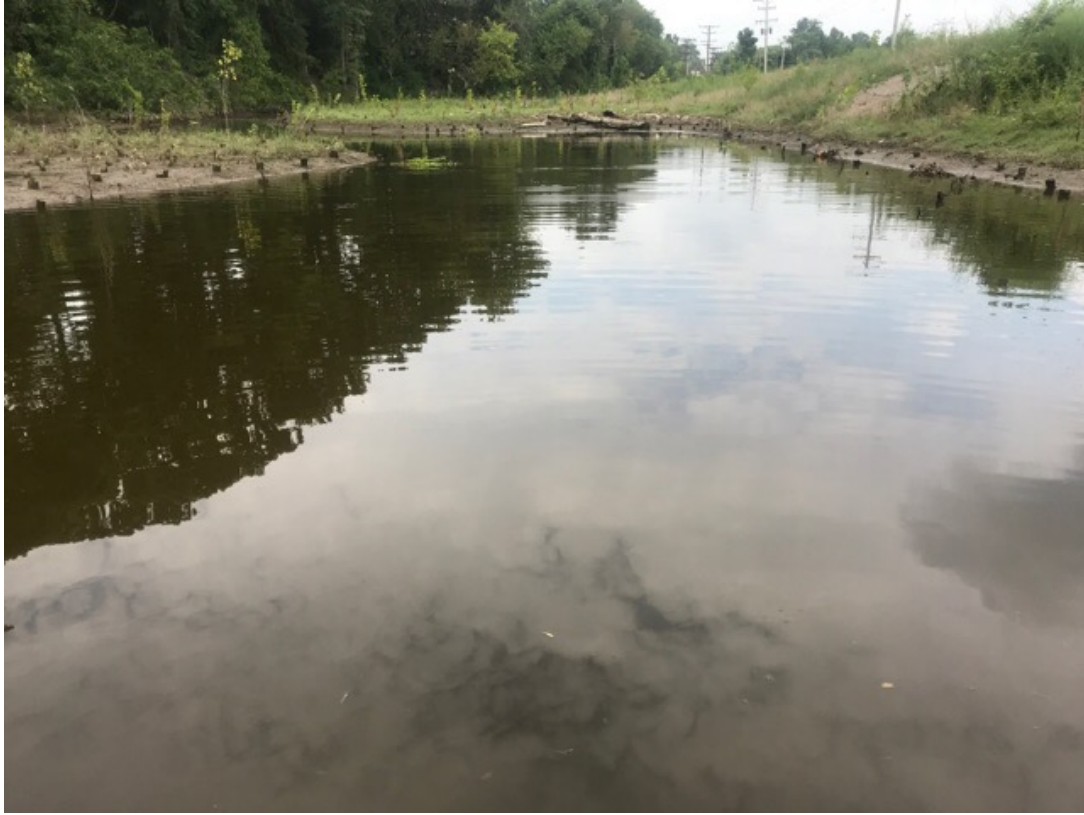
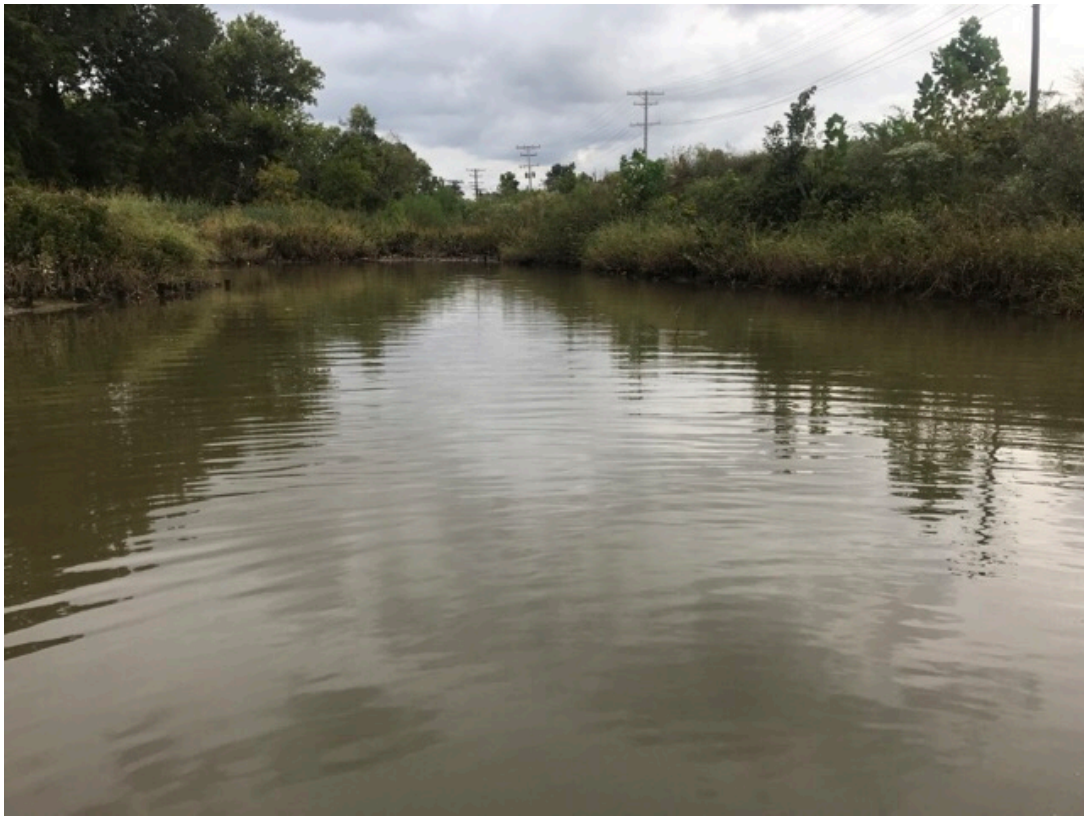
Figure A-93. Upstream view from thalweg at Station 08+33, 2018 (top) and 2019 (bottom).

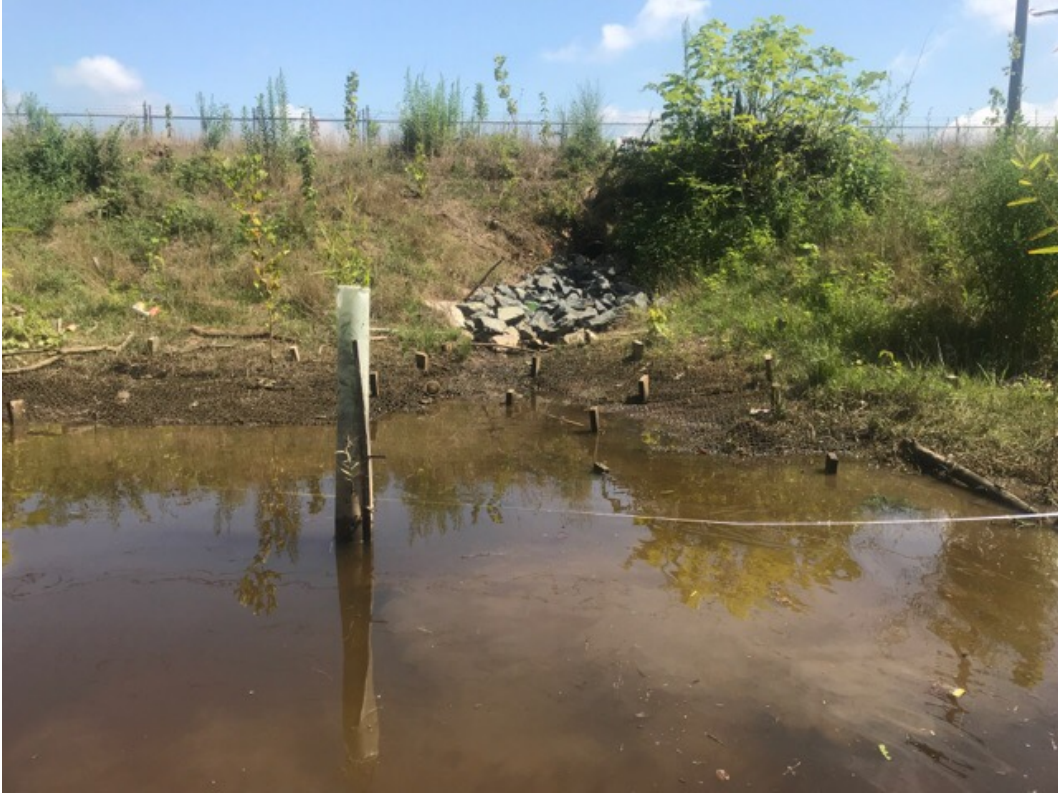
Figure A-94. Outfall / barren area and new vegetation on left streambank at Station 08+32, 2018 (top) and 2019 (bottom).

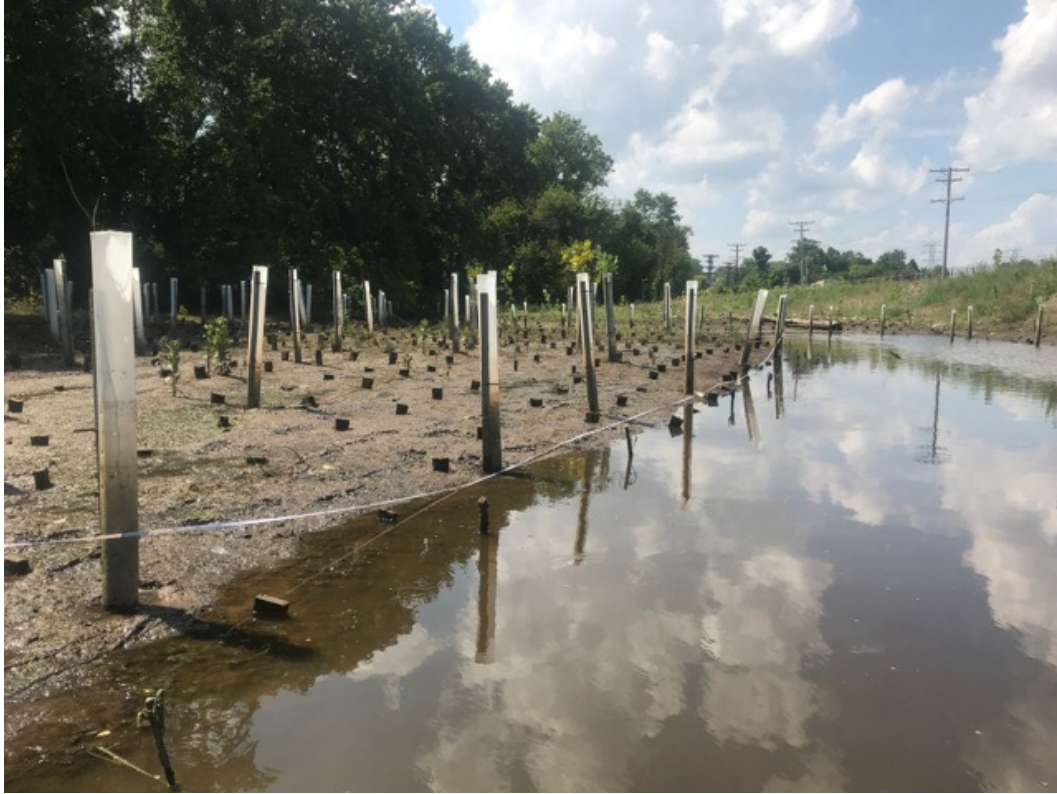
Figure A-95. Barren wetland area and new vegetation on the right streambank at Station 08+41, 2018 (top) and 2019 (bottom).

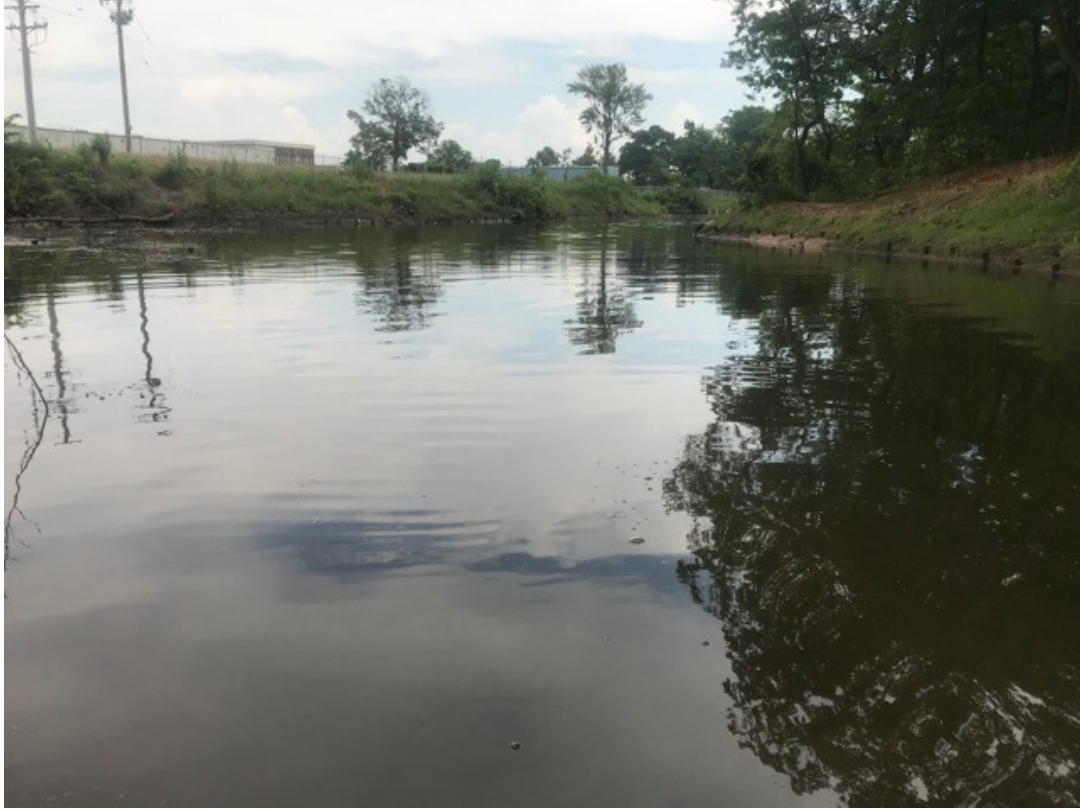
Figure A-96. Downstream view from thalweg at Station 09+67, 2018 (top) and 2019 (bottom).

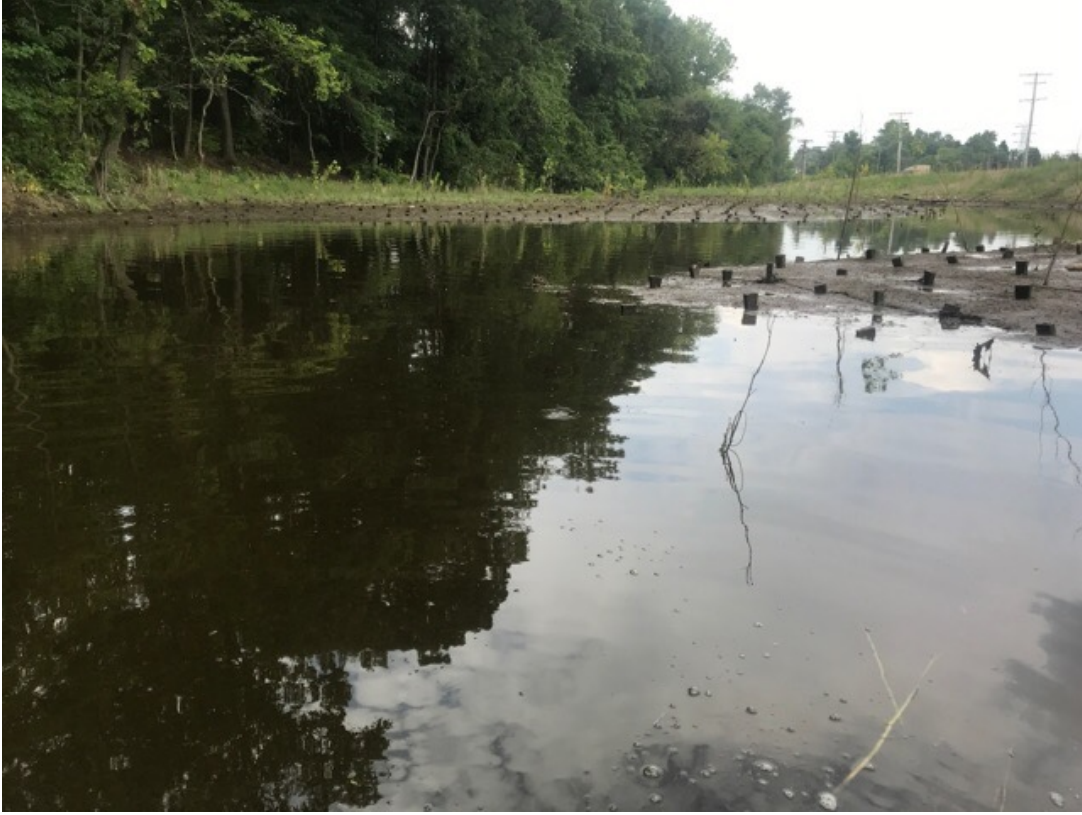
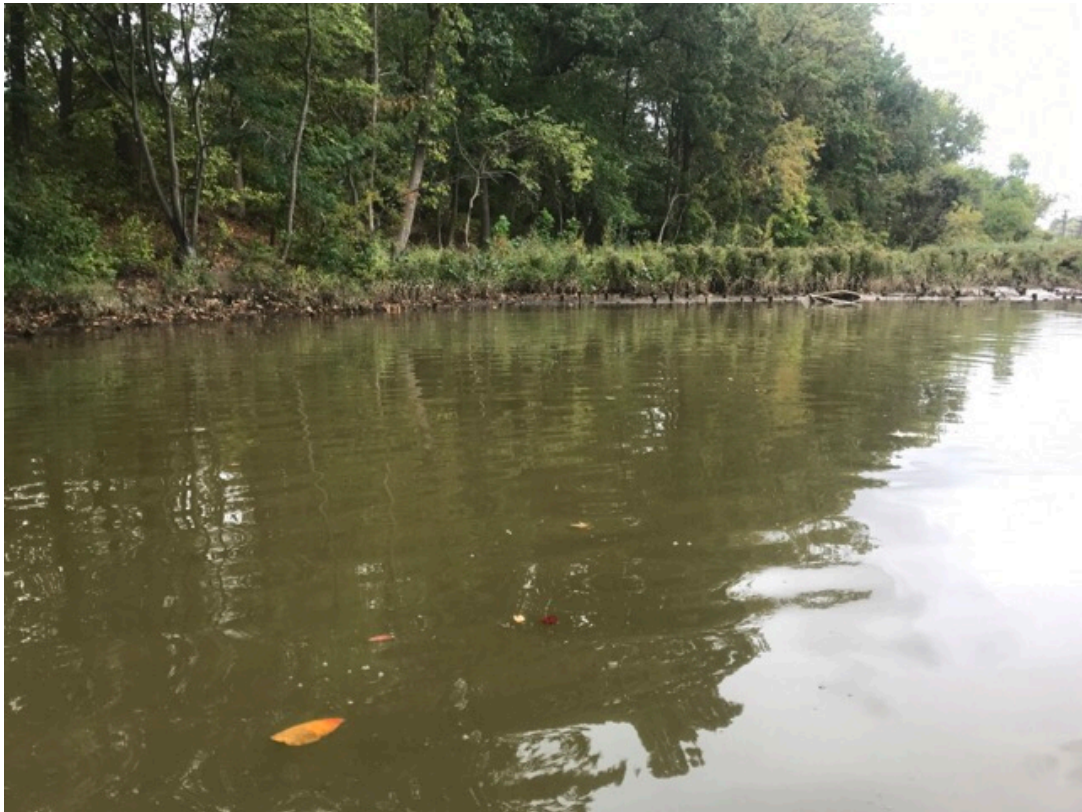
Figure A-97. Upstream view from thalweg at Station 09+67, 2018 (top) and 2019 (bottom).

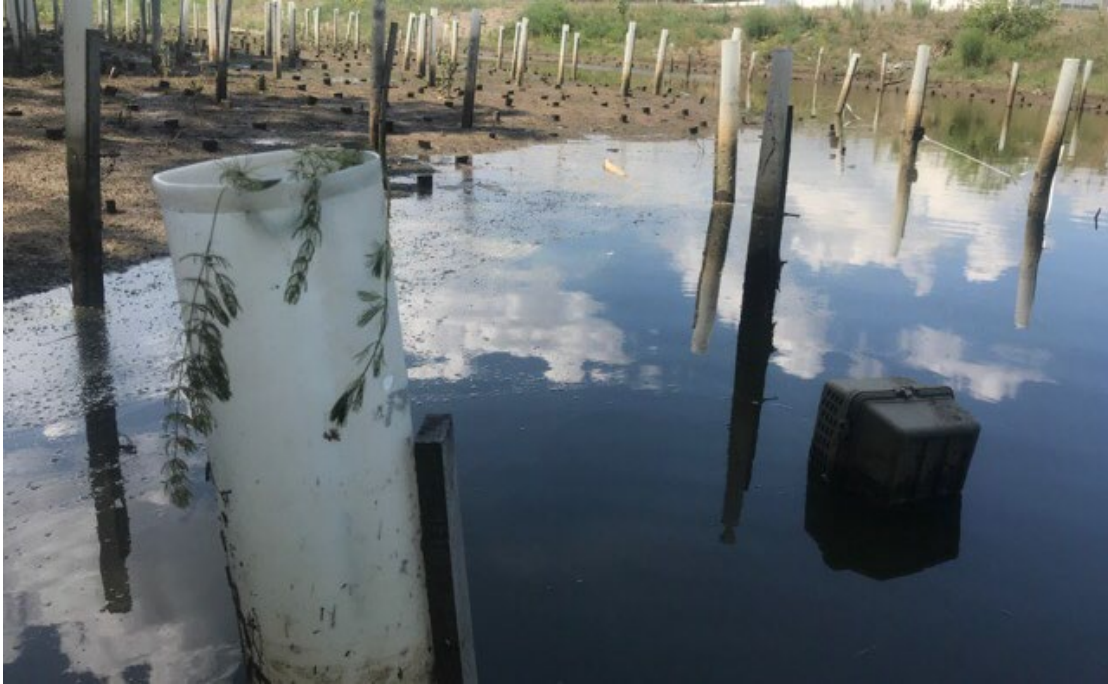
Figure A-98. Inundated tree tubes and new vegetation on the right streambank at Station 09+09, 2018 (top) and 2019 (bottom).

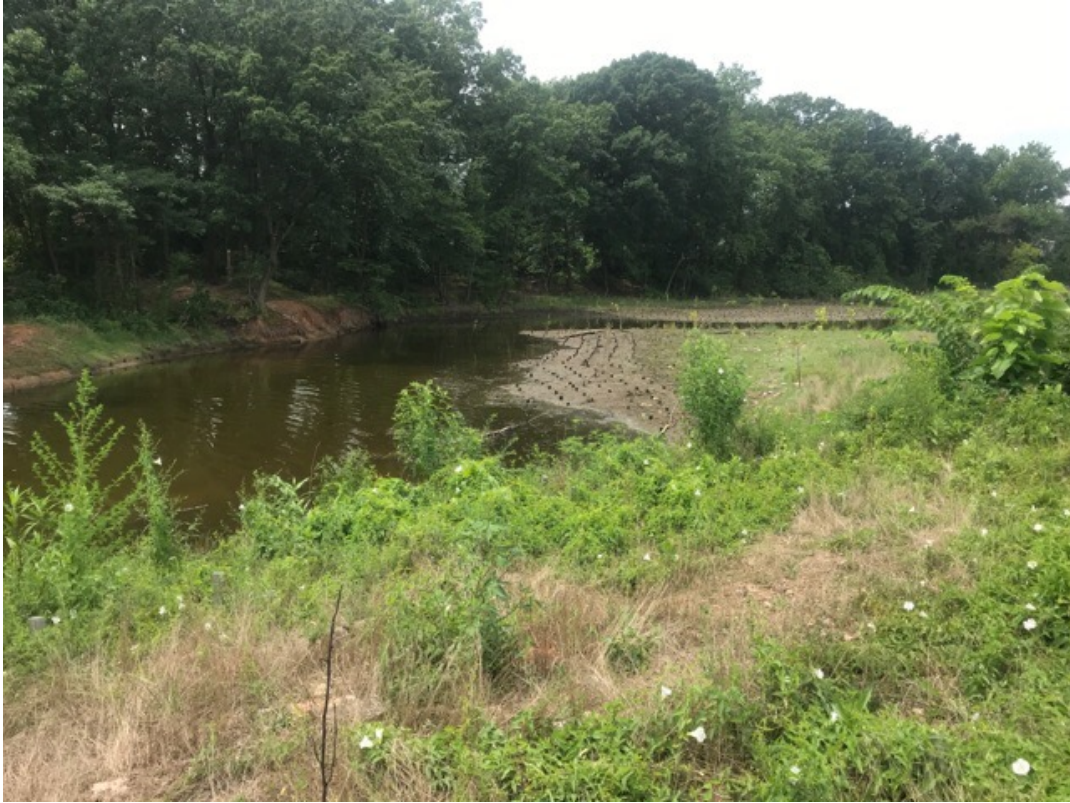
Figure A-99. Upstream view of wetland area at Station 10+00, 2018 (top) and 2019 (bottom).

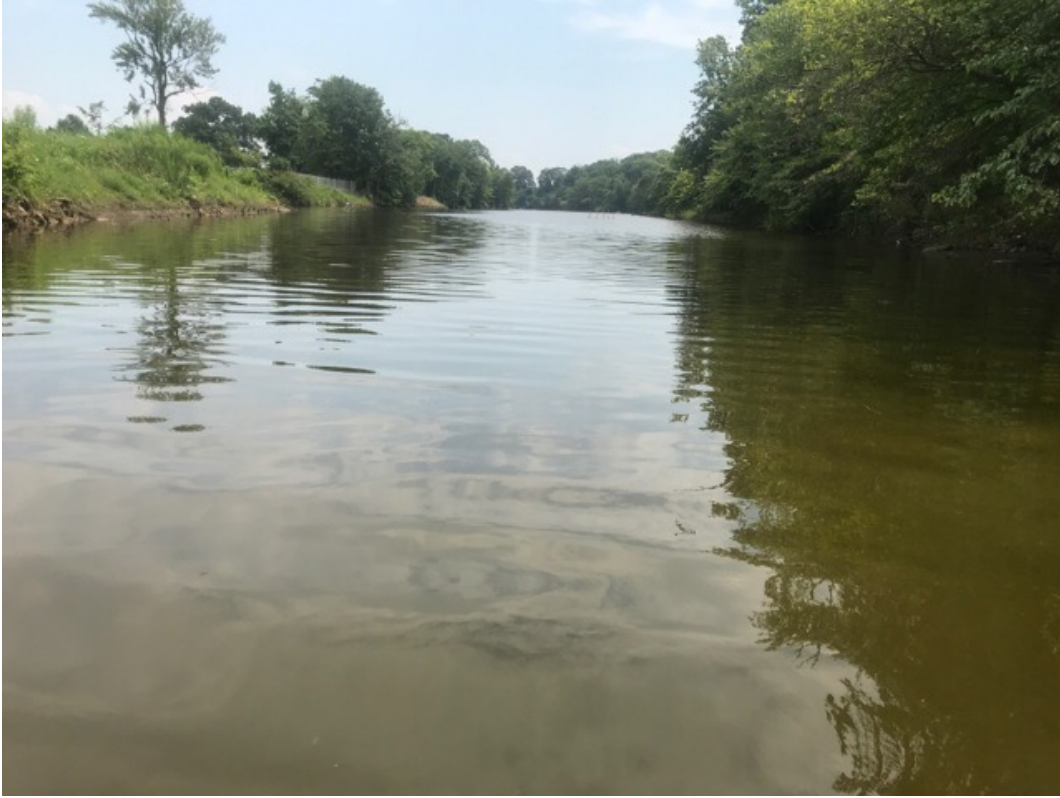
Figure A-100. Downstream view from thalweg at Station 11+00, 2018 (top) and 2019 (bottom).

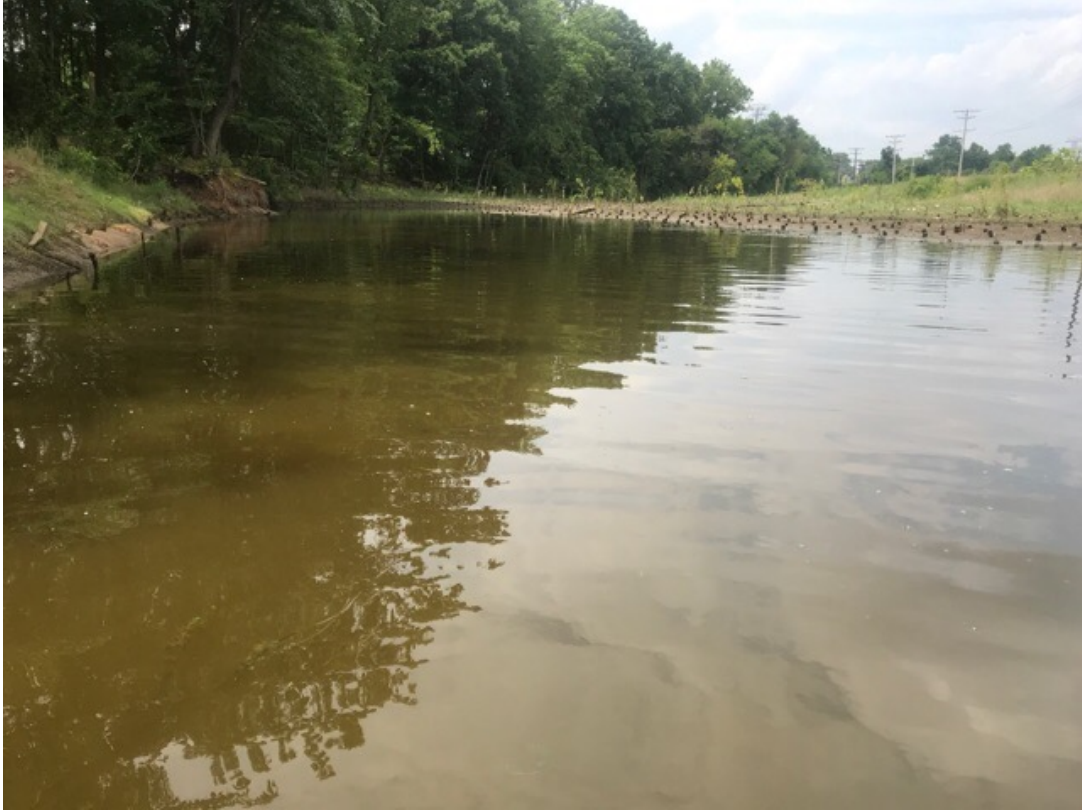
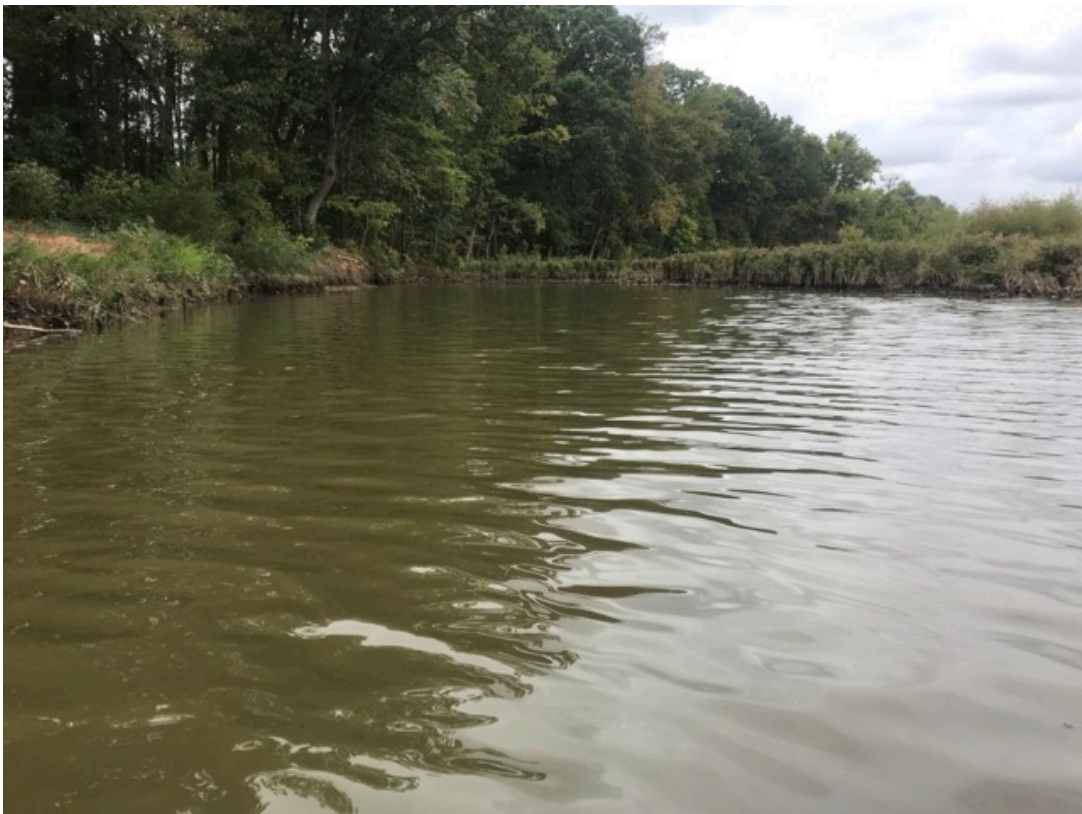
Figure A-101. Upstream view from thalweg at Station 11+00, 2018 (top) and 2019 (bottom).

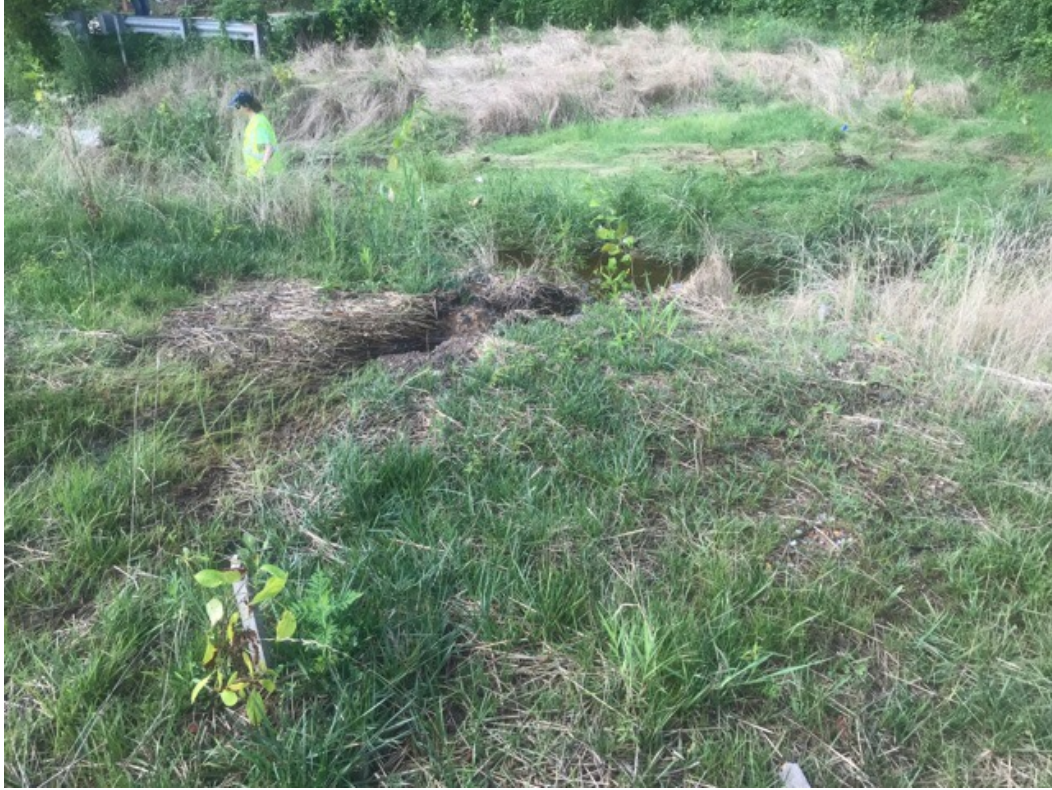
Figure A-102. View from top of floodplain, left streambank at Station 01+30, 2018 (top) and 2019 (bottom).

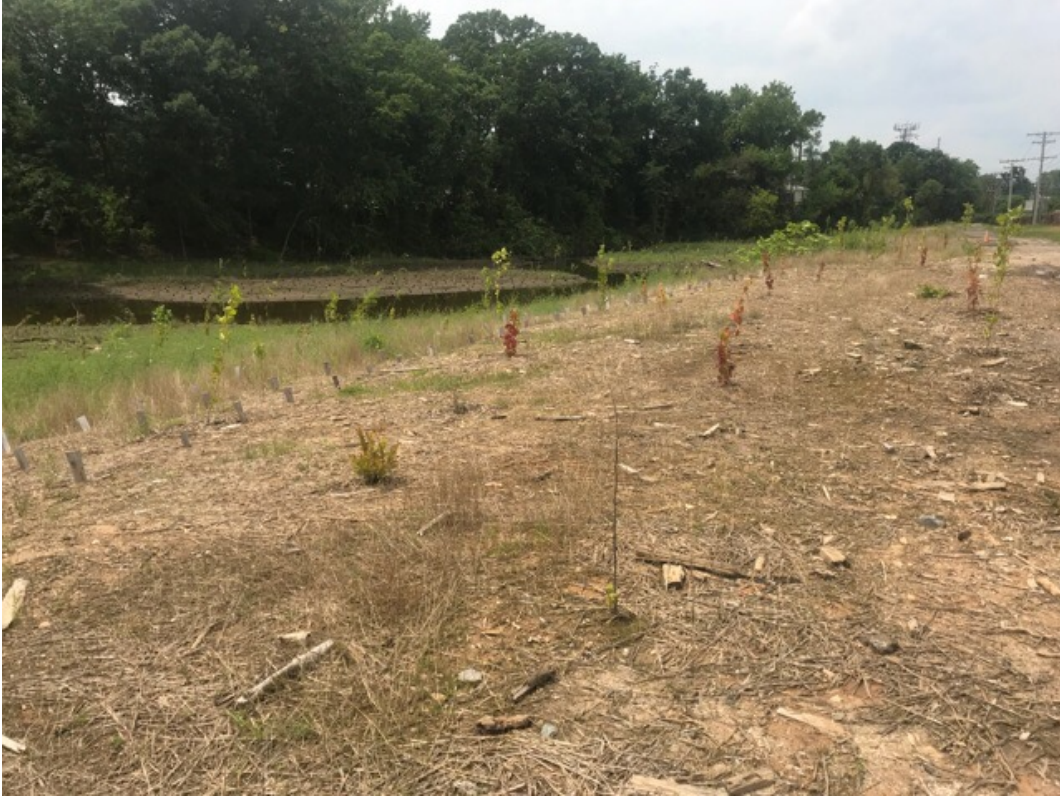
Figure A-103. Upstream view from top of floodplain, left streambank at Station 10+70, 2018 (top) and 2019 (bottom).
