Subject: Transmittal of the Bulkhead and Storm-Drain Assessment, Blocks D and F,  
Lockheed Martin Middle River Complex,  
2323 Eastern Boulevard  
Middle River, Maryland

# **Bulkhead and Storm-Drain Assessment, Blocks D and F, Lockheed Martin Middle River Complex 2323 Eastern Boulevard Middle River, Maryland**

Tetra Tech, Inc.

March 2016

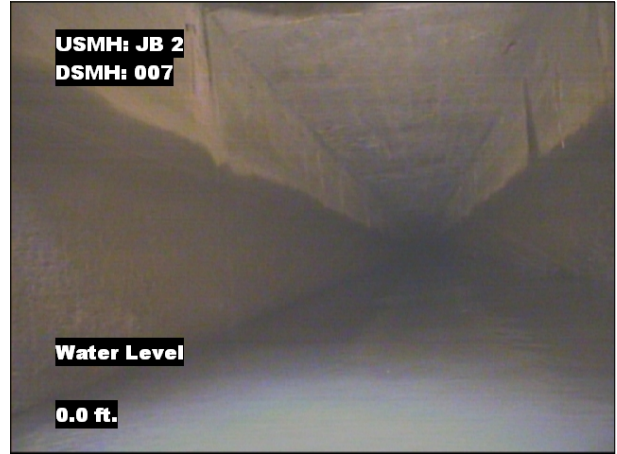
Photo: JB\_2\_007\_MWL\_0.0.jpg, VCR No.: 1  
0FT, Water Level, 30% of cross sectional area
